Town of Sandown Wetland Evaluation Report

Town of Sandown, NH
Conservation Commission

August 2008

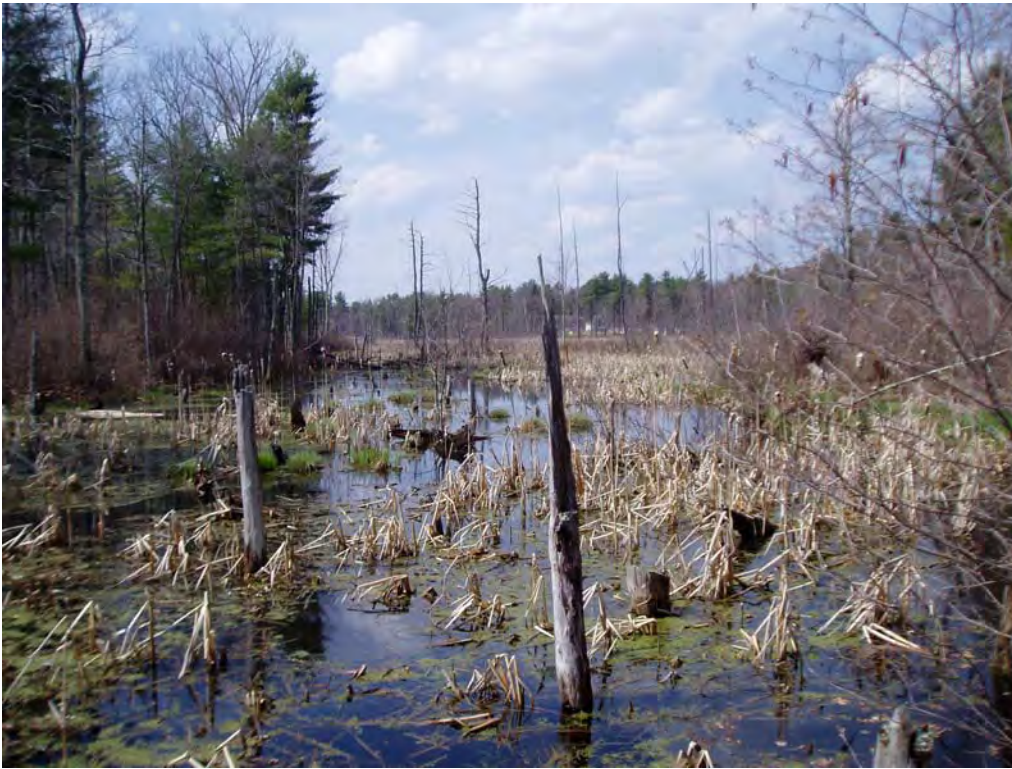
3. This photo shows the narrow section of wetland connecting the upper and most southern components. An earlier beaver dam was observed here.

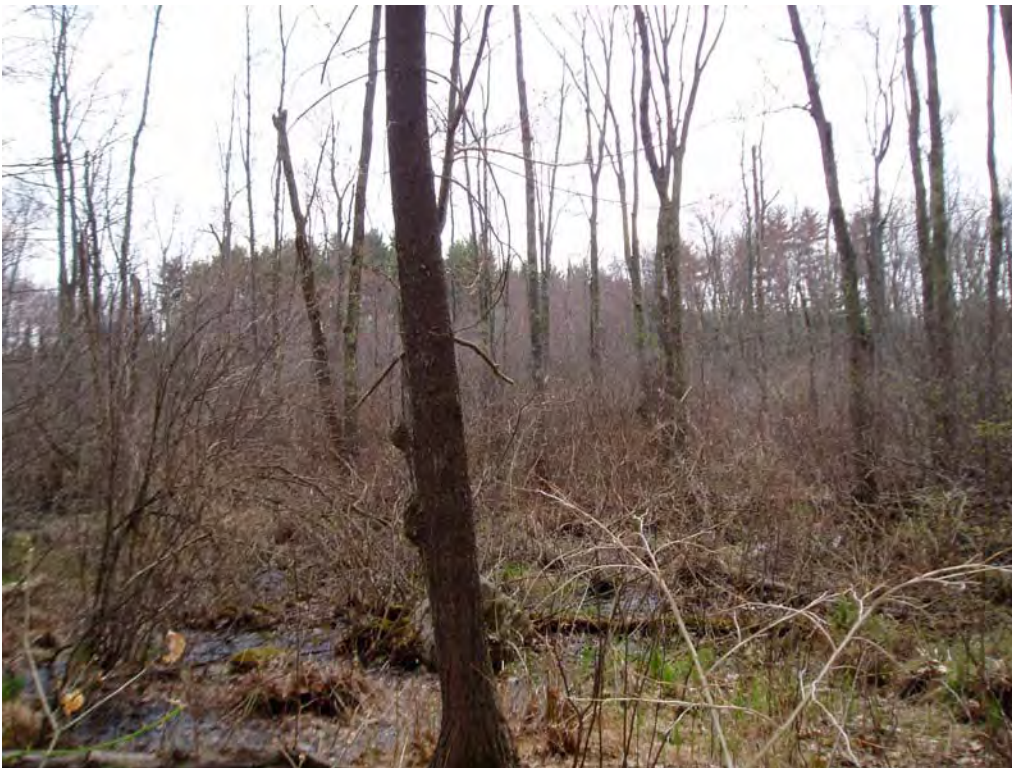
4. This photo shows the most southern wetland component (PFO1E/PSS1E). Here, a chiefly red maple tree layer overtops a thick scrub-shrub layer.

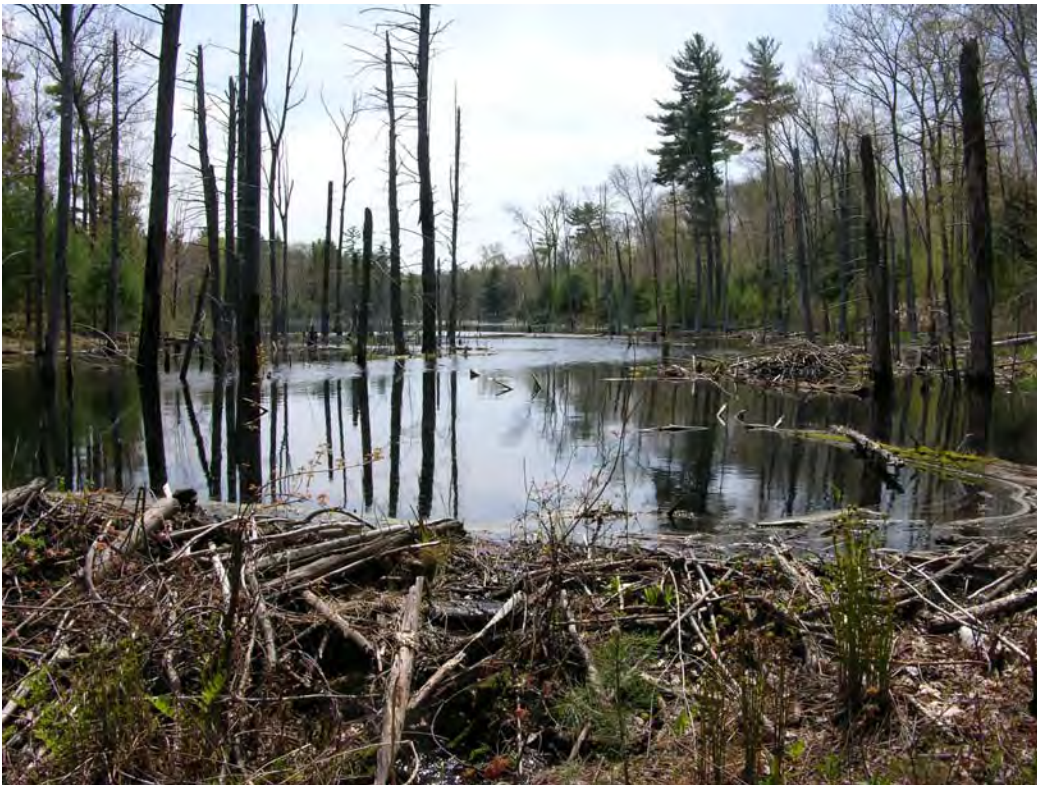
1. This is a view from the beaver dam at the northern end of Wetland #6. Dead trees and deep marsh dominated this portion of the wetland.

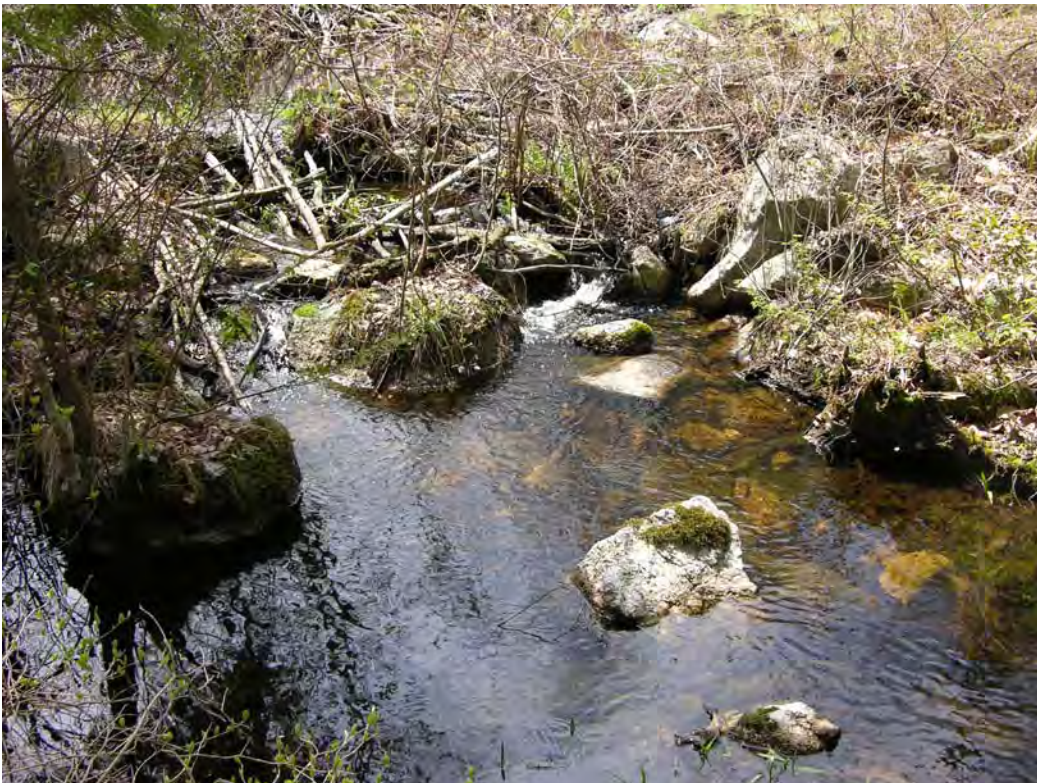
2. This is a photo of the stream that drains from Wetland #6 to Wetland #7.

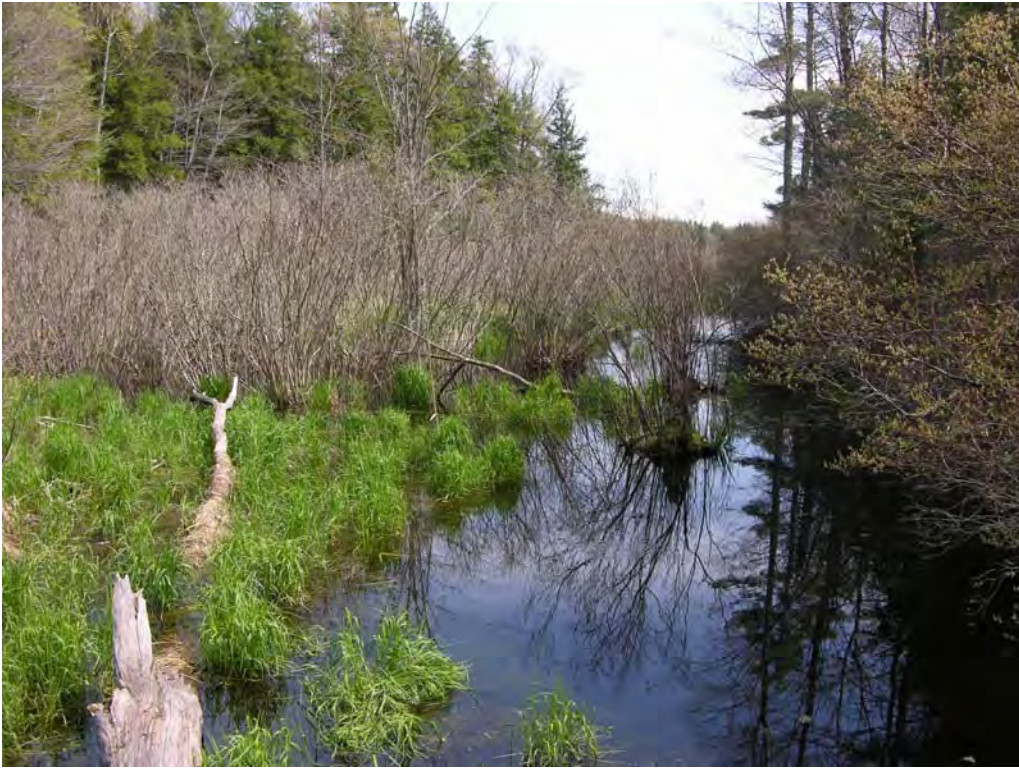
1. The northern end of Wetland #7 includes a thick scrub-shrub marsh system with pockets of open water. This is high value habitat for Blanding's turtle.

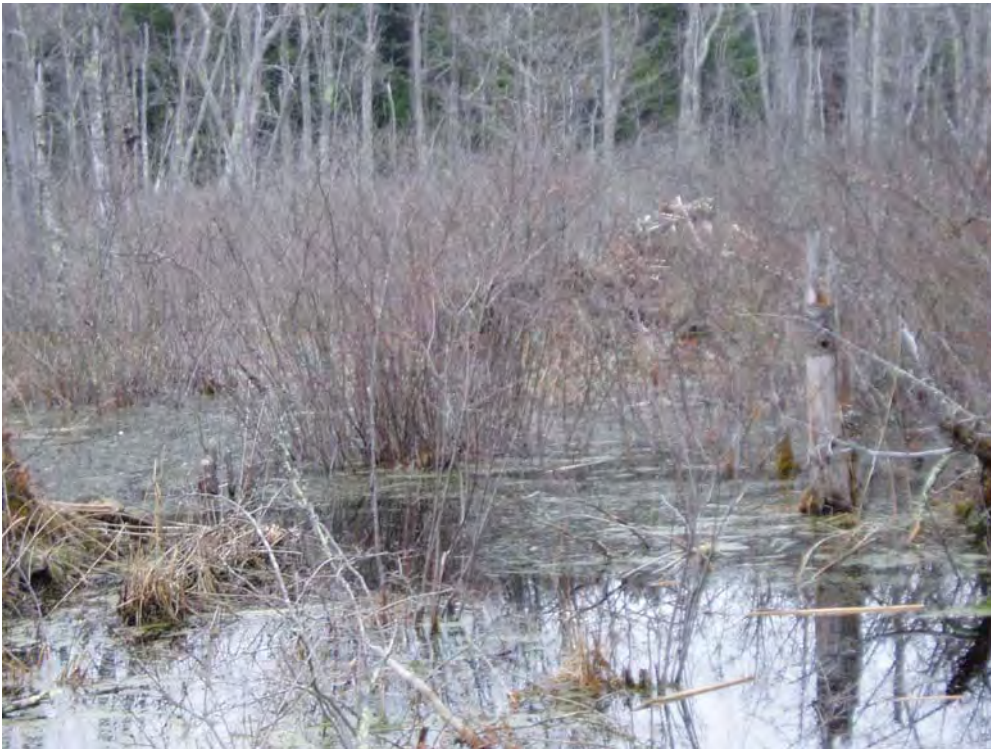
2. A beaver lodge (right, rear) was observed in the thick shrub layer in Wetland #9b. The impoundment of surface water by beaver normally attracts a multitude of other wildlife species.

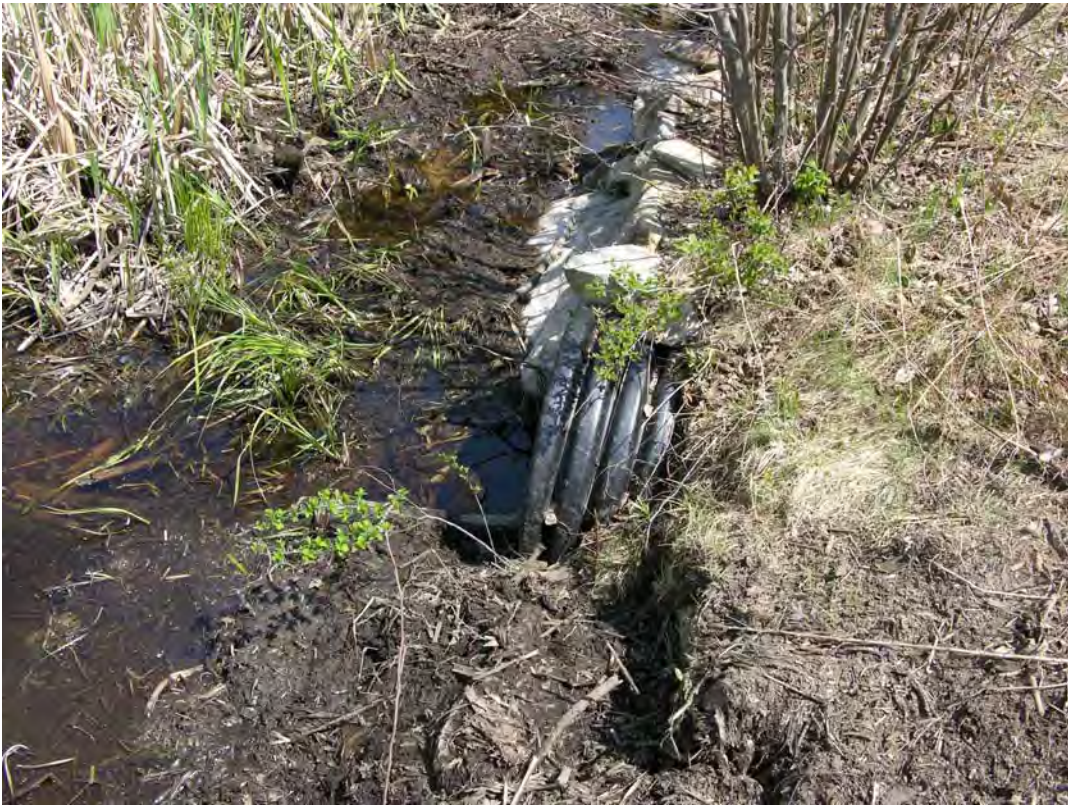
5. This is a view of one of the three 24” diameter culverts which connect Wetland #9b to #9a under the residential driveway.

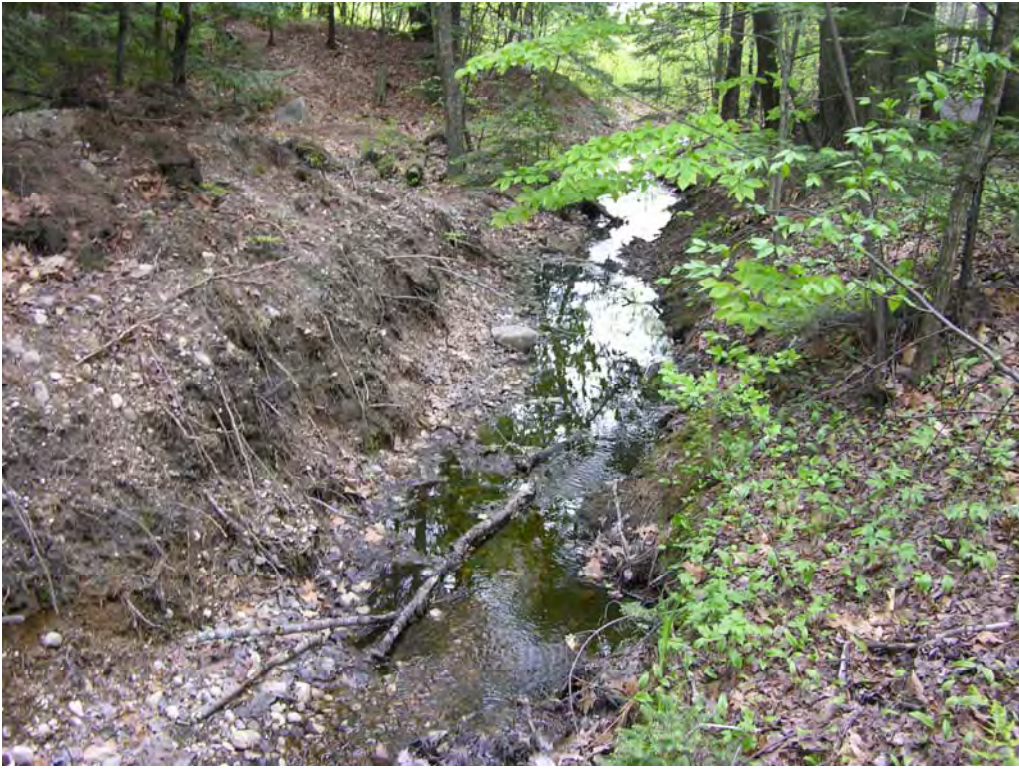
3. This is a view of the outlet of Wetland #22 which drains along the railroad bed to Wetland #14. This area has been recently dredged and a beaver dam may have been removed.

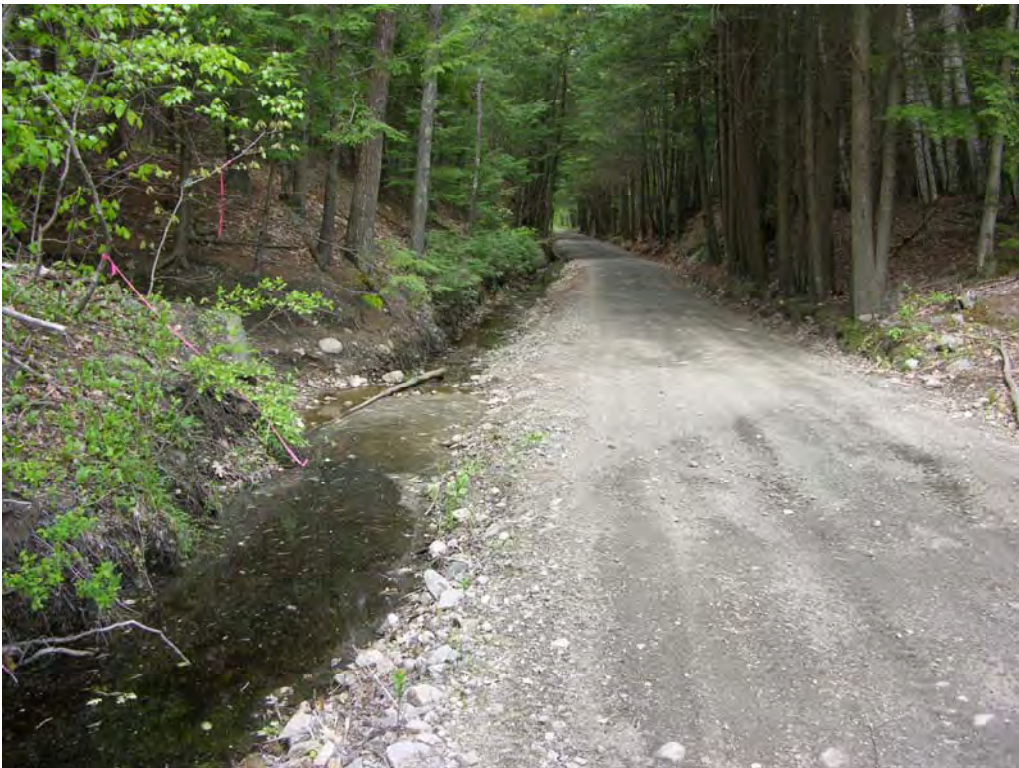
4. It appears that water levels have been lowered in this wetland by maintenance dredging in the ditches along the railroad bed.

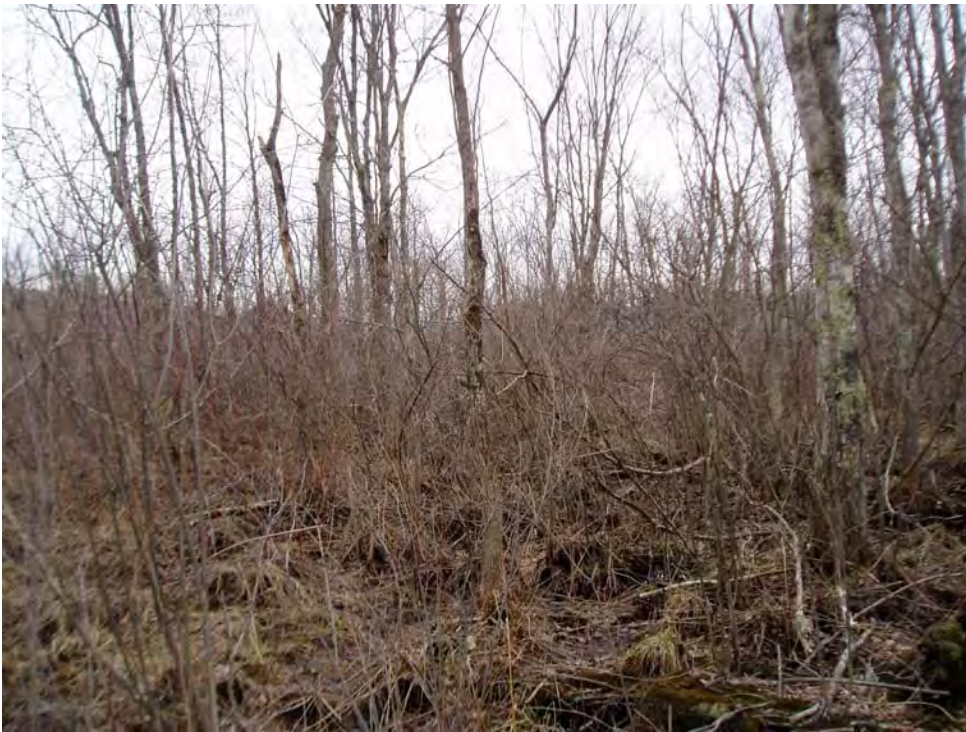
1. Wetland #26 is situated just south of the Chester town line. The larger wetland system extends northward to the Exeter River. Historical ditching was evident throughout this wetland.

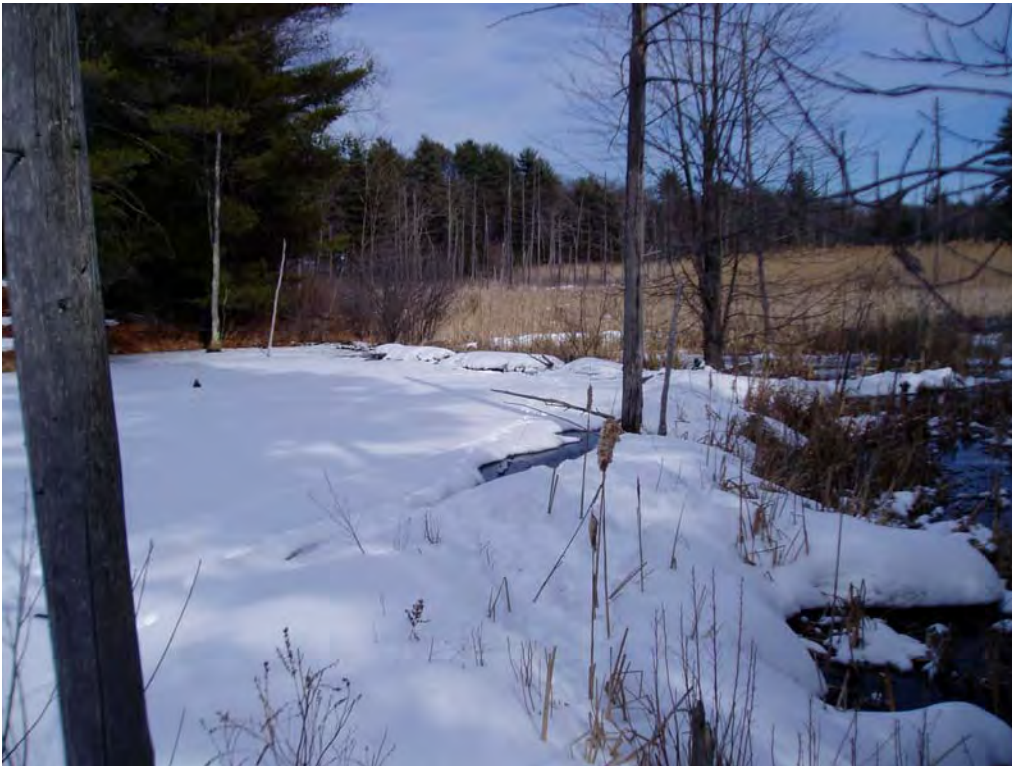
2. This photo shows one of the several beaver dams that separated the individual beaver flowages.

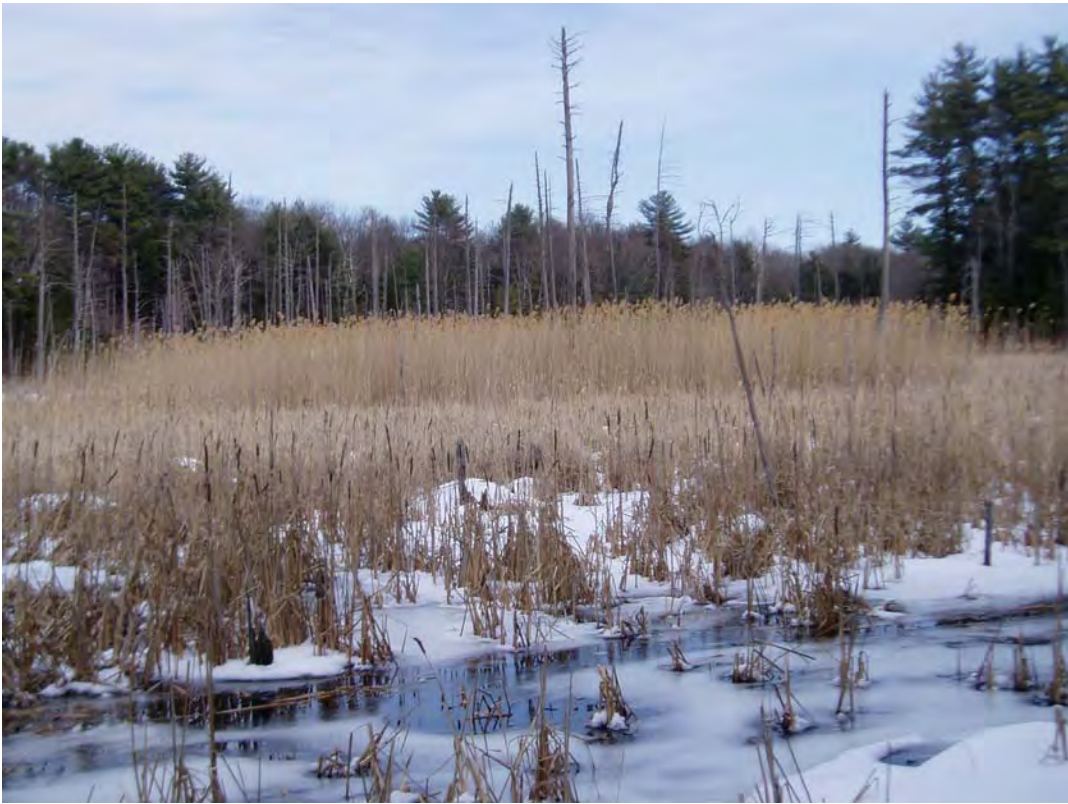
5. Common reed (phragmites), an invasive species, was noted in one of the beaver flowages (the taller vegetation in photo). This invasive often displaces other naturally occurring wetland plants and over time reduces plant diversity.

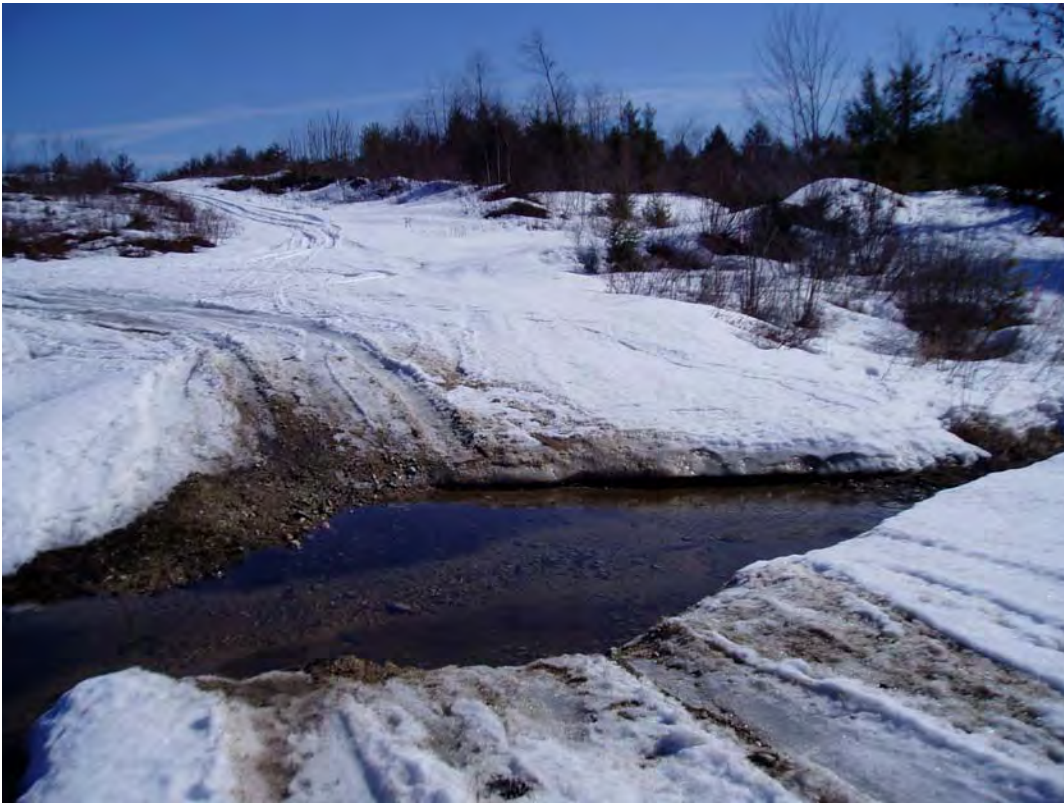
3. This photo shows a heavily used snowmobile/ATV crossing at the most southern end of Wetland #29. Efforts should be made to employ an appropriate crossing structure on this power line road to protect surface waters entering Wetland #31.

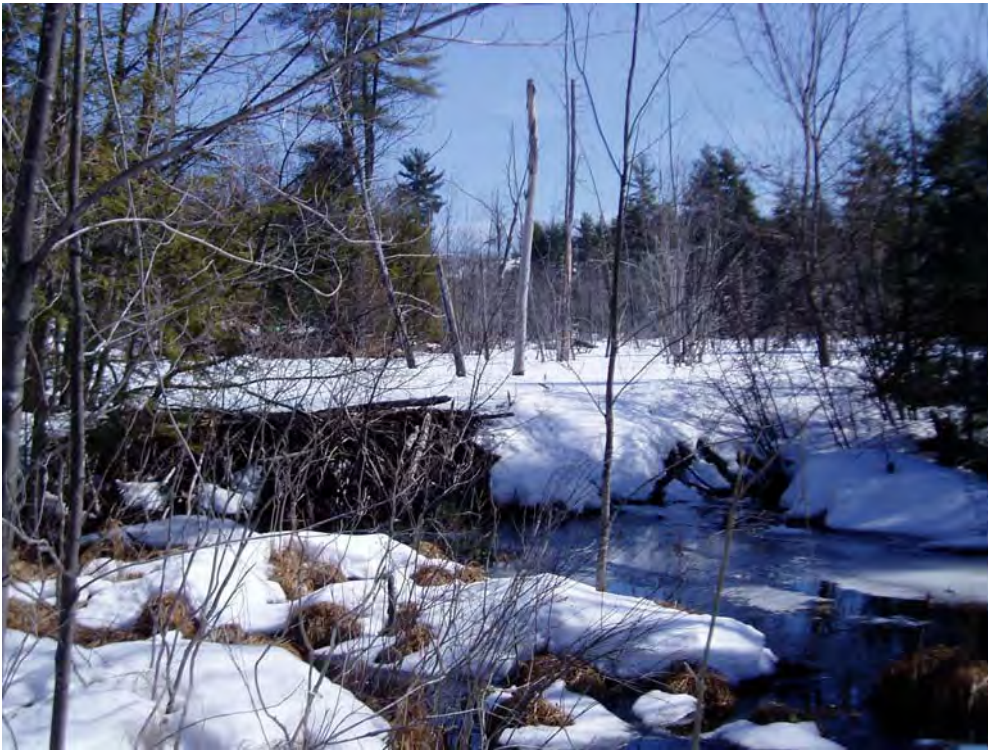
3. This photo provides a view of Wetland #31 looking east from its most western end. Here, a second dam structure was noted.

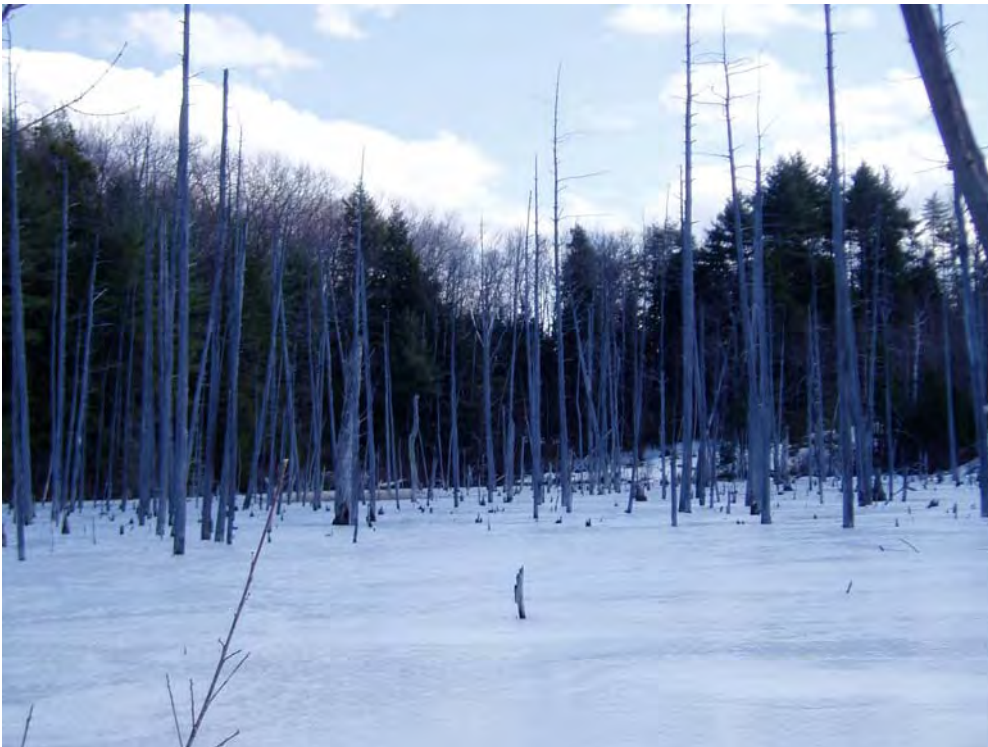
4. The impoundment of water by beaver often surrounds trees which eventually kill them. This photo shows a component within Wetland #31 where this has happened. These trees later provide surfaces in which birds glean for insects.

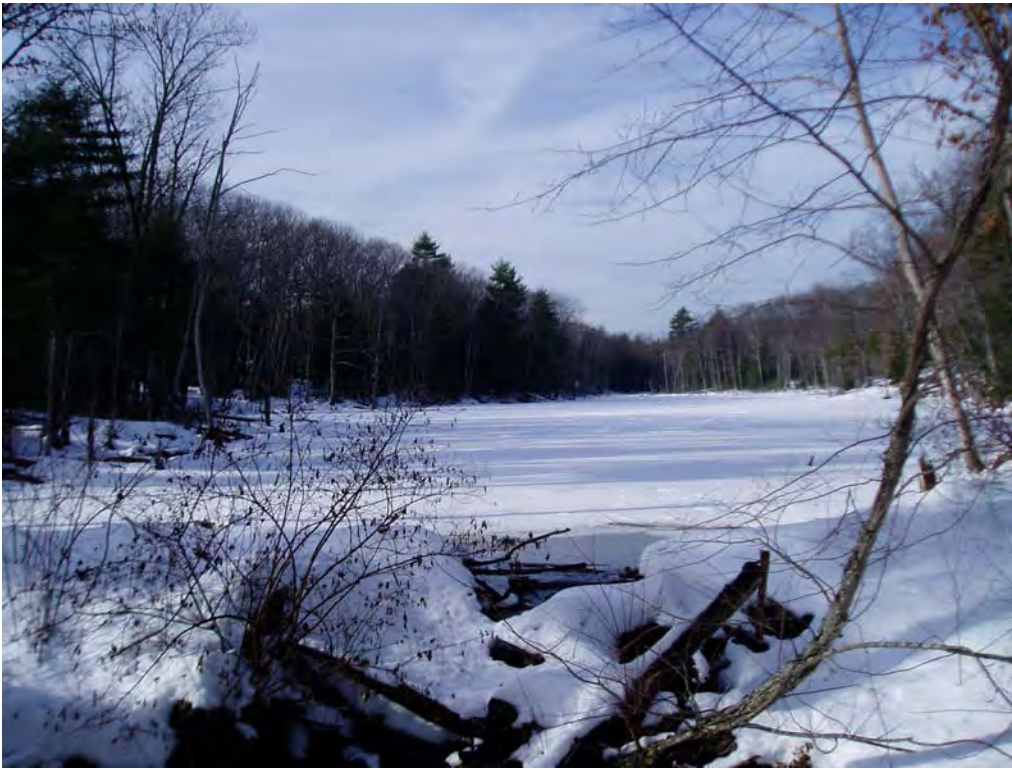
1. Wetland #33 contains a small surface water that has been historically impounded. A perennial stream exits this wetland on the southeast.
