# James Hall Vegetated Roof Nutrient Removal Efficiency and Hydrologic Response

# **James Hall Vegetated Roof Nutrient Removal Efficiency and Hydrologic Response, Final Report, April 2014**

The University of New Hampshire Stormwater Center

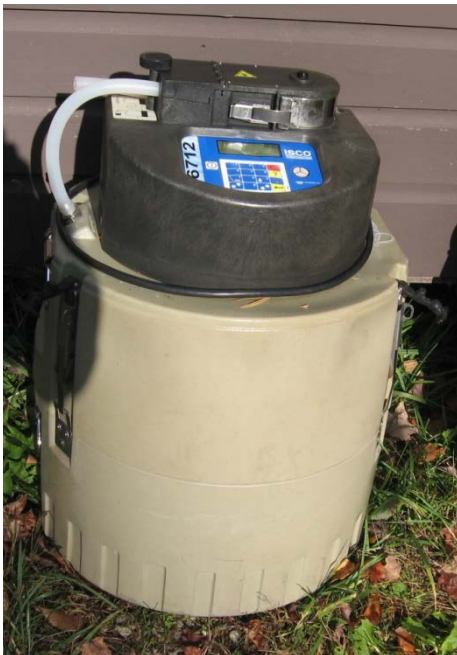
**Figure 1: ISCO Portable Sampler with 6712 programmable control head.**

Teledyne ISCO 6712 Portable samplers (Figure 1) were used to monitor hydrology and take water quality samples during storm events. Each sampler was outfitted with an ISCO 730 Bubbler module to continuously monitor water depth throughout each rain event. Using programmable features of the 6712 the monitored water depth was instantaneously computed into flow using Mannings' equation. Flow values are used to quantify runoff volumes which help to determine flow-weighted intervals. The samplers are equipped with twenty-four 1 liter sample bottles lined with disposable LDPE liners to ensure integrity of each sample. Rainfall was recorded using an ISCO 674 Rain Gauge located at the UNHSC field facility approximately 1 mile from the study site. The 1 liter composite samples are generated using a USGS Decaport Cone Splitter and sample splitting matrix developed by UNHSC research staff. Whatman Glass Microfiber Filters were used for processing the filtered s
