Wetlands Evaluation for Philbrick's Pond Marsh Drainage Evaluation North Hampton, NH

Wetlands Evaluation for Philbrick's Pond Marsh Drainage Evaluation, North Hampton, NH

Wetlands Evaluation

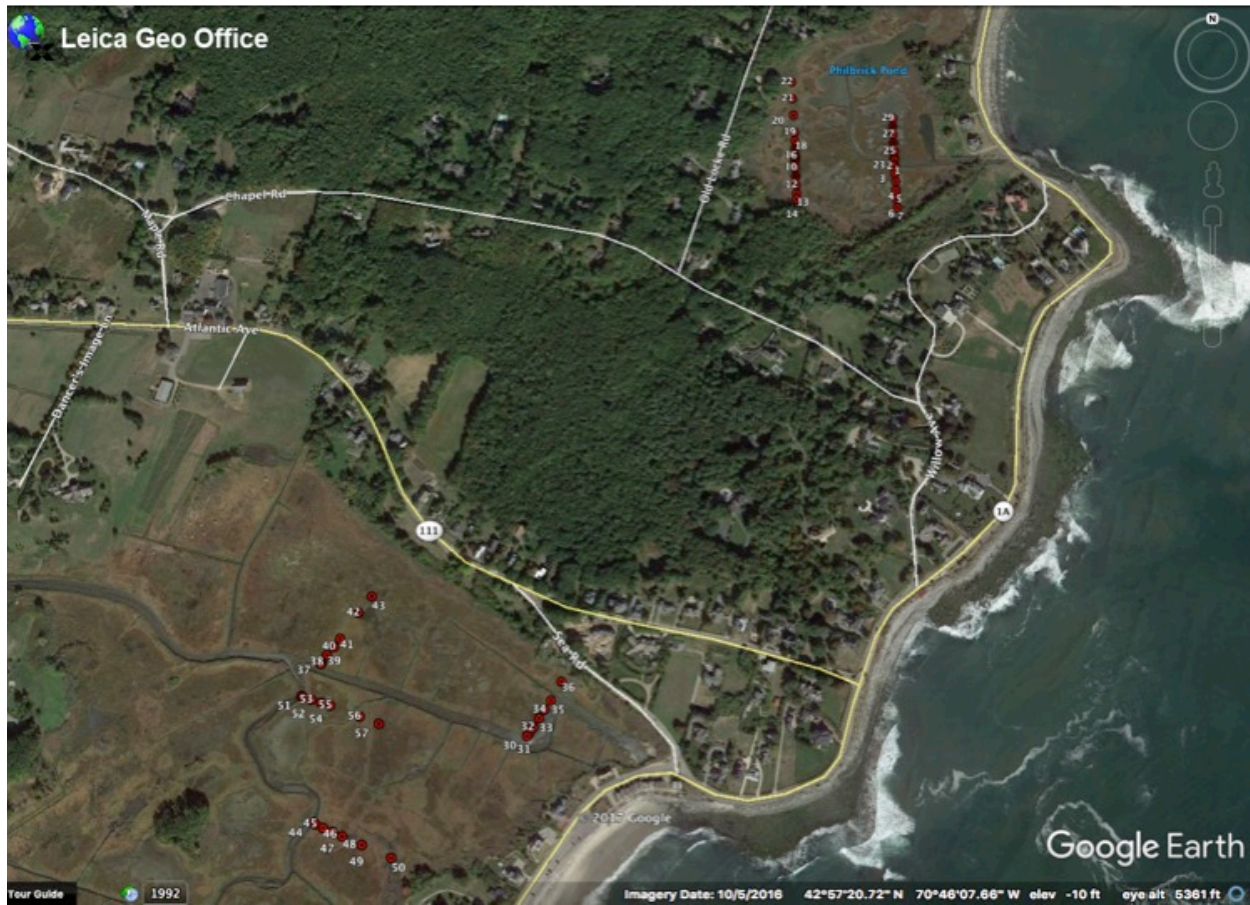
Figure 1. Overview of Philbrick's Pond (upper right) and Little River (lower left); two back-barrier marshes along the Atlantic coast of New Hampshire.

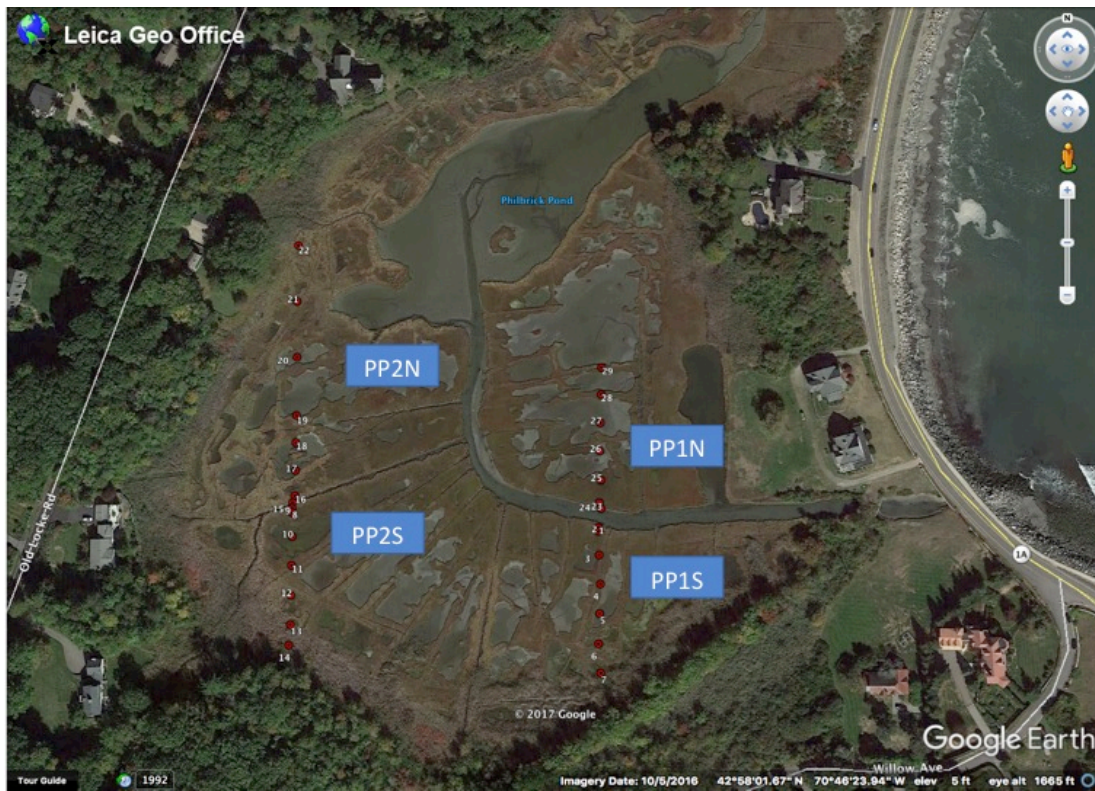
Figure 2. Stations along four transects in Philbrick's Pond sampled in 2017.

Philbrick's Pond ("PP") Marsh and Little River ("LR") Marsh were both assessed as part of the NH Coastal Program's salt marsh monitoring program at the turn of the century, which involved collections of species composition and abundance of salt marsh plants along transects running from major tidal creeks to the upland edge at randomized locations. Using positions documented in the original database, we re-occupied four transects in each of the two marshes (Figure 1), and collected data in August from 0.5 m² plots at 1, 10, 50 feet and every 50 feet thereafter up to 200 feet. After 200 feet, 50 or 100 foot intervals were used to obtain seven plots per transect. This resulted in 29 plots at PP Marsh (Figure 2) and 28 at LR Marsh (Figure 3).

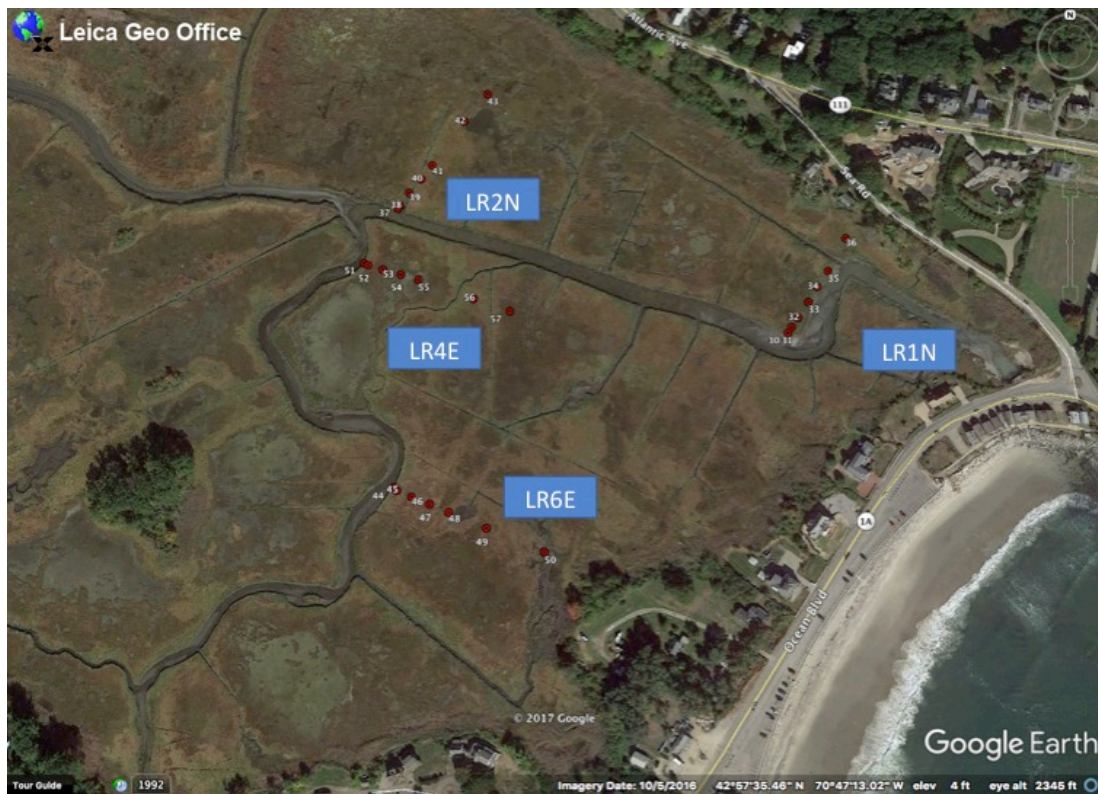
Figure 3. Stations along four transects in Little River Marsh Pond sampled in 2017.

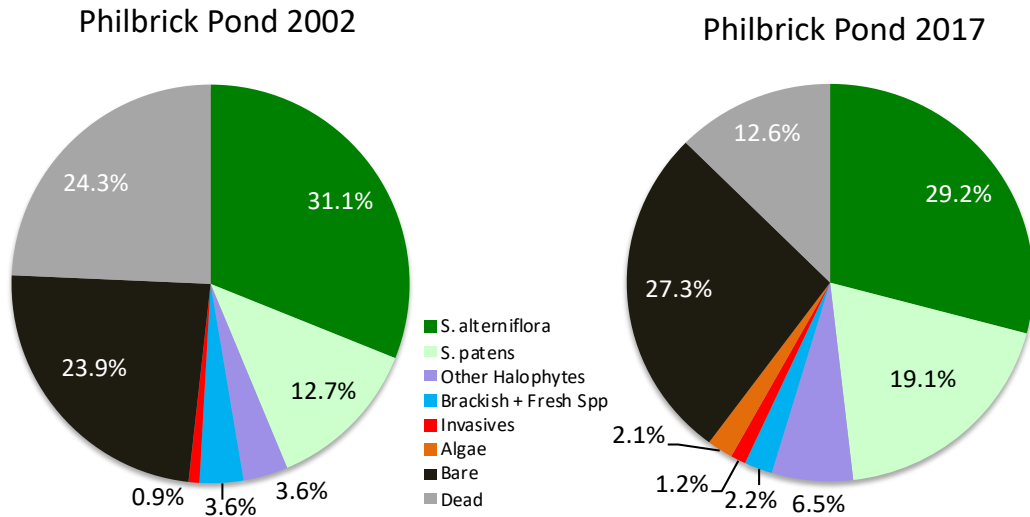
Notes: Other Halophytes = all halophytes except SA and SP. In 2002, monitoring done by NHCP, which measured open water as a category factored into 100% cover; assumed bare. 2002 n=52, 2017 n=29 due to different sampling intensity.

Figure 4. Vegetation cover averaged across four transects at Philbrick’s Pond Marsh in 2002 and 2017.

Lower elevations, impeded drainage and more stressful conditions were reflected in the vegetation of Philbrick's Pond Marsh. In 2017, we found typical salt marsh plants (halophytes: *Spartina alterniflora*, *S. patens*, and others) covering about 55% of the plots and 40% bare sediment or dead grasses (Figure 4). Plant cover was similar to the original survey in 2002, with slightly less *S. alterniflora* (cordgrass) but more *S. patens* (salt hay). The most dramatic changes appear to have occurred sometime after the mid-twentieth century, but before 1984 when Dr. Short interpreted the large unvegetated areas still seen today as: "an area of dead saltwater hay (*Spartina patens*) covered by a thick mat of blue green algae."

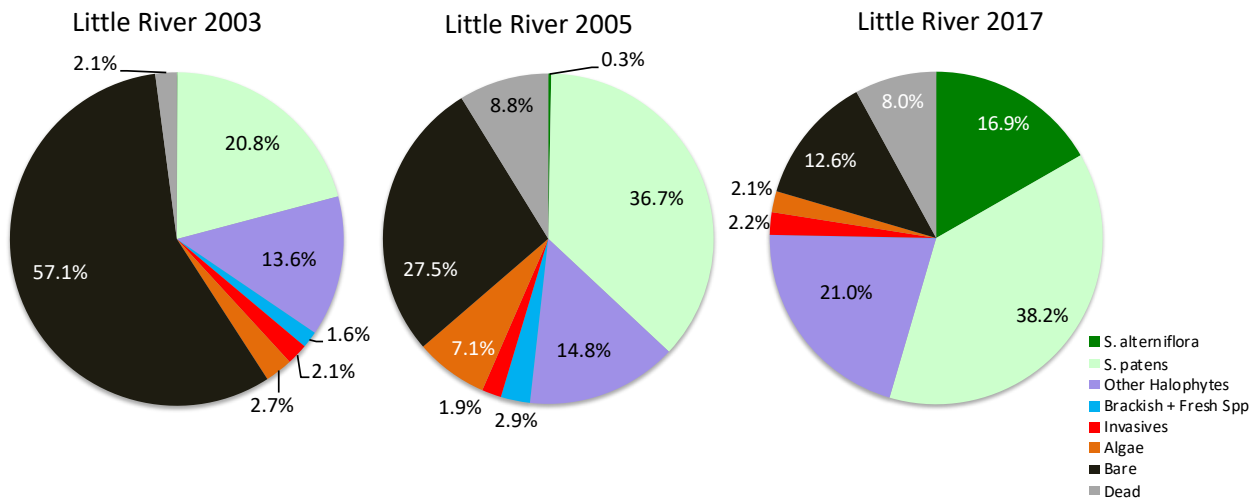
Notes: Other Halophytes = all halophytes except SA and SP. In 2003 and 2005, monitoring done by NHCP, which measured open water as a category factored into 100% cover; assumed bare. 2003 n=131, 2005 n=140, 2017 n=28 due to different sampling intensity and more transects in 2003 and 2005.

Figure 5. Vegetation cover averaged across four transects at Little River Marsh in 2017 compared with earlier results that combined more transects and closer plot spacing in 2003 and 2005. A large tidal restoration project was completed in 2000, resulting in loss of fresher plant species.

In comparison, Little River Marsh showed a dramatic recovery from the large tidal restoration completed in 2000, based on data from 2003 and 2005 in addition to 2017 (Figure 5). Dead plants and bare ground were dominant at 60% cover in 2003, but decreased to 20% cover in 2017 while *S. patens* and *S. alterniflora* both increased, contributing to a total of 76% halophyte cover in 2017. With LR Marsh now largely restored (Chmura et al. 2012) it can serve as a reference marsh to compare conditions in Philbrick's Pond Marsh.

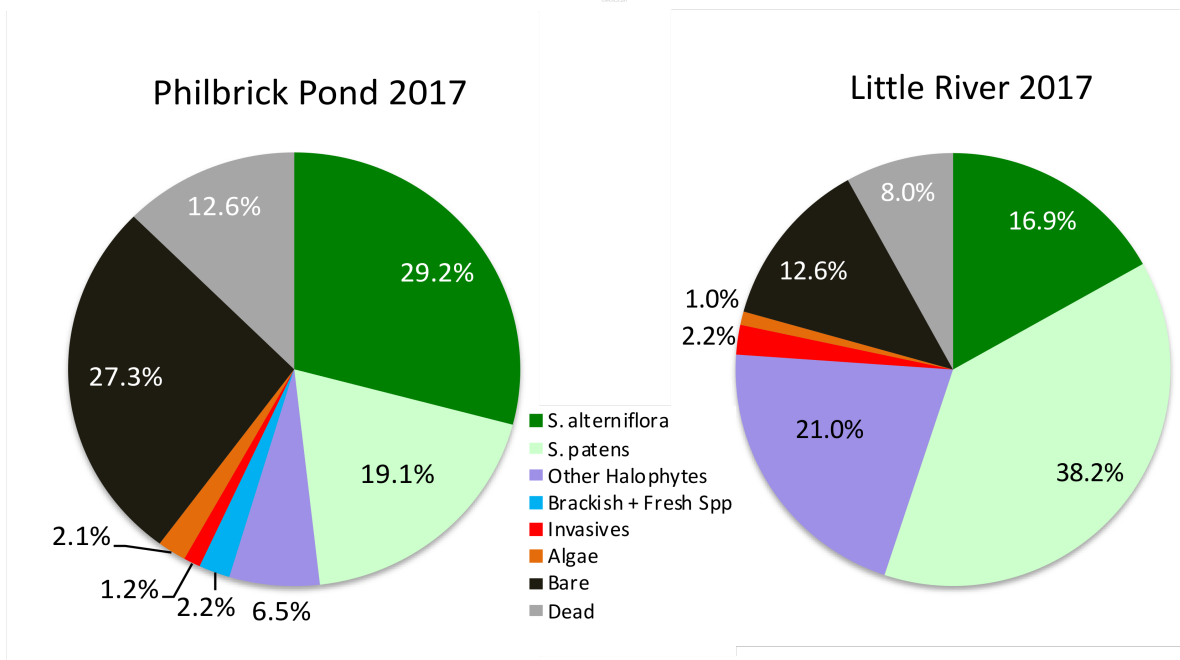
Note: Other Halophytes = all halophytes except SA and SP.

Figure 6. Vegetation cover averaged across four transects at Philbrick's Pond Marsh and Little River Marsh in 2017.

In 2017, our reference site at Little River Marsh was dominated by salt hay (38%) but also had a variety of other high marsh plants (halophytes) summing to 21% cover (Figure 6). In wetter areas (areas with greater flooding and/or less drainage), tall cordgrass was found to dominate the vegetation, contributing 17% cover. We found only 20% cover of dead and bare and 2% cover of invasive species, notably *Phragmites australis* (common reed). In sharp contrast, Philbrick's Pond Marsh showed 40% dead and bare (including the plots that fell within the large pools), likely due to stressful conditions. When compared to Little River Marsh, we found half as much salt hay, the high marsh dominant, and almost twice as much *S. alterniflora*, which is better adapted to the more stressful inundated conditions at Philbrick's Pond Marsh.
