## 2016 Oyster Reef Restoration Project Funded by the Aquatic Resources Mitigation Program

# Oyster Reef Restoration in Great Bay Estuary

FINAL REPORT - March 31, 2017

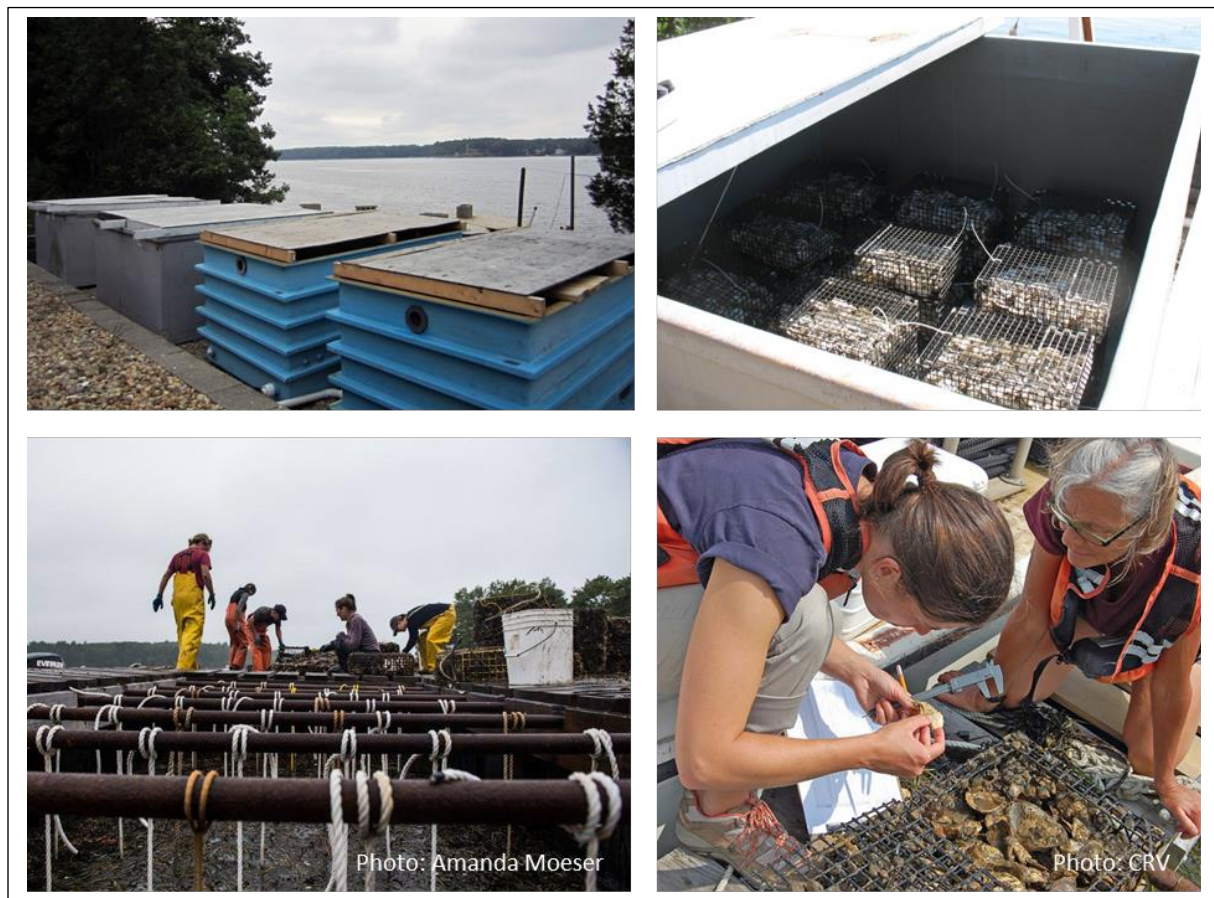
Fig. 4. Overview of SOS production showing remote setting tanks with seasoned shell in cages (upper photos) and maintaining spat on nursery raft (lower photos).

Preparation of seasoned, recycled oyster shell and the remote setting tanks at Jackson Estuarine Laboratory occurred on June 15 – 21, 2016 (Fig. 4). Approximately 12 million oyster larvae were received on June 22, 2016 and placed into the remote setting tanks. The resulting live oyster SOS were moved from the remote setting tanks to the nursery rafts in Adams Cove on June 27, 2016.
