# Oyster Bed Mapping in the Great Bay Estuary, 2012-2013

A Final Report to  
The Piscataqua Region Estuaries Partnership and  
New Hampshire Department of Environmental Services

Submitted by  
Raymond Grizzle and Krystin Ward  
University of New Hampshire  
Jackson Estuarine Laboratory, 85 Adams Point Road  
Durham, NH 03824

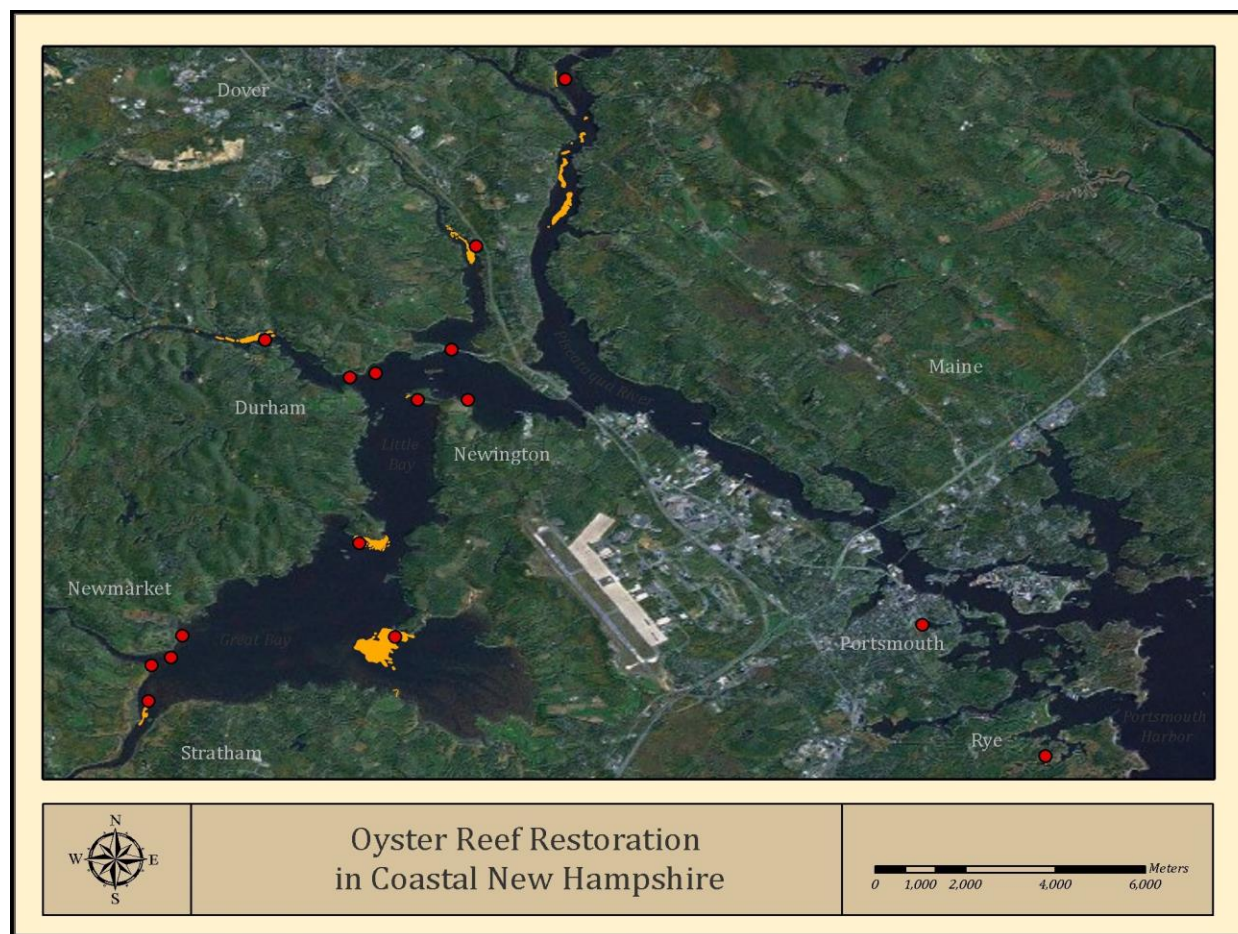
Fig. 1. General locations of major oyster restoration projects since 2000 (red circles) in relation to six major natural oyster beds (yellow polygons).

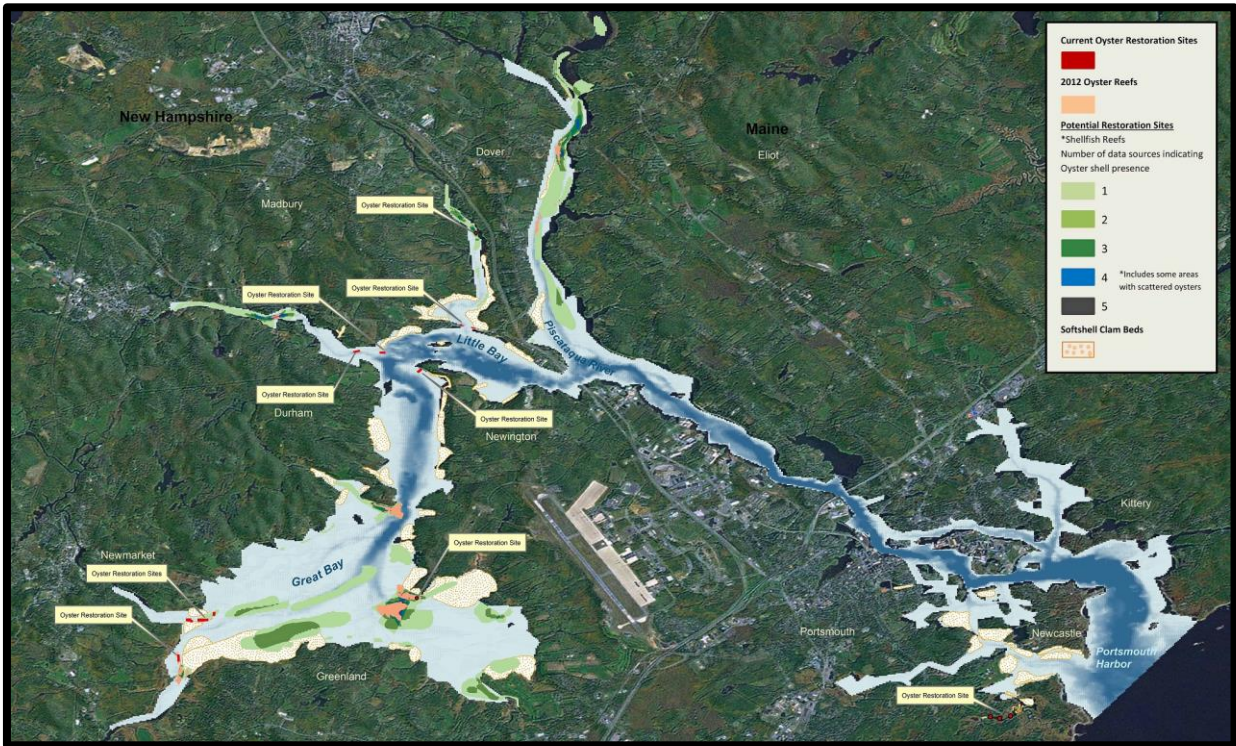
Fig. 2. Locations where live oysters (green to blue polygons) were shown on historical maps; note color coding to show the number of historical maps where each bed was shown, thus giving an estimate of accuracy), and major recent oyster restoration projects (revised from Odell et al. 2006) (also see Fig. 1).

is also a need to determine the boundaries of some of the oyster restoration projects that have been conducted since 2000. Therefore, the second objective of the present project was to map as many of the areas as practical where available information indicated live oysters historically occurred in the Great Bay Estuary, and where major recent restoration projects have been completed (Fig. 2).

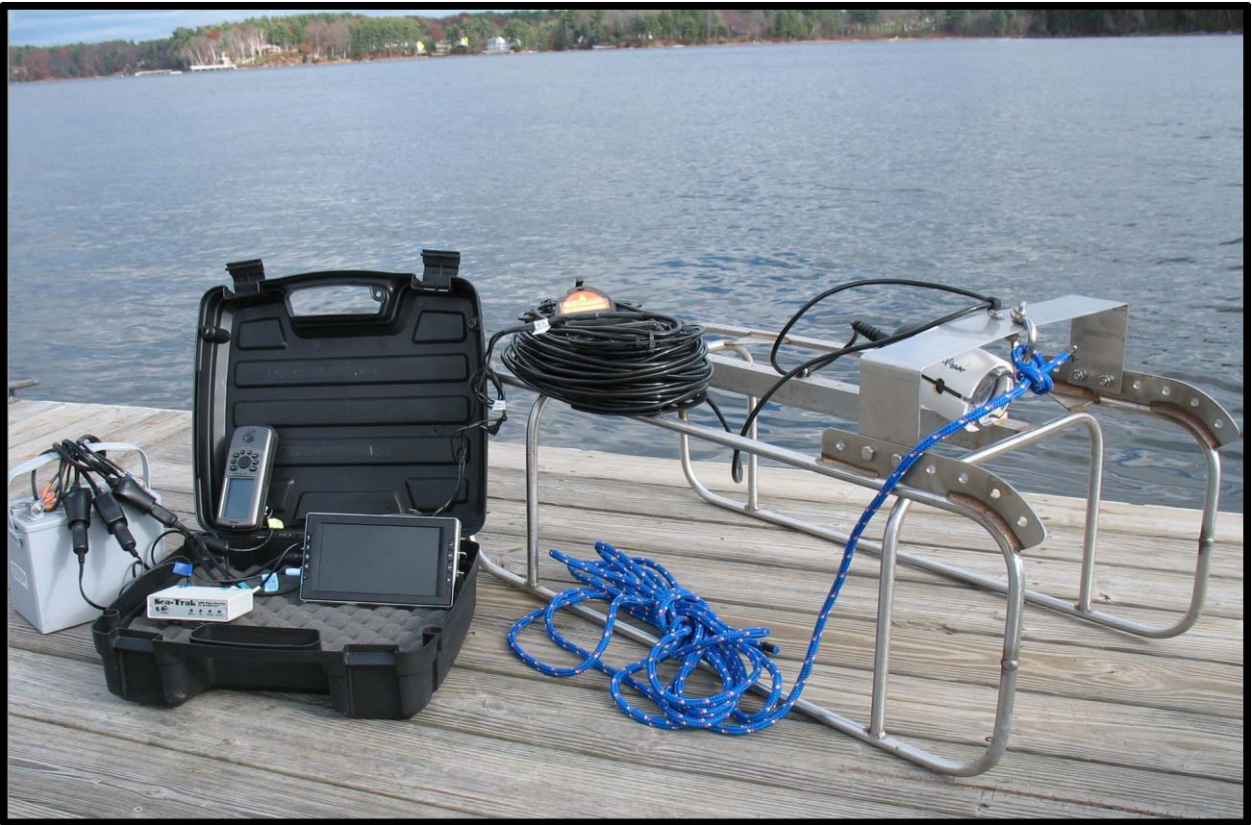
Fig. 3. Towed underwater video system showing major components (see text for details).

Towed underwater videography was used to map the six major oyster beds in the Great Bay Estuary system that are regularly sampled by NHF&G (Objective 1; see above), and historical beds and major restoration areas (Objective 2; Table 1). Methods used in previous surveys (Grizzle and Brodeur 2004; Grizzle and Ward 2009) and as described in detail in Grizzle et al. (2008) were used in the present project. Briefly, a video system consisting of a SeaViewer model 550 color camera was deployed in towed mode on a sled with imagery continuously recorded onto a digital video recorder along multiple transects across each mapping area and extending beyond the boundaries of where live oysters were observed (Fig. 3). A Garmin 76CSx GPS unit was used with WAAS mode activated and horizontal position data recorded near-continuously along each shiptrack and overlaid onto the video imagery. A minimum of five transects were traversed along the major axis of each mapping area with 5 to 20 m distance between transects. All imagery was reviewed in the laboratory and classified into one of two categories: “non-reef” (<20% shell cover, no live oysters visible) and “reef” (>20% shell cover and potentially [based on video imagery] live oysters).

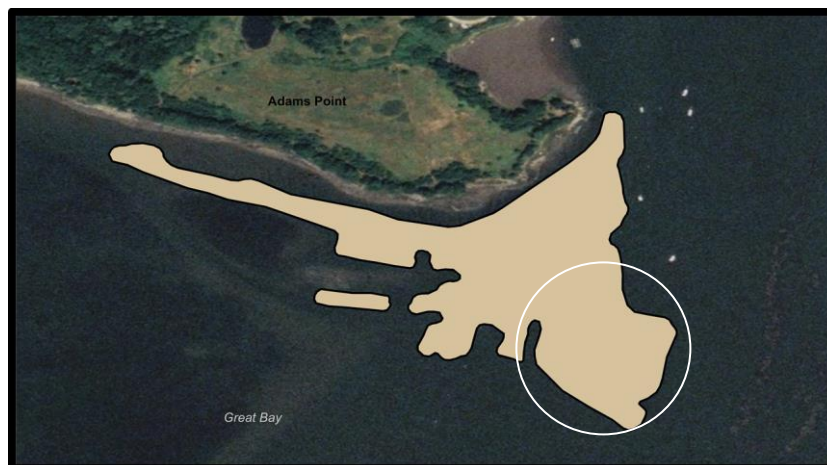
Fig. 4. Polygon for Adams Point reef based on video imagery recorded on October 8, 2012. Circle indicates bottom area probably not mapped in previous recent surveys (see Appendix A for metadata).

The Adams Point reef area appears to have increased substantially compared to the 2001 survey (Table 2). Most of the increase, however, is likely due to a new area being surveyed in 2012 southeast of the main portion of the reef (Fig. 4). Previous video surveys (e.g. Grizzle et al. 2008b) had not imaged this area due to water depth or other reasons. A portion of this “new” area had dense cover by live oysters, and had the overall appearance

of a healthy reef. Based mainly on the contiguous nature of the new area with previously mapped portions of the reef, it seems likely that this area had just been overlooked in previous surveys.

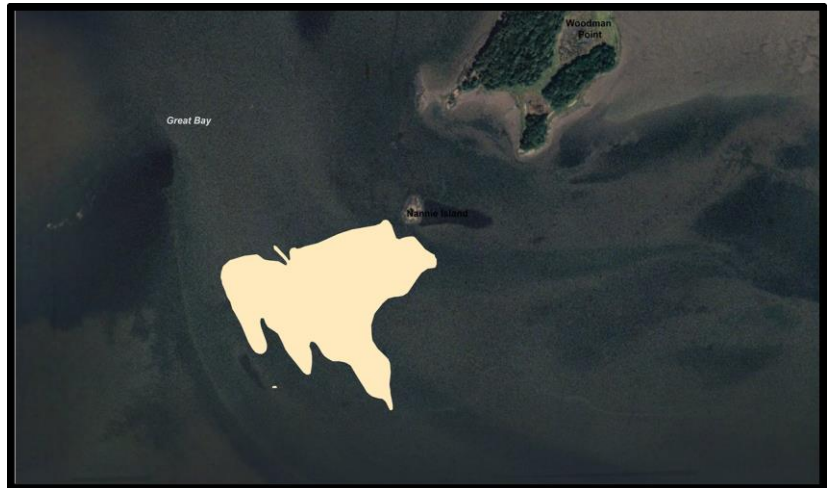
Fig. 5. Polygon for Nannie Island reef based on video imagery recorded on November 19, 2012 (see Appendix A for metadata).

The Nannie Island reef area mapped in 2012 was similar to that for 1997, but substantially less than that reported by NHF&G for 2001 (Table 2). As noted above, all previous mapping efforts differed in methods used and/or how “reef” or “shell bottom” area was defined. Thus, direct comparisons are not possible. Our previous studies on this reef using sonar methods and towed video (as in 2012) did not quantify bottom area coverage, but comparisons of the resulting polygons (see Figs. 13 and 15 in Grizzle et al. 2008b) indicate similar overall shape and size to that for 2012 (Fig. 5). Thus, although live oyster densities have varied substantially in recent years, we suggest that the total areal coverage by live oysters on the Nannie Island reef probably has not changed substantially in the recent past.

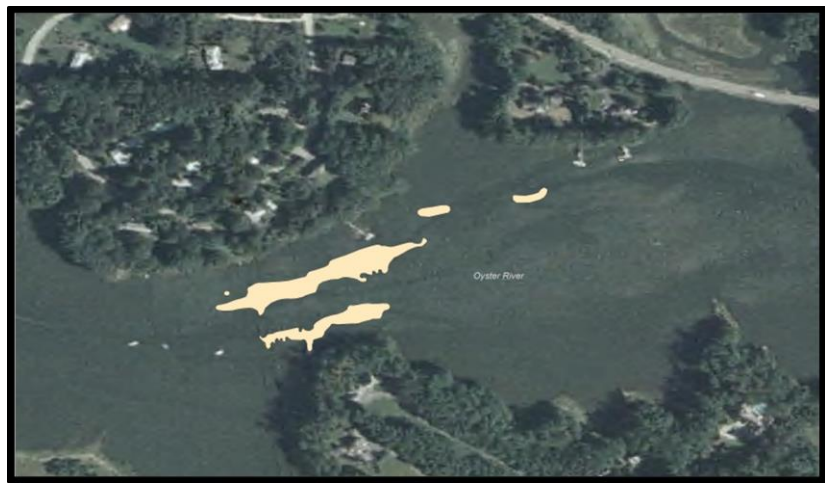
Fig. 6. Natural reef in Oyster River and two restoration areas based on video imagery recorded on November 15, 2012 (see Appendix A for metadata).

The reported Oyster River reef area coverage has only varied minimally since 1997 (Table 1). The shape of the reef, however, apparently has varied in the recent past. Previous video surveys had indicated live oyster bottom in the same overall area but no obvious “non-reef” area in the middle portion, as was found in the present survey (Fig. 6). Thus, it seems reasonable to conclude that the Oyster River reef may have decreased somewhat in size since the last survey in 2001. (See Objective 2 section below for discussion of restoration areas.)

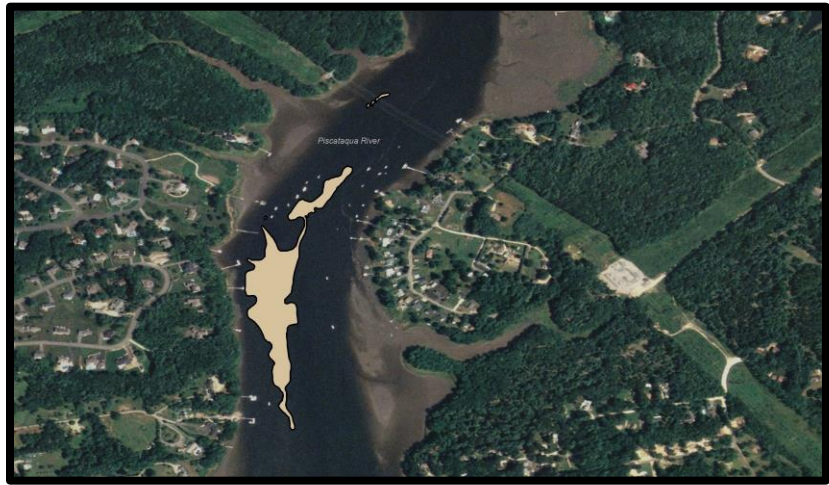
Fig. 7. Polygon for Piscataqua River reef based on video imagery recorded on November 6, 2012 (see Appendix A for metadata).

All previous surveys of the Piscataqua River reef reported much higher bottom area coverage compared to the present (2012) survey (Table 1). The general area mapped in the present survey was similar to that in previous surveys, and similar video methods were used (Grizzle and Brodeur 2004; Grizzle et al. 2008a). Also, the overall shape of the reef area was similar in 2012 in those areas where live oysters and >20% shell cover occurred (Fig. 7). Thus, it seems reasonable to conclude that the Piscataqua River reef has decreased substantially in areal coverage since the most recent previous survey was conducted (2003).

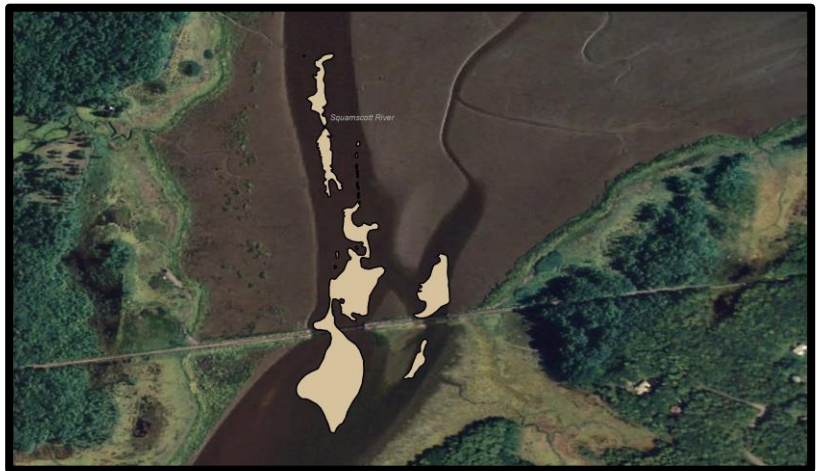
Fig. 8. Polygon for Squamscott River reef based on video imagery recorded on October 10, 2012 (see Appendix A for metadata).

The additional areas surveyed in the Squamscott River were mainly in an uncharted channel east of the main navigational channel where previous surveys had occurred (Fig. 8).

When considering only those areas imaged in previous video mapping efforts, the overall shape and size of the polygons differ somewhat. For example, the area of the Squamscott reef south of the railroad trestle is larger than reported previously, but the northern area is smaller (compare Fig. 8 herein with Fig. 3 in Grizzle et al. 2008a).

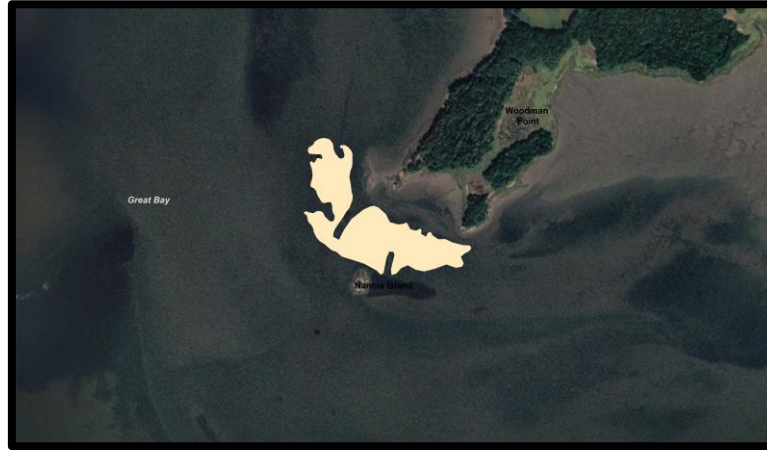
Fig. 9. Polygon for Woodman Point reef based on video imagery recorded on October 10, 2012 (see Appendix A for metadata).

In contrast, those areas of the Woodman Point reef video mapped previously are similar in shape and size to the 2012 survey. The additional areas surveyed for the Woodman Point reef were west of the extension of a rocky outcrop from the land north of the reef southward into the Great Bay (Fig. 9). Previous surveys (Grizzle et al. 2008b) had stopped at this point. During the present survey, the mapping was continued west of the outcrop and a substantial areal coverage of live reef was discovered. Areal coverage of this portion of the overall reef alone was approximately six

acres. If this “new” area is subtracted from the total areal coverage given in Table 2, then the 2012 data are similar to previous recent surveys.

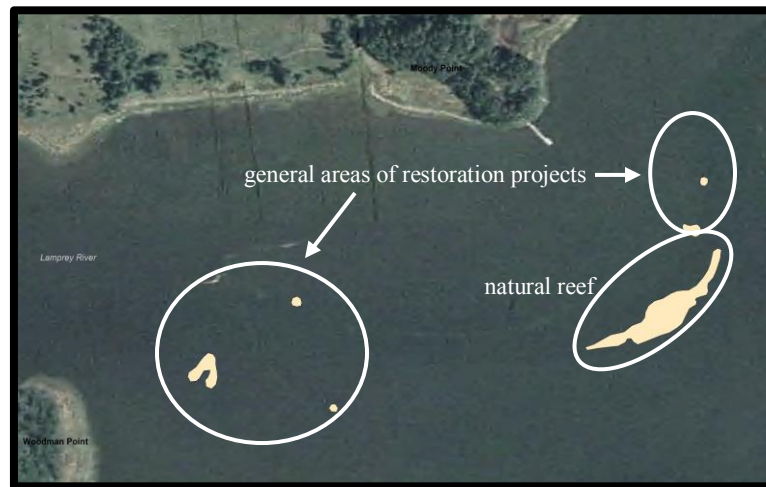
Fig. 10. Polygons for natural Lamprey River reef and two restoration areas based on video imagery recorded on June 19, 2013 (see Appendix B for metadata).

The Lamprey River survey area included a “new” natural reef that was thought to no longer exist, and two separate restoration areas (Fig. 10). Qualitative sampling on the natural reef indicated a substantial amount of vertical structure as well as some large (>100 mm shell height) individuals and multiple year classes on some clusters. The reef surface was also very hard and appeared to be quite thick, indicating many years of shell accretion. This is likely the historical reef known to have been in existence for decades. The restoration areas shown in Figure

10 were constructed in 2011 by deposition of a base layer of dead mollusc (mostly surf clams) followed by scattered live oyster spat-on-shell produced by remote setting. Most of the “reef” areas shown represent some combination of surf clam shell and live oysters from the spat-on-shell put out as part of the restoration process and naturally recruited oysters.

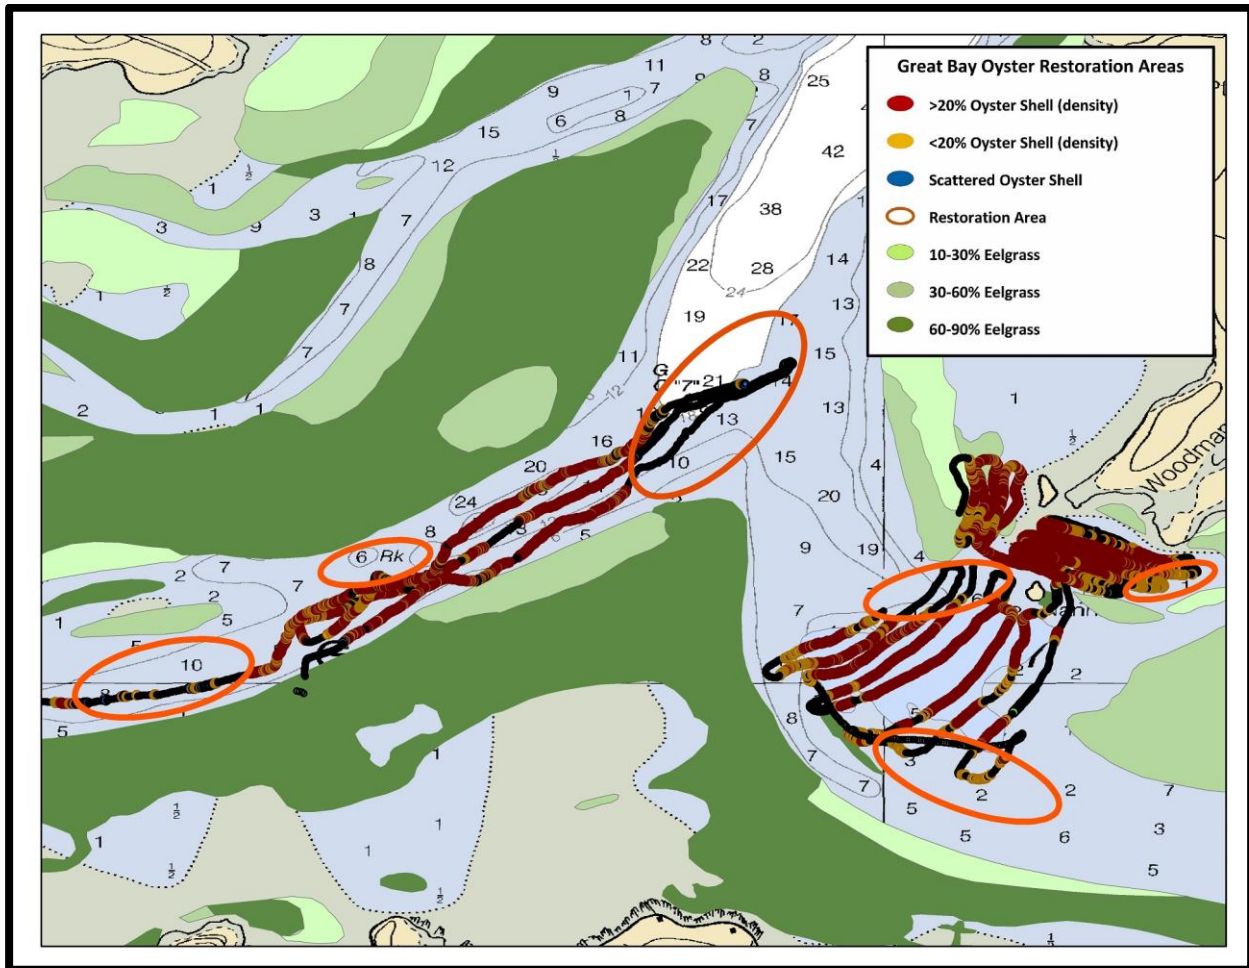
Fig. 11. Composite map showing potential oyster restoration areas (orange polygons) in Great Bay based on 2012 classified video shiptracks and recent (201x) mapping of eelgrass on bathymetric chart base map (water depth in feet).

The natural oyster reef shown on some historical maps (Fig. 2; also see Odell et al. 2006) in the channel area of middle and western Great Bay was found to be extensive, with “reef” (>20% shell and live oysters visible) area covering 35.2 acres (Fig. 11; Appendix B). The general area also included a substantial amount of sparse shell bottom, mostly consisting of dead oyster shell. The extent of live oyster reef in this area was surprising. Moreover, the extent of sparse shell bottom extending away from the main reef at both ends (east and west) likely indicated the historical spatial extent of this reef. This spatial arrangement of features—a central area of dense live oysters with adjacent areas of sparse mostly dead shell—suggests excellent conditions for future oyster restoration projects. Additionally, the same general situation exists in the nearby Nannie Island/Woodman Point reef area. Therefore, a map showing these conditions as well as the most recent available (from 2012) map of eelgrass was produced to illustrate the extent of potential oyster restoration sites for central Great Bay (Fig. 11). Although more detailed mapping of each of the six potential oyster restoration areas would be needed to adequately design each project, we estimate that >100 acres of bottom area likely represents excellent oyster restoration opportunities.

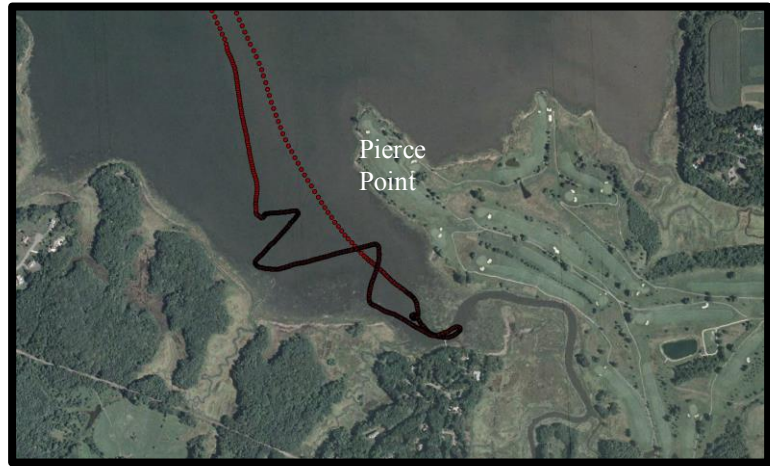
Fig. 12. Shiptracks recorded on June 19, 2013 showing area in southeastern Great Bay where oyster reef occurred historically.

The general area of a historical natural oyster bed in southeastern Great Bay at the mouth of the Winnicut River (see Fig. 2 above) was surveyed by navigating a zig-zag pattern out of the River and probing the bottom with a PVC pipe to determine bottom type (Fig. 12). The entire area consisted of muddy substrate, very soft in many places. Shell material was only encountered in a few areas near mid-channel just south of Pierce Point, and included shell material beneath several centimeters of bottom sediment. No “hard bottom” was encountered.

This overall combination of conditions suggests that the reef may have been buried during a storm or other event involving substantial sediment transport. We have observed a similar situation in the Bellamy River at an oyster restoration site. Thus, we conclude that most likely this reef no longer exists.

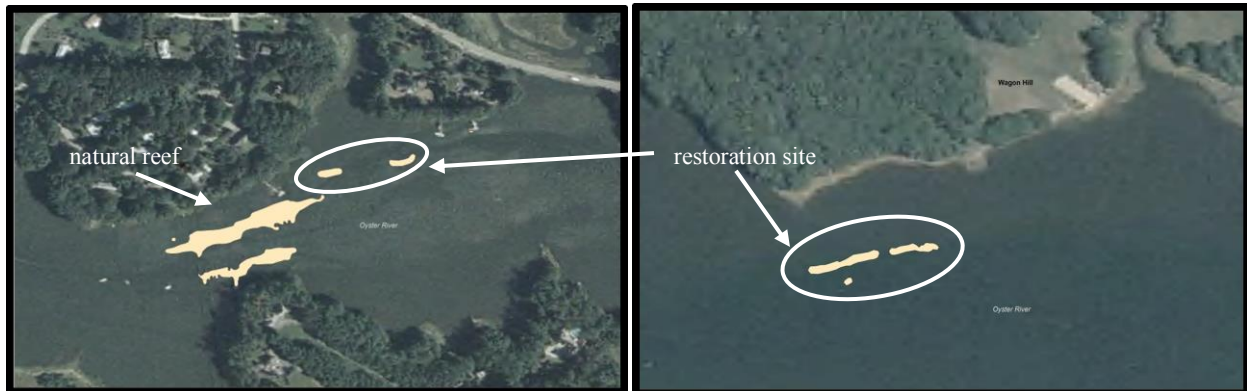
Fig. 13. Polygons showing extent of “shell bottom” at two oyster restoration sites in the Oyster River based on video imagery recorded on June 19, 2013 (See Appendix B for metadata).

In addition to the natural reef in the Oyster River, two oyster restoration sites were mapped in 2013. The first area was adjacent to the natural reef, and the second was near the mouth of the Oyster River (Fig. 13; also see Fig. 6 above). Both were constructed by deposition of a base layer of dead

mollusc (mostly surf clams) followed by scattered oyster spat-on-shell produced by remote setting. The video imagery indicated some combination of surf clam shell and live oysters in both areas. The video imagery confirmed the presence of abundant mollusc shell base material as well as live oysters in both areas. The base shell in most areas had a thin coating of silt, and some appears to have been substantially buried. Macroalgae had colonized the shell in many areas, and crabs and other invertebrates were visible in the imagery. These areas are scheduled for quantitative sampling and additional characterization by video and other methods in 2013.

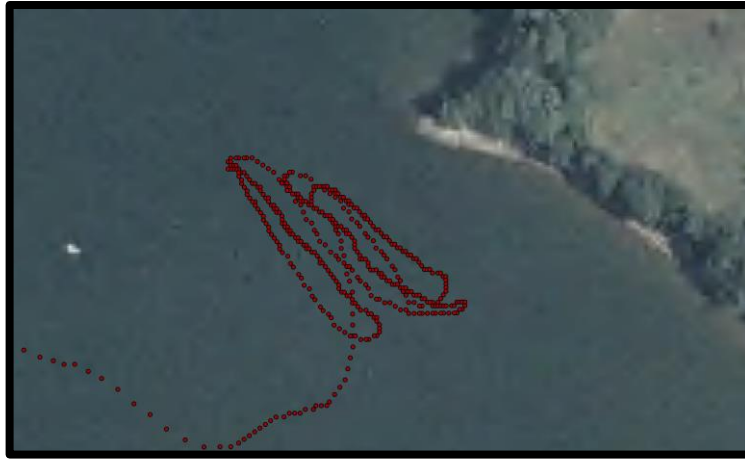
Fig. 14. Polygon for oyster restoration site in Little Bay at Fox Point based on video imagery recorded on June 19, 2013 (see Appendix B for metadata).

The final restoration site mapped in 2013 was at Little Bay/Fox Point, which was constructed in 2010 (Fig. 14). This area was chosen for restoration because most of the site was on natural rocky bottom, and adjacent to a natural oyster reef that had not been previously mapped or sampled. Unfortunately, the video imagery recorded in 2013 was of poor quality in most areas. The entire area covered by the shiptracks shown in Figure 14 was rocky bottom with substantial macroalgal patches, and live oysters were observed in many areas. This area is scheduled for more video imaging and quantitative sampling in 2013.

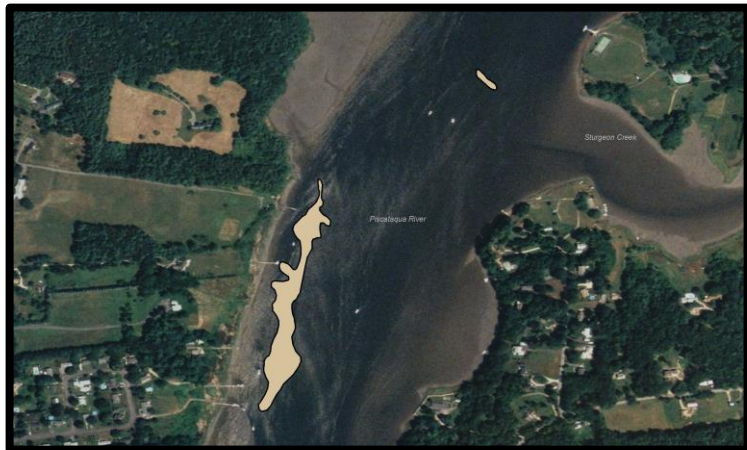
Fig. 15. Polygon for natural Piscataqua (South) River reef based on video imagery recorded on November 6, 2012 (see Appendix B for metadata).

In addition to the target survey areas listed in Table 1, a “new” natural reef was discovered in 2012 while using towed video to survey a potential restoration site in the Piscataqua River. This reef is south of the known Piscataqua River reef regularly sampled by NHF&G, but it is within the overall area of the upper Piscataqua River that historically had natural beds (Fig. 2). This “new” reef covered a bottom area of 3.9 acres, and represents a significant addition to the known natural oyster beds in New Hampshire (Fig. 15). A 1.5-acre area adjacent to and east of the natural bed is scheduled for construction/restoration in summer 2013. The restoration area will represent an addition onto the natural reef, likely in an area that historically was live oyster reef. The restoration area is scheduled for quantitative sampling and video mapping in 2013 and 2014.

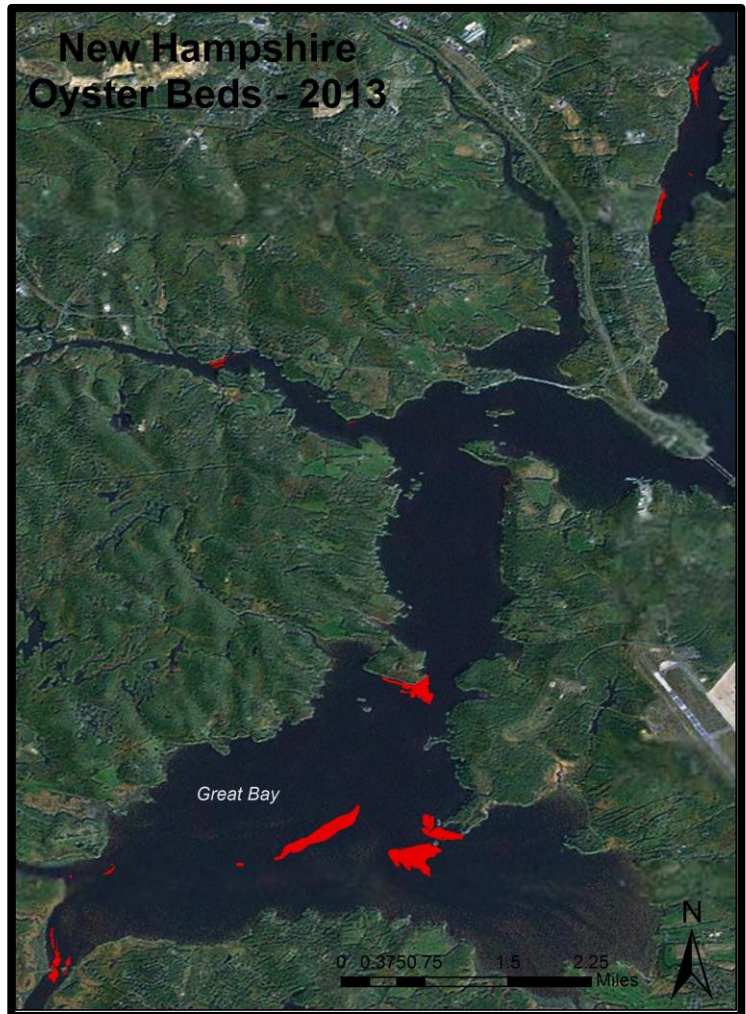
Fig. 16. Natural and restored oyster reefs mapped in the present project (red polygons).

The present study substantially expands the total bottom area coverage and overall distribution of known “oyster bottom” in New Hampshire. Figure 16 is an overview map showing both natural and restored oyster beds—defined as >20% shell cover and some live oysters observed in the video imagery—mapped in the present study. In sum, these areas total 120 acres. The major additions compared to previous surveys were two “new” beds, one in mid-Great Bay (35.2 ac) and one at the mouth of the Lamprey River (0.9 ac), that were known to occur historically but had not been surveyed in recent decades.

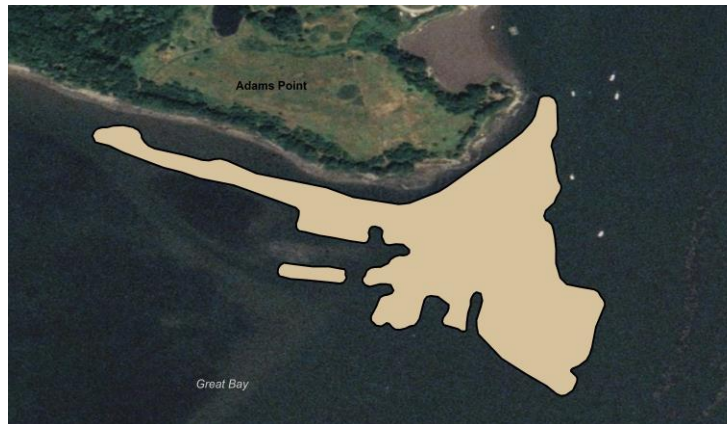
### Adams Point Oyster Bed

At each site surveyed, a SeaViewer model 550 color video camera was deployed in towed mode on a sled with video imagery continuously recorded onto a digital video recorder. Garmin 76CSx and 541s GPS units were used with WAAS mode activated, with horizontal position data (advertised positional accuracy: 3 m) recorded near-continuously along each shiptrack. The imagery was viewed in real-time to locate areas with significant amounts of oyster shell and live oysters. When oysters were encountered, the extent of the oyster bottom in that area was delineated by navigating multiple parallel transects. All imagery was later reviewed in the laboratory and classified into the category of: "high density" oysters (>20% cover by shell and some live oysters visible). This provided near-continuous classification of the seafloor along each shiptrack. The Adams Point Oyster Bed polygon is 15.9 acres.

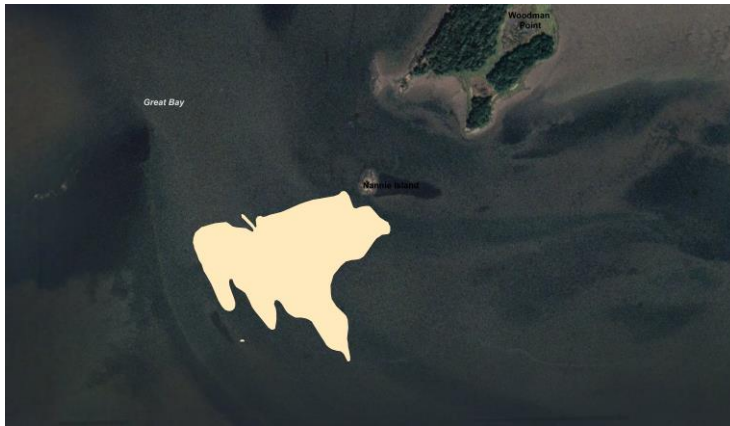
## Nannie Island Oyster Bed

At each site surveyed, a SeaViewer model 550 color video camera was deployed in towed mode on a sled with video imagery continuously recorded onto a digital video recorder. Garmin 76CSx and 541s GPS units were used with WAAS mode activated, with horizontal position data (advertised positional accuracy: 3 m) recorded near-continuously along each shiptrack. The imagery was viewed in real-time to locate areas with significant amounts of oyster shell and live oysters. When oysters were encountered, the extent of the oyster bottom in that area was delineated by navigating multiple parallel transects. All imagery was later reviewed in the laboratory and classified into the category of: "high density" oysters (>20% cover by shell and some live oysters visible). This provided near-continuous classification of the seafloor along each shiptrack. The Nannie Island Oyster Bed polygon is 32.4 acres.

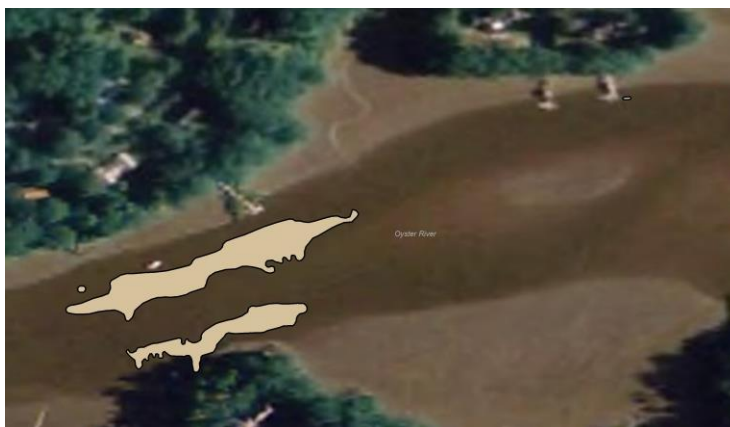
## Oyster River Oyster Bed

At each site surveyed, a SeaViewer model 550 color video camera was deployed in towed mode on a sled with video imagery continuously recorded onto a digital video recorder. Garmin 76CSx and 541s GPS units were used with WAAS mode activated, with horizontal position data (advertised positional accuracy: 3 m) recorded near-continuously along each shiptrack. The imagery was viewed in real-time to locate areas with significant amounts of oyster shell and live oysters. When oysters were encountered, the extent of the oyster bottom in that area was delineated by navigating multiple parallel transects. All imagery was later reviewed in the laboratory and classified into the category of: "high density" oysters (>20% cover by shell and some live oysters visible). This provided near-continuous classification of the seafloor along each shiptrack. The Oyster River Oyster Bed polygon is approximately 1.4 acres.

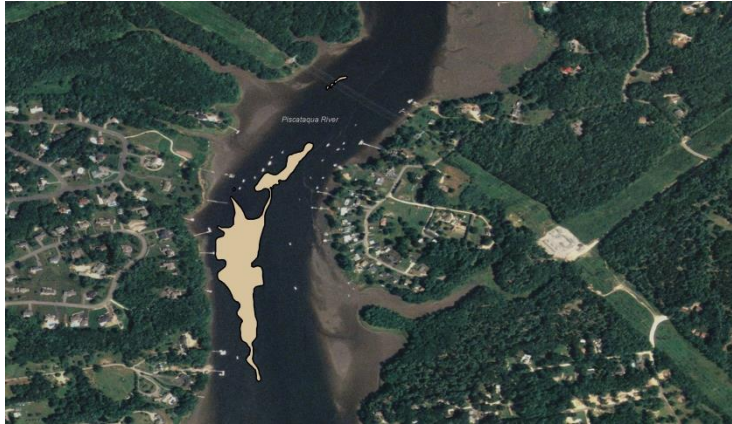
## Piscataqua River Oyster Bed

At each site surveyed, a SeaViewer model 550 color video camera was deployed in towed mode on a sled with video imagery continuously recorded onto a digital video recorder. Garmin 76CSx and 541s GPS units were used with WAAS mode activated, with horizontal position data (advertised positional accuracy: 3 m) recorded near-continuously along each shiptrack. The imagery was viewed in real-time to locate areas with significant amounts of oyster shell and live oysters. When oysters were encountered, the extent of the oyster bottom in that area was delineated by navigating multiple parallel transects. All imagery was later reviewed in the laboratory and classified into the category of: "high density" oysters (>20% cover by shell and some live oysters visible). This provided near-continuous classification of the seafloor along each shiptrack. The Piscataqua River Oyster Bed polygon is 7.7 acres.

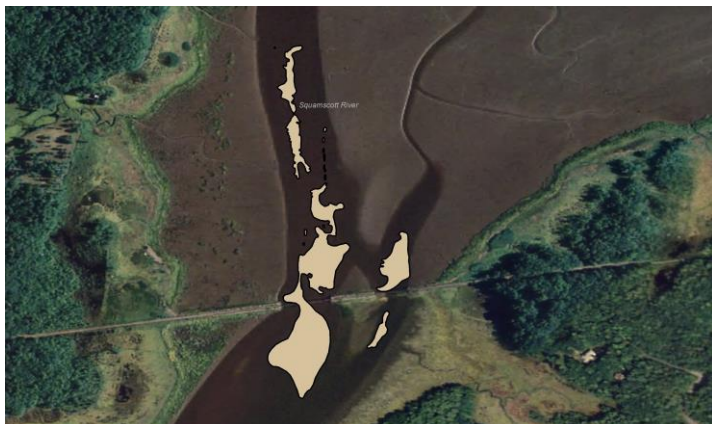
## Squamscott River Oyster Bed

At each site surveyed, a SeaViewer model 550 color video camera was deployed in towed mode on a sled with video imagery continuously recorded onto a digital video recorder. Garmin 76CSx and 541s GPS units were used with WAAS mode activated, with horizontal position data (advertised positional accuracy: 3 m) recorded near-continuously along each shiptrack. The imagery was viewed in real-time to locate areas with significant amounts of oyster shell and live oysters. When oysters were encountered, the extent of the oyster bottom in that area was delineated by navigating multiple parallel transects. All imagery was later reviewed in the laboratory and classified into the category of: "high density" oysters (>20% cover by shell and some live oysters visible). This provided near-continuous classification of the seafloor along each shiptrack. The Squamscott River Oyster Bed polygon is 7.7 acres.

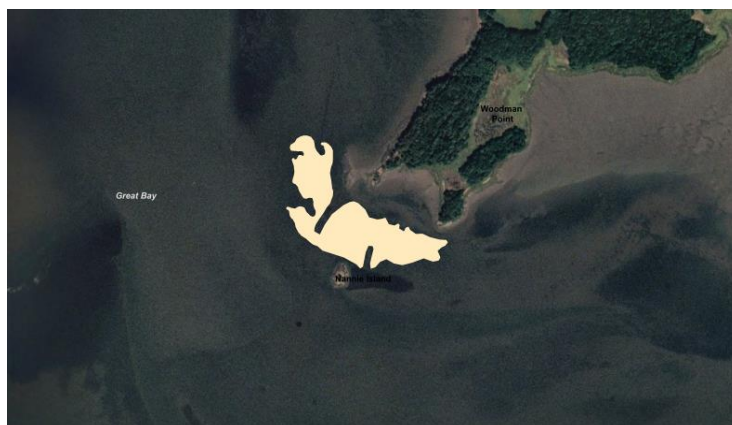
## Woodman Point Oyster Bed

United States, North East, New Hampshire, Great Bay, Woodman Point, Oyster Reef, Crassostrea virginica, Eastern Oyster, Oyster, Underwater Video, Seaviewer, Density

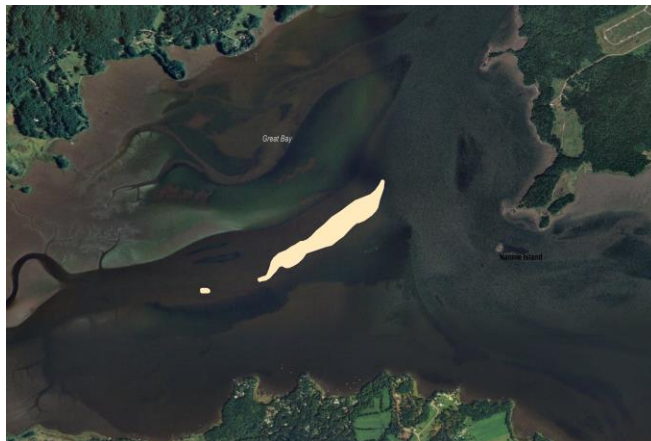
### Mid-Great Bay Oyster Bed

United States, North East, New Hampshire, Great Bay, Oyster Reef, *Crassostrea virginica*, Eastern Oyster, Oyster, Underwater Video, Seaviewer, Density

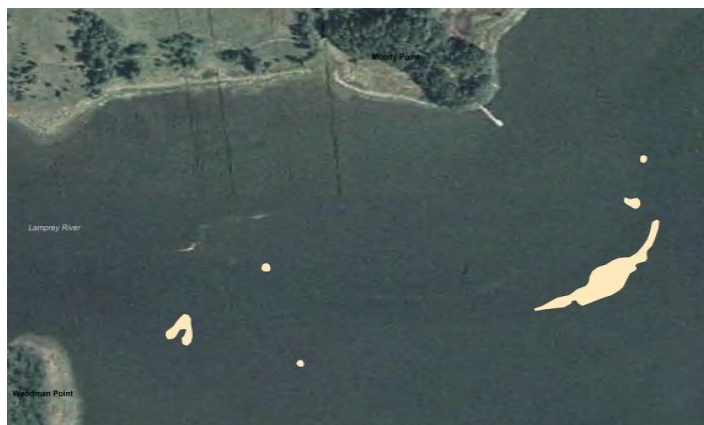
## Lamprey River Oyster Bed

United States, North East, New Hampshire, Great Bay, Lamprey River, Oyster Reef, *Crassostrea virginica*, Eastern Oyster, Oyster, Underwater Video, Seaviewer, Density

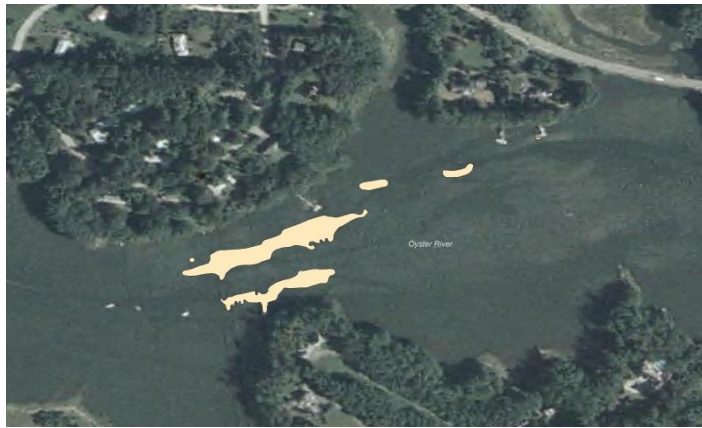
## Oyster River Oyster Bed

United States, North East, New Hampshire, Great Bay, Oyster River, Oyster Reef, *Crassostrea virginica*, Eastern Oyster, Oyster, Underwater Video, Seaviewer, Density

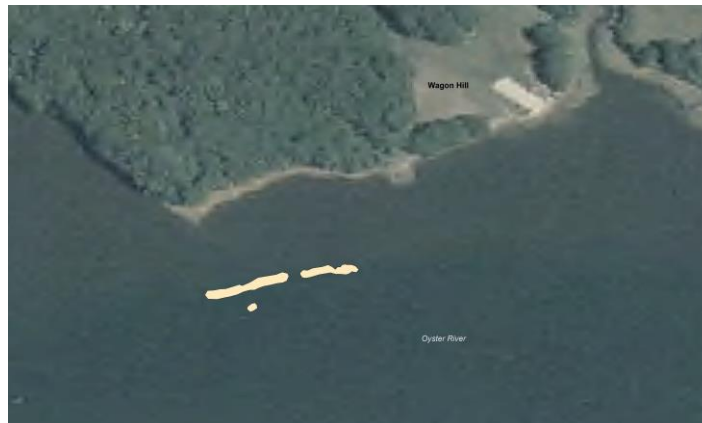
## Oyster River Restored Area

United States, North East, New Hampshire, Great Bay, Oyster River, Oyster Reef, Crassostrea virginica, Eastern Oyster, Oyster, Underwater Video, Seaviewer, Density

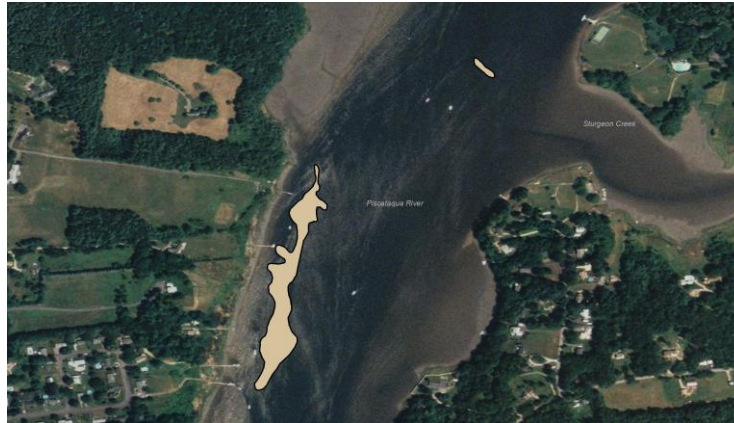
## Piscataqua (South) River Oyster Bed

United States, North East, New Hampshire, Great Bay, Piscataqua River, Oyster Reef, *Crassostrea virginica*, Eastern Oyster, Oyster, Underwater Video, Seaviewer, Density

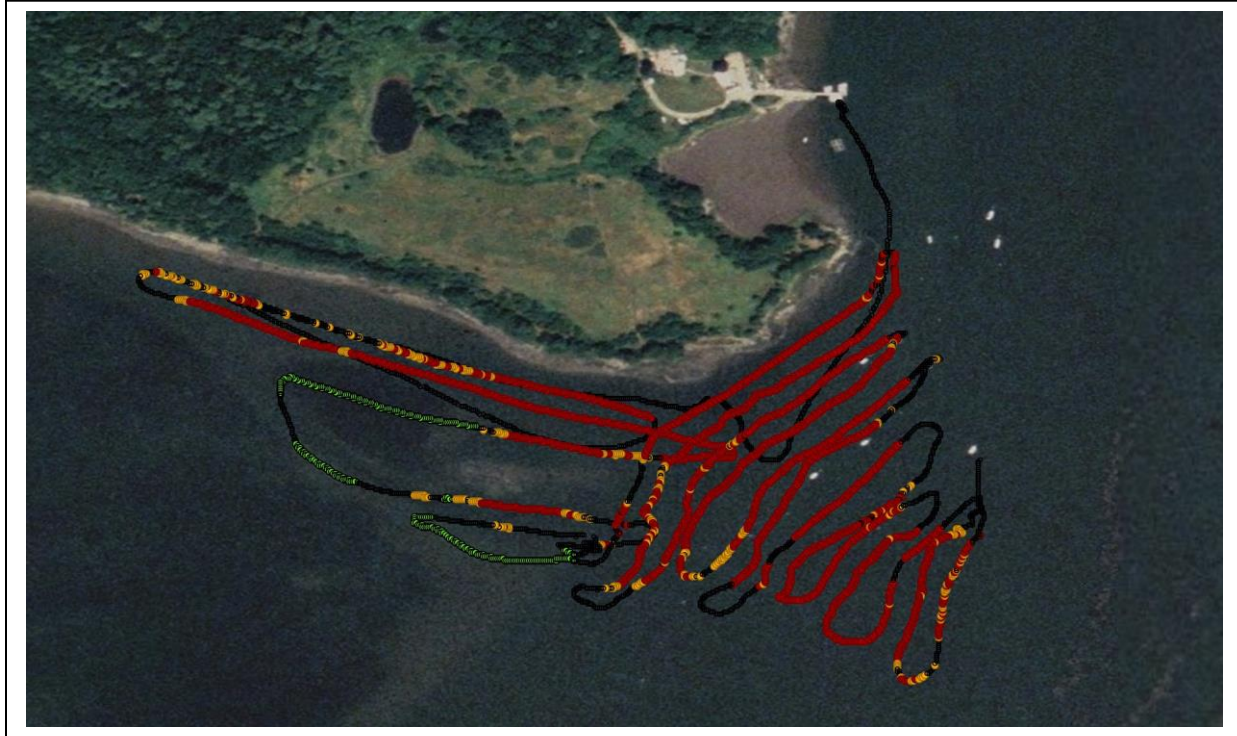
### Adams Point

For all figures below: black outlined open circles="non-reef" (no shell or live oysters) or no visibility; red circles="reef" (>20% shell cover, live oysters); yellow circles="sparse shell" (<20% shell cover); green=eelgrass
