An Analysis of River Channel Change Over Time in the Lamprey River

An Analysis of River Channel Change Over
Time in the Lamprey River

Environmental Science: Hydrology Undergraduate

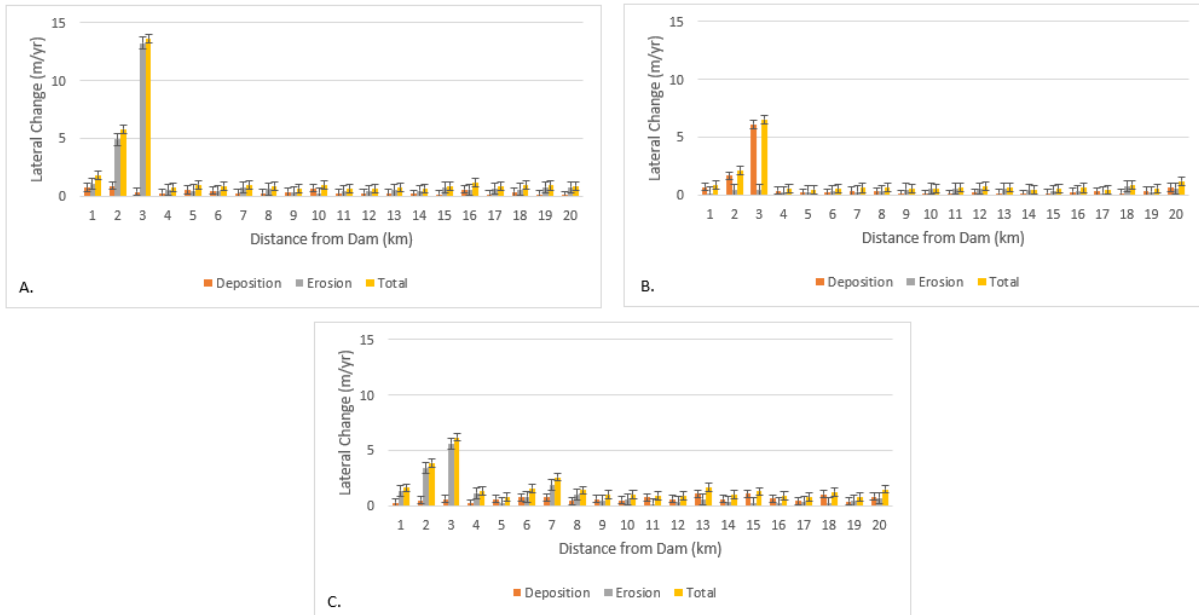
Figure 5: Bar graphs showing the erosional, depositional, and total lateral change for each period. A is from 1992 to 1998, B is from 1998 to 2013, and C is from 2013 to 2018.

The erosion, deposition, and total change values are highly variable depending on the reach (Figure 5). The overall average erosional and depositional changes over all reaches and time periods are 0.93 +/- 0.52 m/yr and 0.53 +/- 0.15 m/yr respectively. The error for the method calculated as standard deviation is 0.491 m/yr for erosion, 0.331 m/yr for deposition, and 0.368 m/yr for total change. Many of the change estimates fall outside of the calculated error, making it likely that there is actual change occurring in these areas (Table 2). The calculated error is also decreasing over time, which is likely caused by the improved imagery (Table 3). The first three reaches have eroded much differently compared to the other reaches (Figure 5). This is likely due to the large impoundment behind Macallen Dam, which floods extensive wetlands.

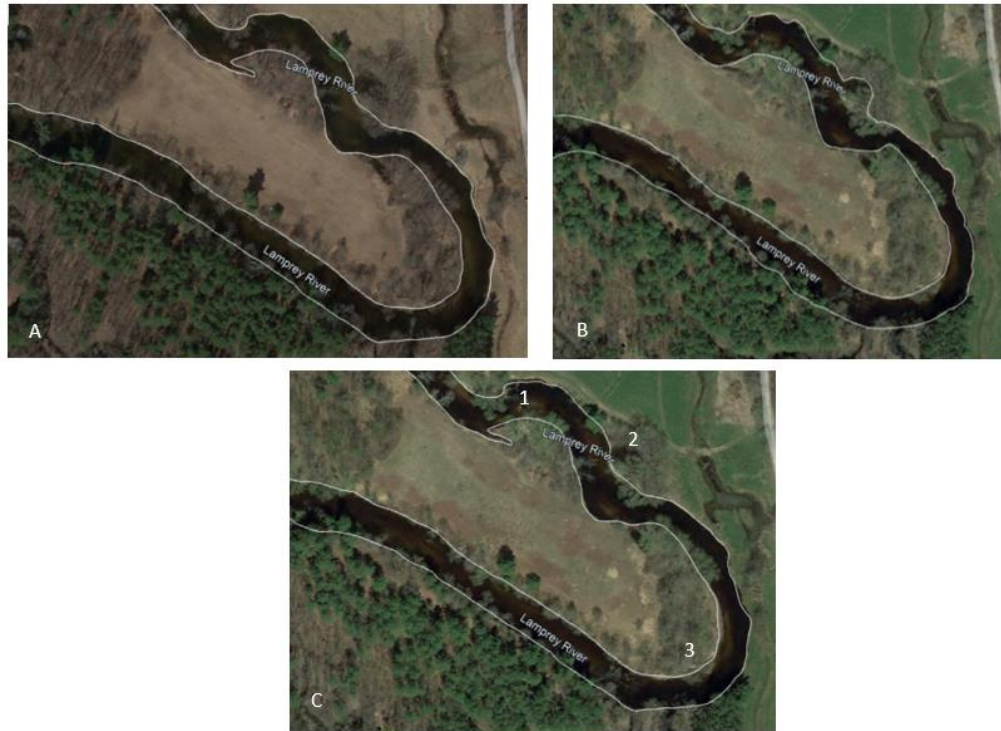
Figure 6: A reach on the Lamprey River. Image A is the 2013 image with the 2013 delineation, image B is the 2018 image with the 2018 delineation, and image C is the 2018 image with the 2013 delineation. The labels 1, 2, and 3 on image C are areas of interest in this reach.

The following section of this paper will document three delineated reaches from this study and analyze the effectiveness of the technique within the reaches as well as determine if the calculated river channel change within the reach can be seen within the imagery. For each case study, image A is the 2013 image with the 2013 delineation, image B is the 2018 image with the 2018 delineation, and image C is the 2018 image with the 2013 delineation. Figure 6 shows the first reach for analysis. Image A and B are delineated accurately and rarely separate from the bank location, aided by the lack of vegetation in this reach compared to other reaches on the Lamprey River. In image C, the areas labeled 1 and 3 are both areas that show the method at work. The 2013 delineation does not match the bank in the 2018 image. Area 1 looks to be an area of erosion, while area 3 looks to be an area of deposition. Area 2 is a location of potential error. In the 2013 delineation the riverbank in area 2 follows a straight line, while in the 2018 delineation there looks to be a cut into the bank. It is hard to determine from the aerial imagery whether that is real change or a delineation error, as there are shadows from the trees in that location (Figure 6).

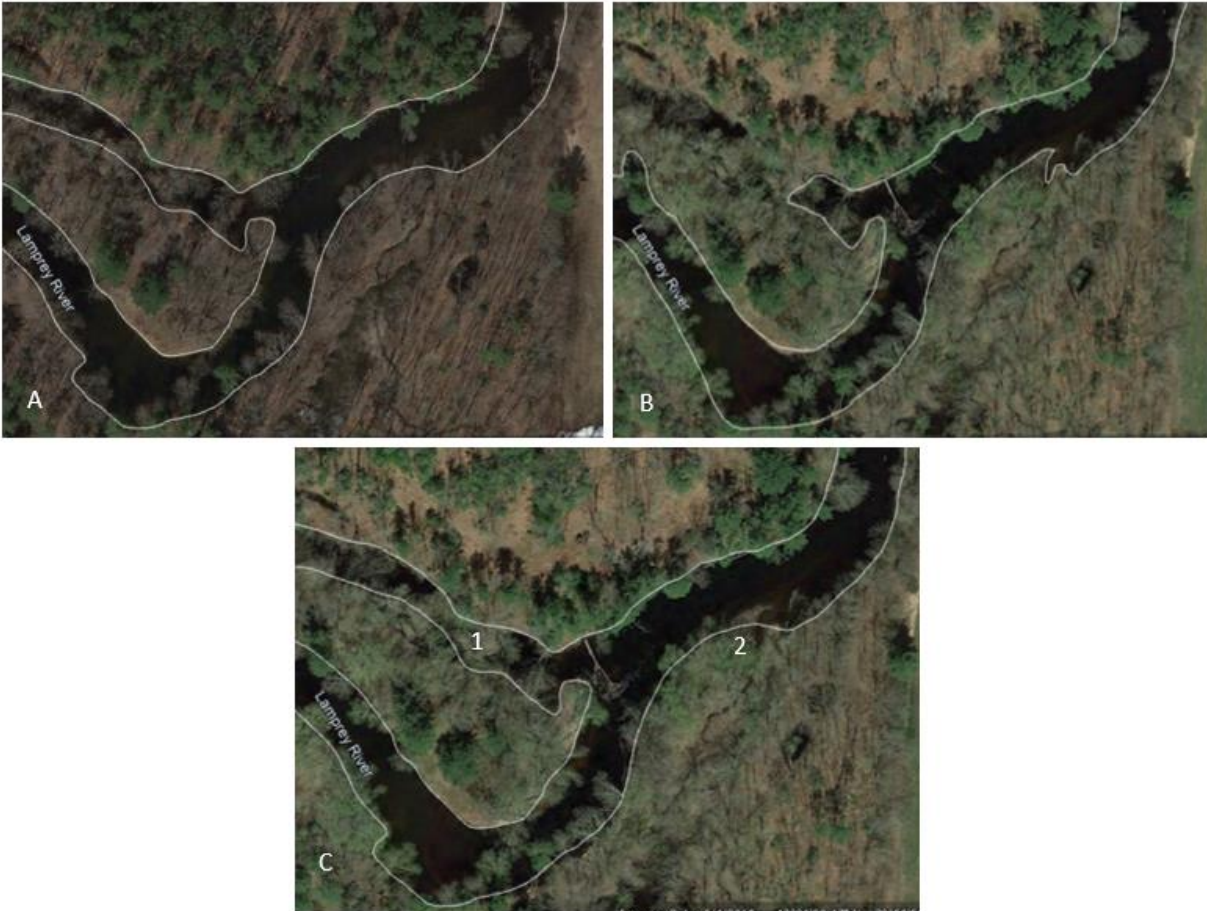
Figure 8: A reach on the Lamprey River. Image A is the 2013 image with the 2013 delineation, image B is the 2018 image with the 2018 delineation, and image C is the 2018 image with the 2013 delineation. Labels 1 and 2 on image C are areas of interest in this reach.

The third and final reach for analysis is shown in figure 8. Areas 1 and 2 in figure 8 are both areas of interest that show real change in the reach. Area 1 looks to be an area that has had deposition and closed off the two sections of the channel shown in image C. While there are many trees in this area that make it hard to see this change, there looks to be a small, connected channel in image A that is no longer there in image B. Area 2 is an area with less tree cover that

is accurately delineated on both images but does show a difference in the river channel. In area 2, there is a small area of both erosion and deposition (Figure 8).
