UNINTENTIONAL RF RADIATION AND RECEPTION IN COAXIAL CABLE TRANSMISSION LINES DUE TO SHEATH CONDUCTOR FAULTS

THESIS

Master of Science
In
Electrical Engineering

May 2018

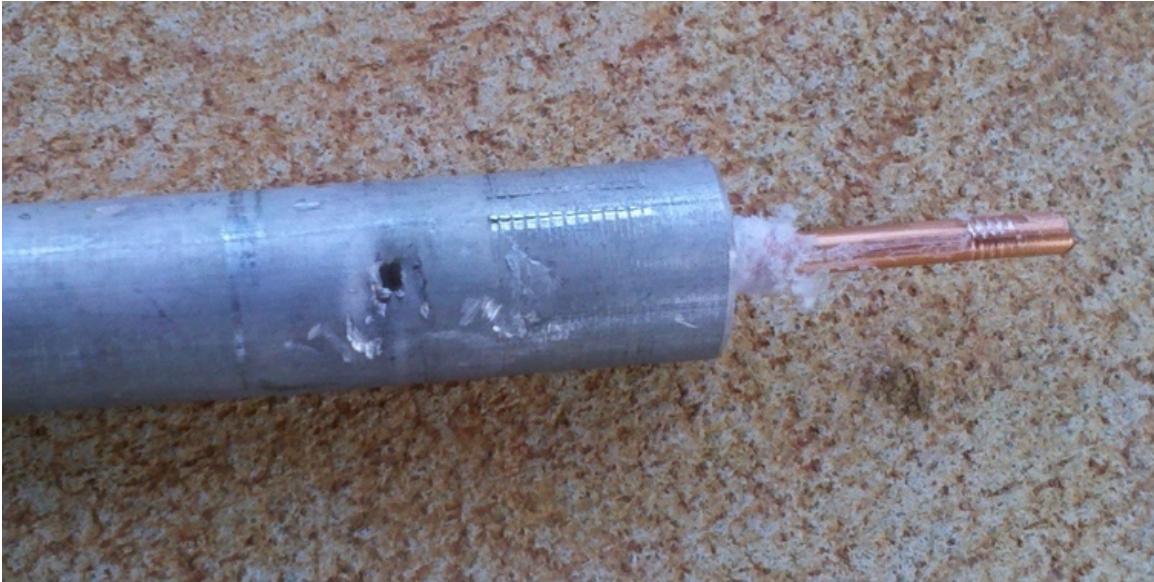
Fig. 1. Small (~2mm) hole in 0.500" coaxial cable caused by tooling

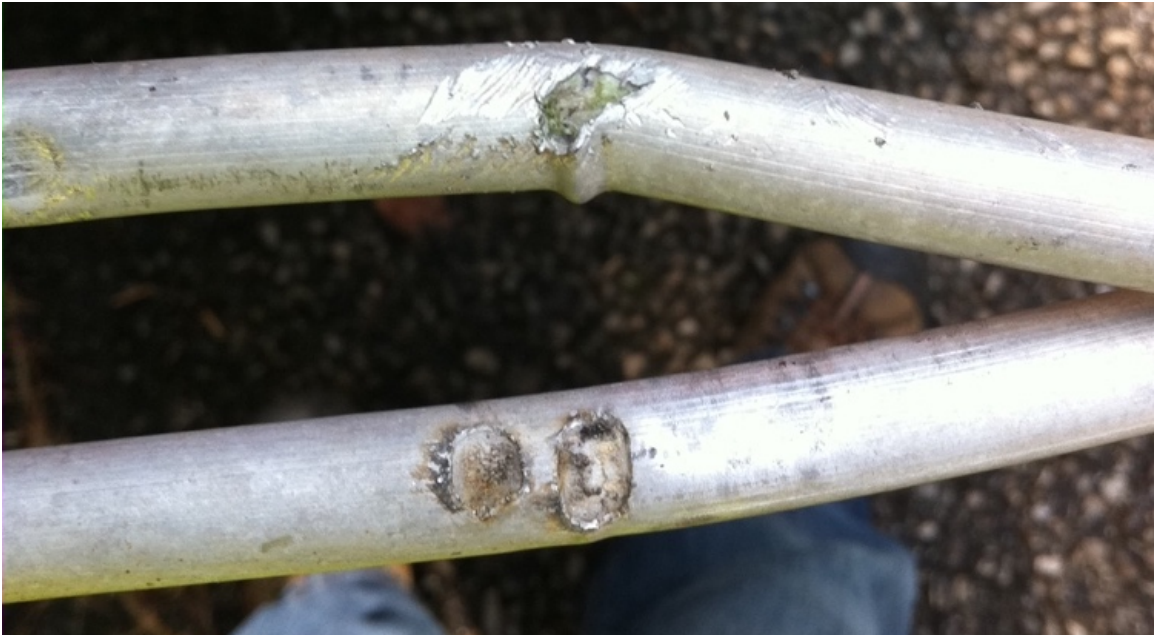
Fig. 2. Abrasion from wind motion (top) and holes from electrical arcing (bottom)

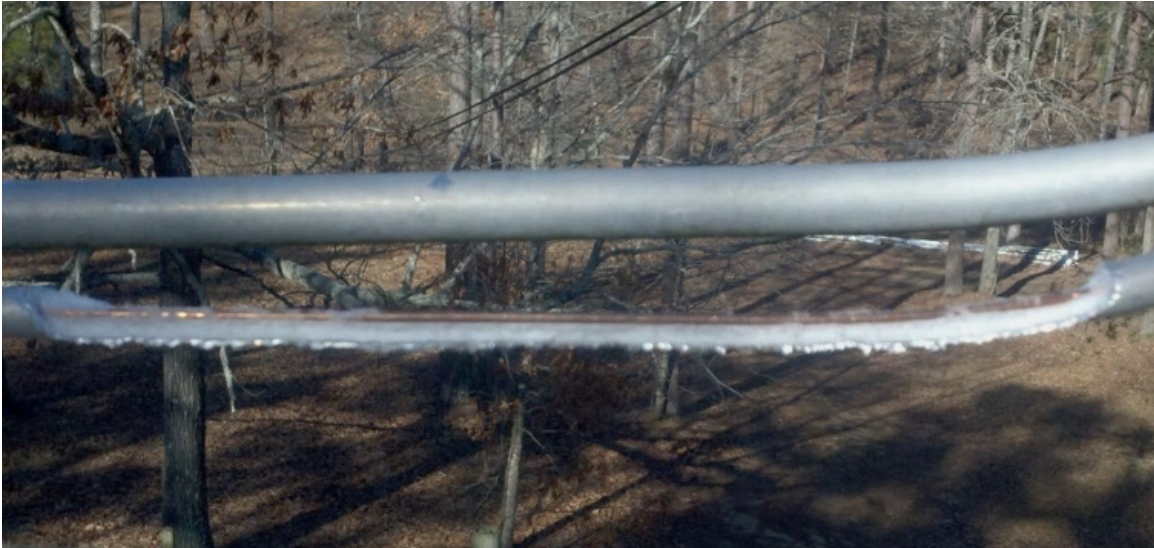
Fig. 10. Squirrel-damaged coaxial cable in an HFC network

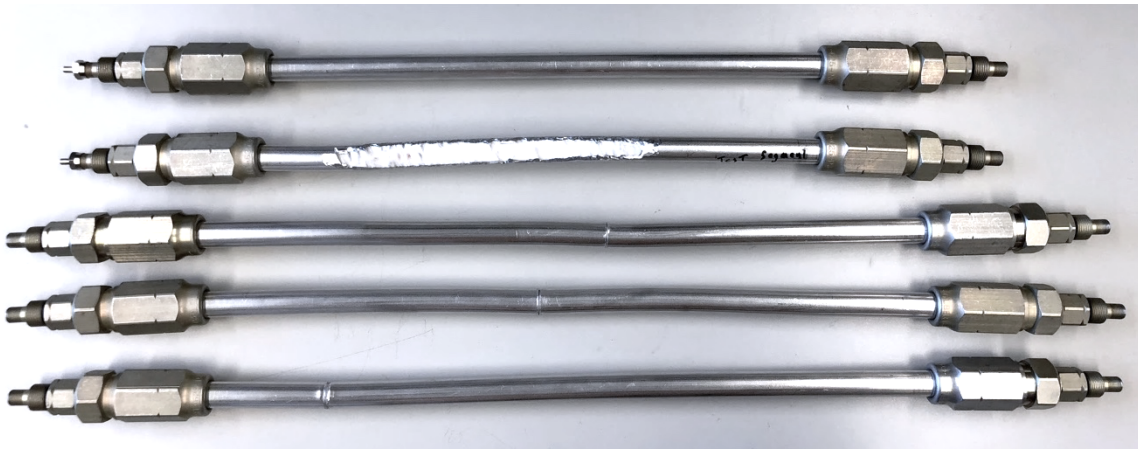
Fig. 11. Test cable segments 00 – 04 (top to bottom)

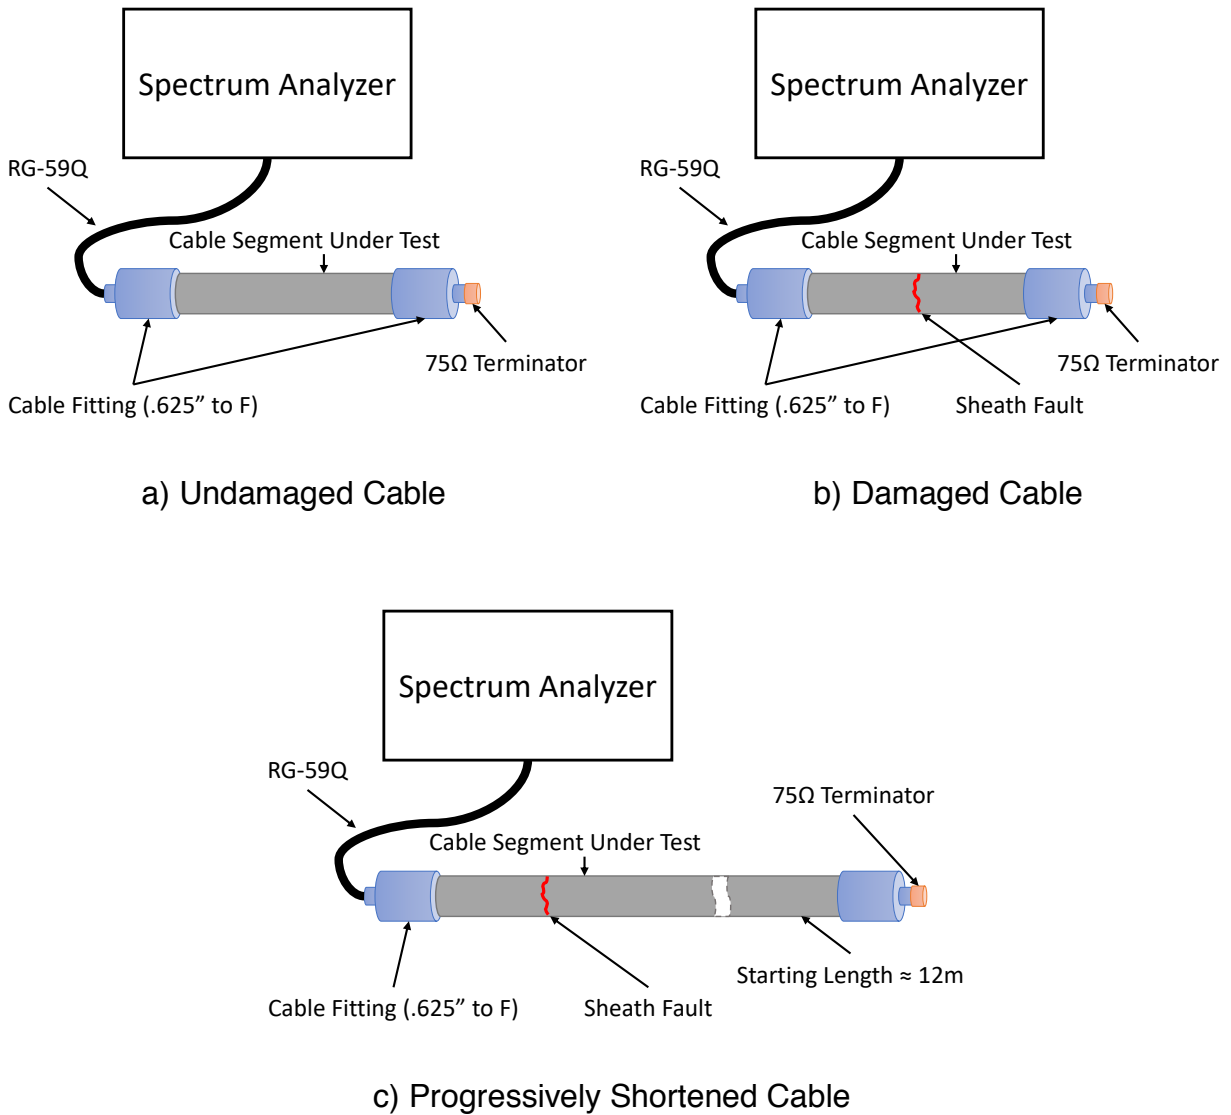
Fig. 13. Ambient signal ingress test setup

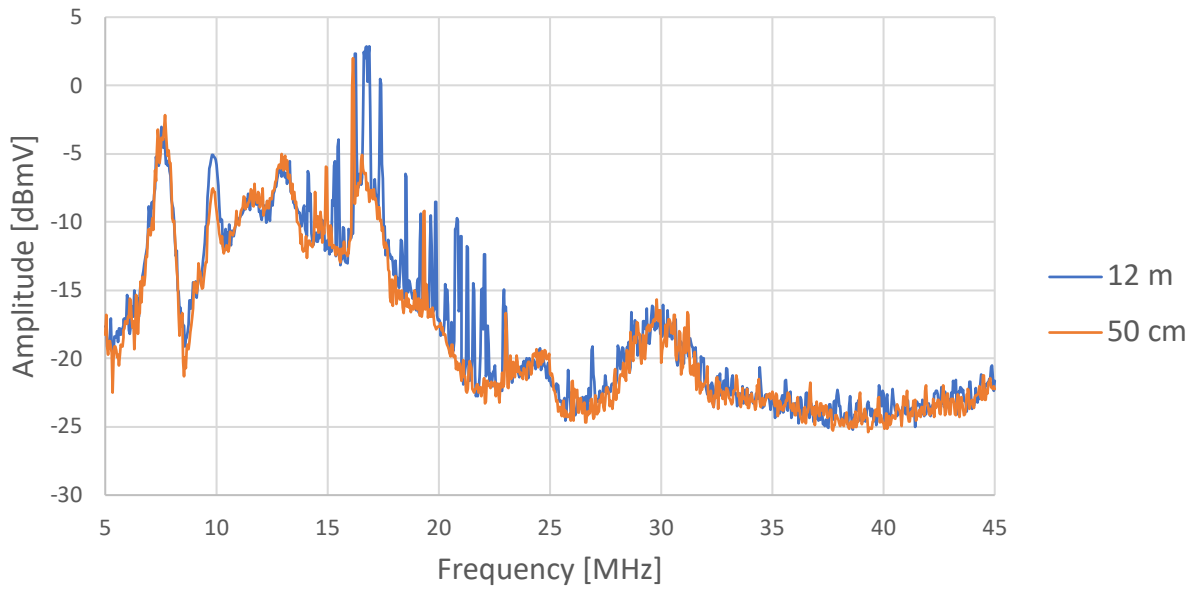
Fig. 15. Test Segment 02 Ingress Spectrum at Different Lengths

such specimen became test cable 02. Results of the ingress spectrum for this specimen at two disparate lengths are shown in Fig. 15. This was not meant to be a detailed assessment of the effects of cable length, nor to eliminate it as a parameter of interest, as the ingress measurements are not calibrated and vary substantially with time and subtle repositioning of the test cable. However, the results were sufficient to support the conclusion that the much more convenient 50cm length would be appropriate for further testing. Later tests, discussed in chapter 3, look in more detail as to the effects of cable length. Similarly, variations in cable termination methods were explored to see if these would have substantial impact on the observed behavior. These were drawn from typical connectorization and termination equipment common to HFC networks (Fig. 14). It was found that this variable did not have a significant impact, and so subsequent tests focused on test segments with straightforward cable termination.

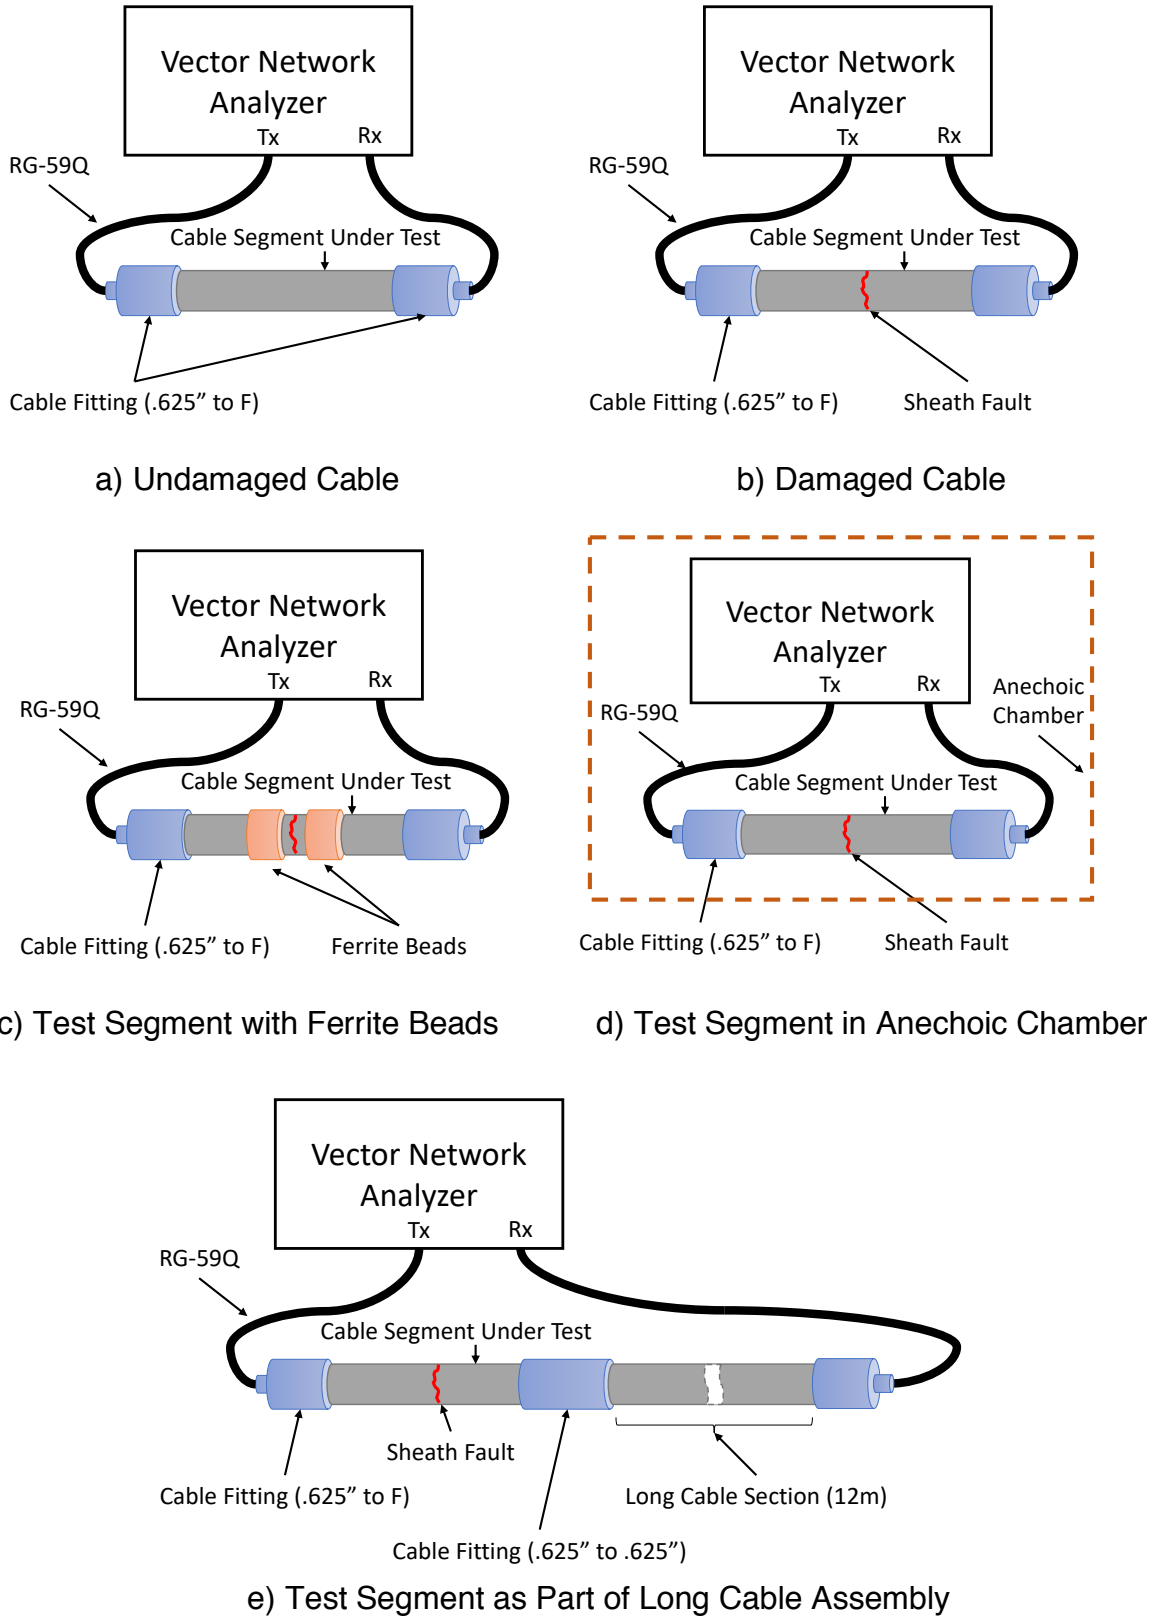
Fig. 16. Reflection and transmission test setup (S_{11} and S_{21})

Another series of tests were performed where the test segments were attached to a longer section of undamaged cable (approximately 12m), with a commonly used connector design to splice 0.625" cables. This longer cable assembly was then connected to the VNA in a through configuration, as illustrated in Fig. 16e. Measurements for various test segments so incorporated were taken with the VNA source connected to the end near the fault, and also with the source connected to the end far from the fault. The motivation for this was to test for the effects of overall cable length and fault position on the radiative properties of the cable segments under test. Lastly, ferrite beads were applied to the longer composite cable assembly under test, combining the configurations of Fig. 16c and Fig. 16e.

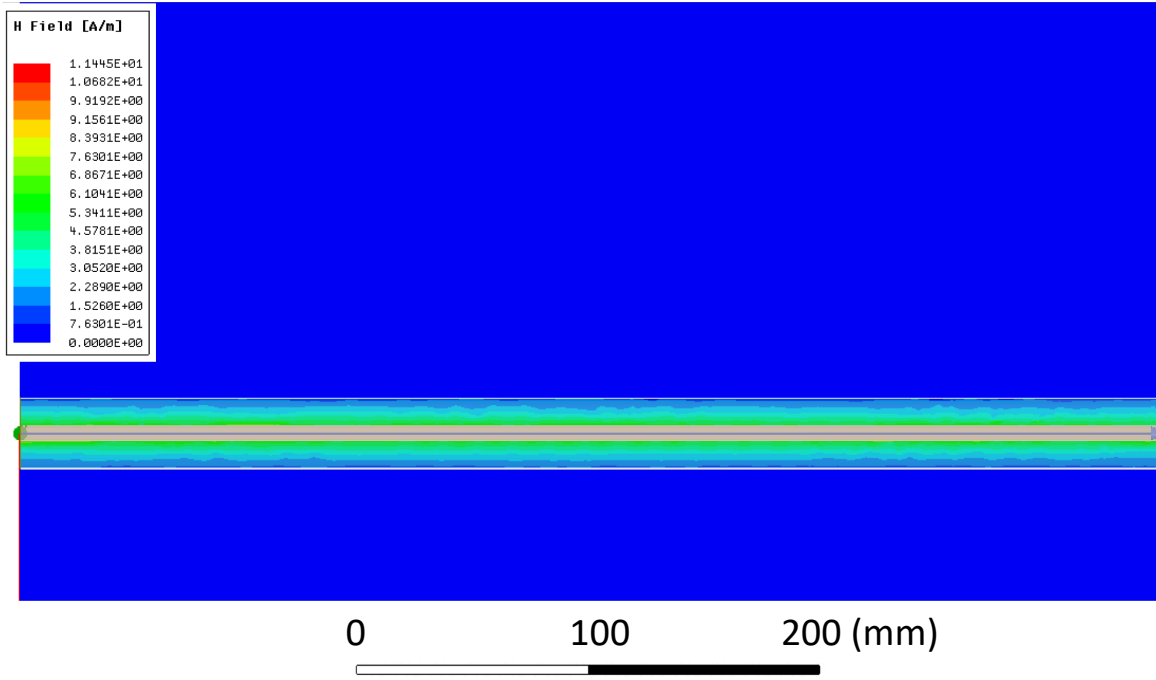
Fig. 28. Simulation of H field lateral section of undamaged cable

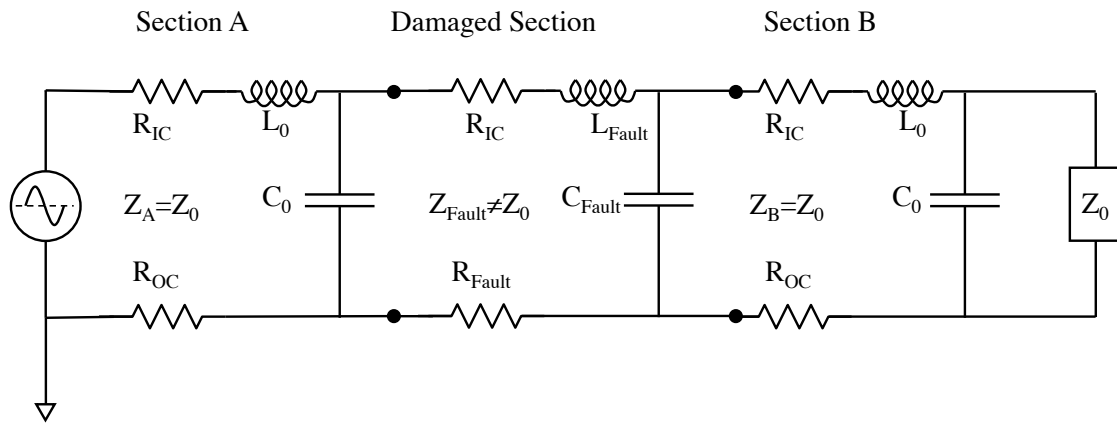
Fig. 31. Lumped element model of squirrel-damaged coaxial transmission line

the shunt capacitance, C_{Fault} , would be reduced relative to undamaged cables, and that R_{Fault} would be greater than R_{OC} , if only by a small amount in absolute terms given R_{OC} 's very low nominal value per meter [9]. Cerri *et al* found that damage to the cable of this sort would be expected to add some additional effective series inductance, making L_{Fault} greater than nominal (L_A and L_B) [13]. In all, these deviations from nominal cause a modest impedance mismatch, which is the cause of the increased return loss.

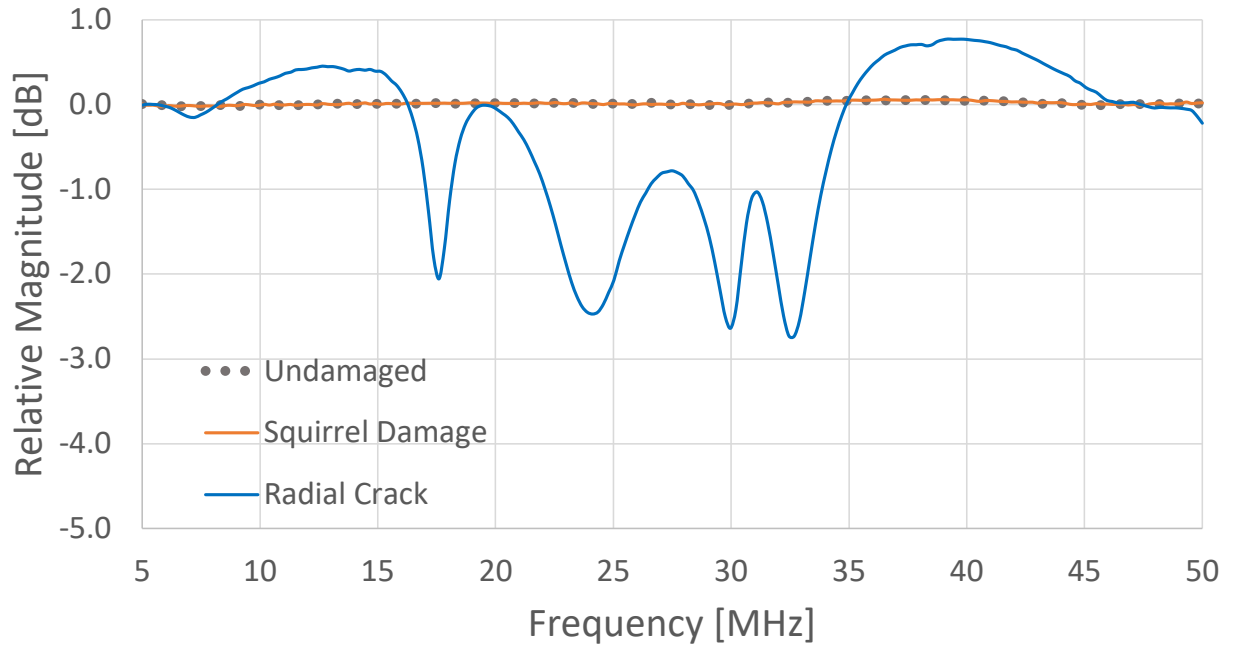
Fig. 39. Power budget of test cables from VNA readings

Whereas in the power budget analysis (Fig. 39) the undamaged and squirrel-damaged segments demonstrated near-perfect conservation of the injected signal (either by reflection or transmission) within the bandwidth of interest, the radial cracked cable substantially deviates from this 0dB line. Intriguingly, it showed both negative and positive variation, suggesting that power is being both lost to radiation and gained from ambient ingress, the latter then being added to the VNA’s measurements for S_{11} and/or S_{21} . The presence of ingress power in the VNA measurements is perhaps unsurprising, given the results of the ambient ingress test discussed above and transmission/reception reciprocity.

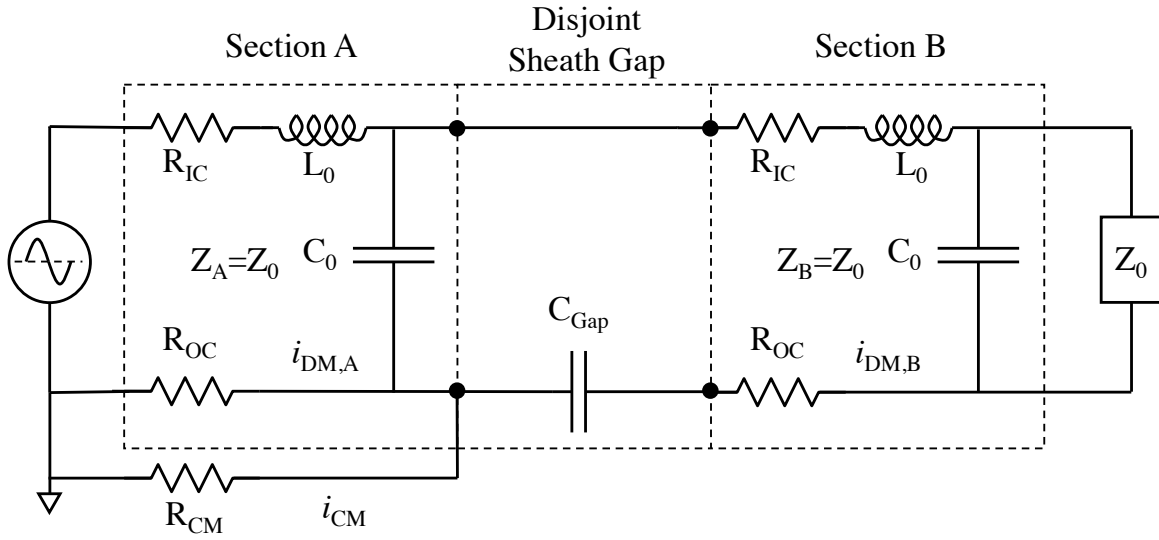
Fig. 48. Lumped element model of a common-mode current path on a coaxial transmission line

If the hypothesis holds that the observed radiative properties of the test cables examined by this work are the result of the common-mode currents that develop in response to sheath faults, then several testable conditions present themselves. Firstly, if there were some way to attenuate the common-mode currents, then some reduction in the attenuation due to radiative losses would be expected. A schematic representation of a transmission line with common-mode currents traveling on the outer surface of the sheath conductor is shown in Fig. 48. A suppression of the common-mode currents would be equivalent to a substantial increase in R_{CM} in this representation. Another prediction would be that if a sufficiently low resistance short across the radial crack fault (C_{Gap} below) were introduced, then according to findings by Hayashi *et al*, a significant reduction in common-mode currents, and therefore radiative losses, should be observed [18, 19]. Lastly, if common-mode currents are suspected as the causal mechanism for radiative losses (and through reciprocity for ingress intrusion), and given HFSS simulations of radial cracks that reproduce such losses, we would expect to find evidence of common-mode currents on the outside of the sheath conductor in those simulations. Fortunately, all three of these predictions can be tested, and are discussed below.

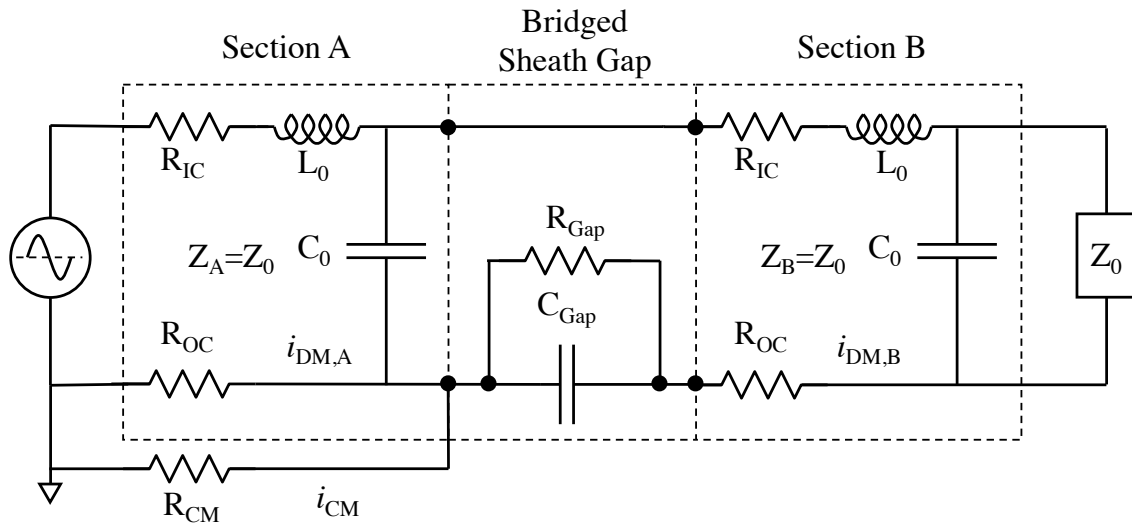
Fig. 53. Lumped element model of a bridged sheath gap fault

Another permutation on the radial crack fault case exists when the fault is not disjoint, either because the two side of the sheath produced by the radial crack maintain some amount of contact, or a physically disjoint radial crack is bridged by some electrical path, such as a resistor or conductor. This corresponds to R_{Gap} in Fig. 53. As mentioned previously, work by Hayahsi *et al* would predict that a radial gap bridged by a resistance element (on the order of as little as 1Ω at DC) will produce common-mode currents, and that within a certain range these currents will increase as overall gap resistance increases [18, 19]. Conversely, a conductive bridge across the gap of the radial crack approaching 0Ω at DC should significantly favor differential-mode currents over common-mode and thereby reduce radiative losses. As can be seen in Fig. 54, the effect of shorting a single point across a radial crack gap with a good conductor has the effect of almost entirely eliminating its radiative losses and is therefore consistent with expectations.
