Evaluation of Effects of Wastewater Treatment Discharge on Estuarine Water Quality

A final report to the New Hampshire Department of Environmental Services
and the New Hampshire Estuaries Project

December 2003

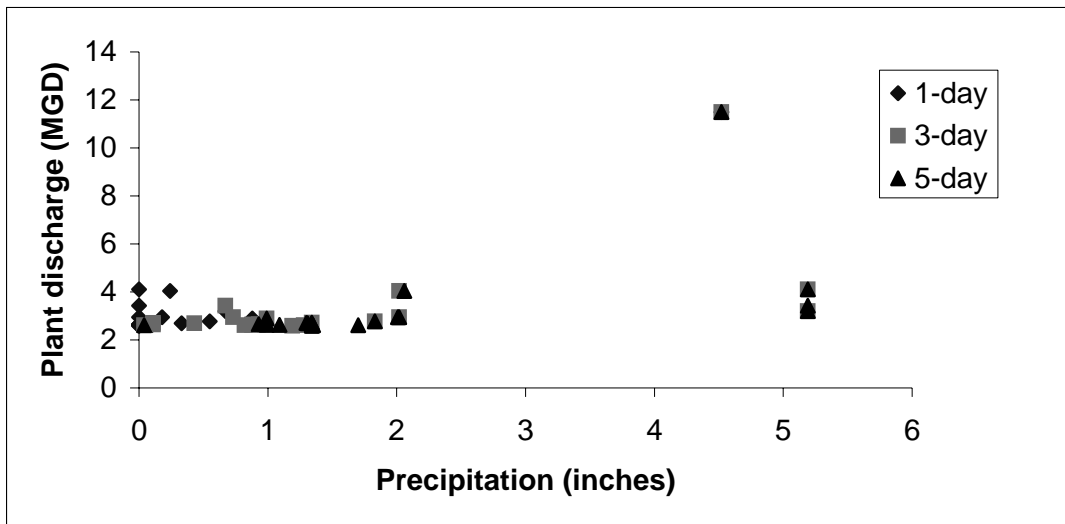
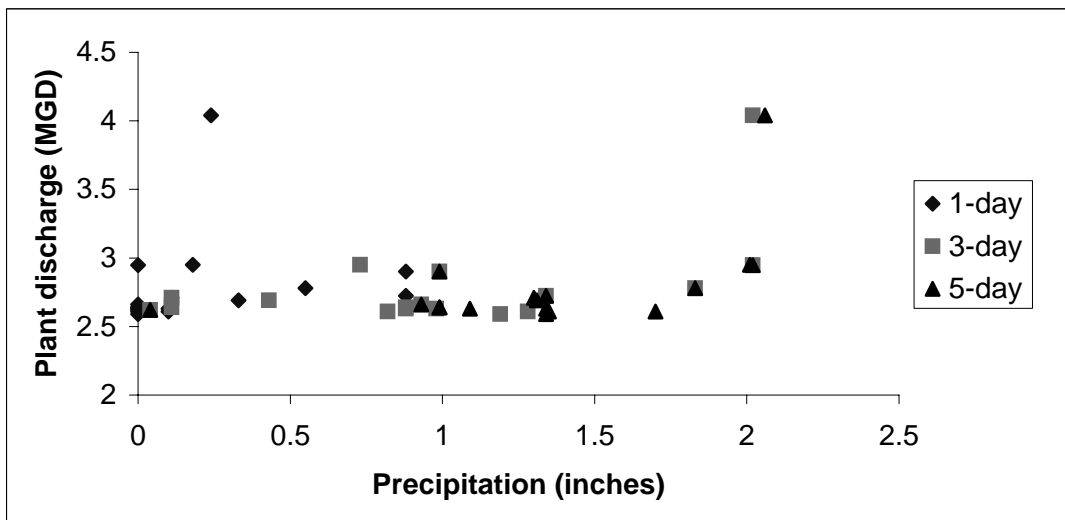
Figure 1. Hampton WWTF high-flow discharge versus 1-day, 3-day, and 5-day precipitation totals. Figure shows data with A) and without B) extreme event recorded on March 22, 2001. No strong relationship exists between high-flow discharge and total precipitation. Linear regressions show that no significant linear relationship exists between high-flow discharge and 1-day precipitation ($R^2 = 0.033$). However, a mild relationship was observed between plant discharge and 3-day ($R^2 = 0.30$) and 5-day ($R^2 = 0.28$) precipitation totals. (Data from March 22, 2001 through March 26, 2001 were treated as outliers and not included in the regression analyses)

The results from both WWTFs show only a minor relationship between high-flow plant discharges and precipitation events (Figures 1 and 2). In each data set there exists a single extreme event, 11.49 MGD on 3/22/2001 for Hampton and 16.8 MGD on 3/22/2001 for Dover caused by an extreme 1-day precipitation event that exceeded 4 inches. It is clear from the data (Figures 1 and 2) that less extreme high-flow plant discharge does not appear to be strongly controlled by precipitation at either of the 2 WWTFs we assessed. Regression analyses, not shown here, further supports this conclusion in that less than 40 % (when extreme events of 3/22/01 were removed from the analysis) of the observed variability in plant discharge could be explained by precipitation. In other words, high flows from WWTFs can occur with or without significant weather-related events.

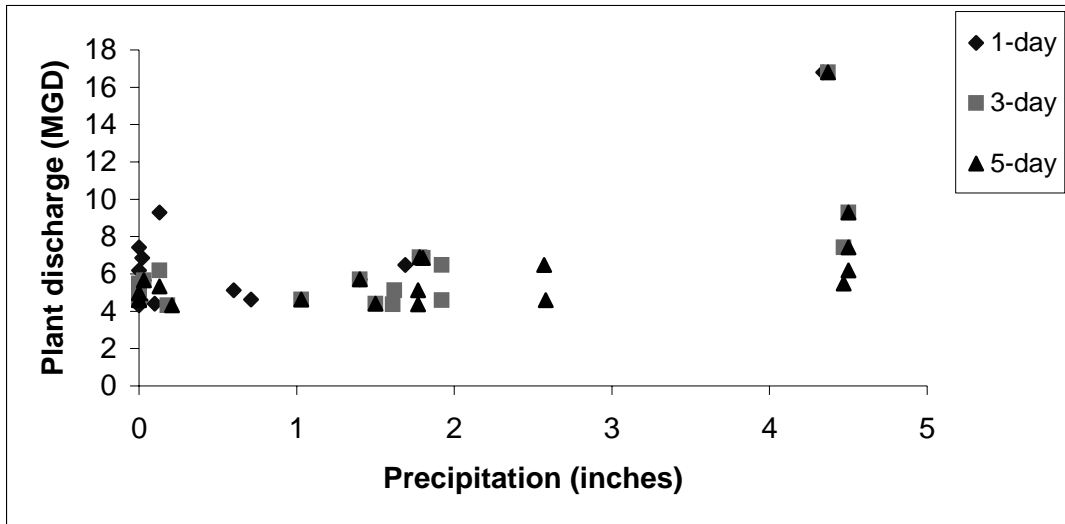
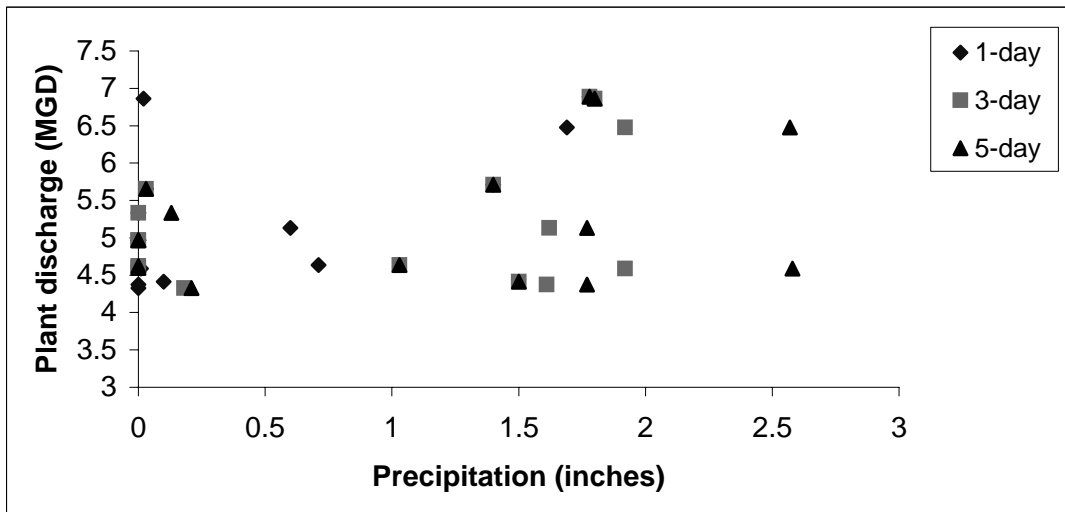
Figure 2. Dover WWTF high-flow discharge versus 1-day, 3-day, and 5-day precipitation totals. Figure shows data with A) and without B) extreme event recorded on March 22, 2001. No strong relationship exists between high-flow discharge and total precipitation. Linear regressions show that a moderate linear relationship exists between plant discharge and 1-day precipitation ($R^2 = 0.39$). Relationships between high-flow discharge and 3-day ($R^2 = 0.16$) and 5-day ($R^2 = 0.13$) precipitation totals were not as strong. (Data from March 22, 2001 through March 26, 2001 were treated as outliers and not included in the regression analyses)

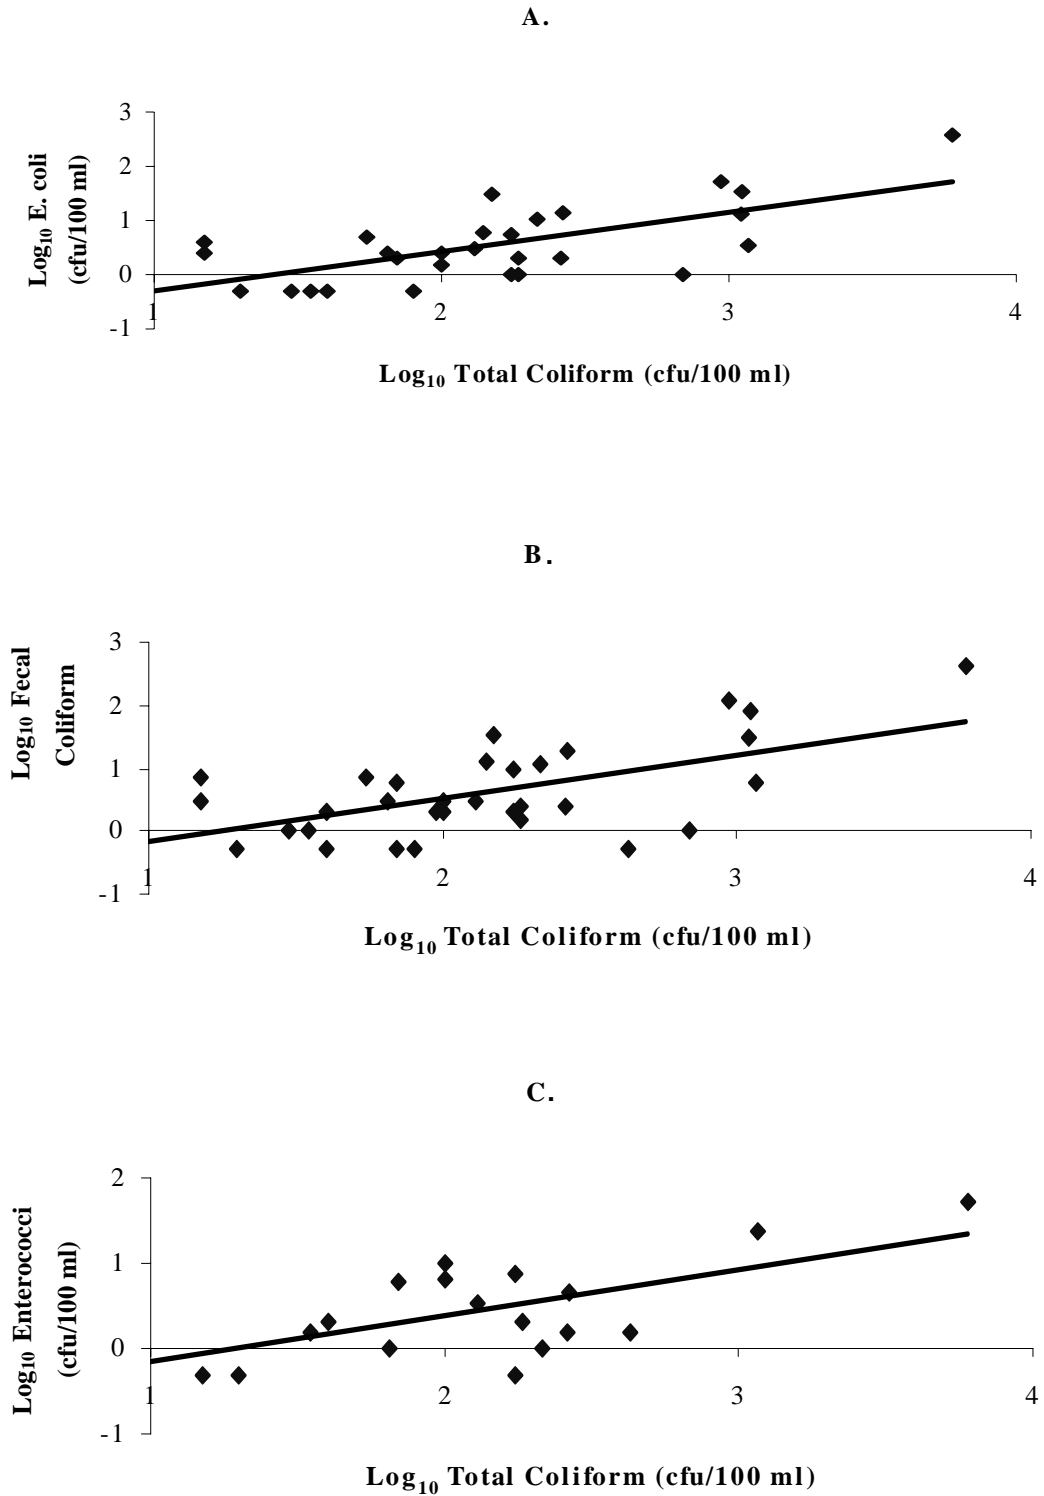
Figure 3: Regression analysis comparing total coliform concentrations with (A) *E. coli*, (B) fecal coliform and (C) enterococci concentrations from 11 WWTFs. Indicator concentrations were log₁₀ transformed.

The bacterial concentrations used in the analysis were \log_{10} transformed. This was deemed necessary as untransformed data were non-normally distributed. The regression analyses performed between bacterial indicator concentrations exhibited low to moderate correlations for the majority of comparisons (Table 6, Figure 3). The least significant relationship was observed between total coliform and fecal coliform concentrations ($R^2=0.4138$, $p<0.05$) and the most significant relationship was found between *E. coli* and fecal coliform concentrations ($R^2=0.9592$, $p<0.05$). The relationship between total and fecal coliforms, while poor, is an important comparison because of the wide use of total coliforms at the WWTF in NPDES monitoring. It is presumed that the ubiquitous nature of total coliforms and their potential to be present independent of fecal contamination contributed to the poor and erratic concentrations observed during the study, and resulted in the poor relationship. Similar results were observed in a previous study of the Exeter WWTF (Jones, 1990), and the suggestion was made to not use total coliforms as a fecal contamination indicator. The strong relationship between *E. coli* and fecal coliform concentrations is not surprising as the analytical methods are similar because they rely on the same growth media (i.e., mTEC). The fact that enterococci are not at all similar to coliforms is borne out in the poor relationships between the two groups of organisms and probably reflects differences in survival through the treatment process.

While all of the relationships between bacterial indicators were significant at the 0.05-level, the R^2 -values and standard errors indicate that the regression analyses for these comparisons should be used only as a loose guideline when calculating unknown bacterial concentrations. As an example, if the total coliform concentration of a WWTF sample was 100 cfu per 100 ml, it would be possible to estimate the fecal coliform concentration based on the following equation (Table 6): $\log(\text{fecal coliform}) = 0.6909 (\pm 0.30) * \log(\text{total coliform}) - 0.8567 (\pm 0.65)$. Inserting the total coliform concentration of 100 into the equation and accounting for the standard error in the parameters, it is possible to estimate a fecal coliform concentration ranging between 0.19 and 59 cfu per

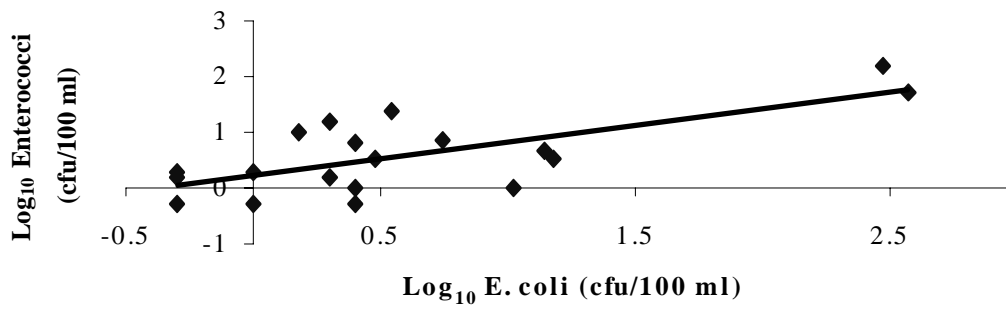
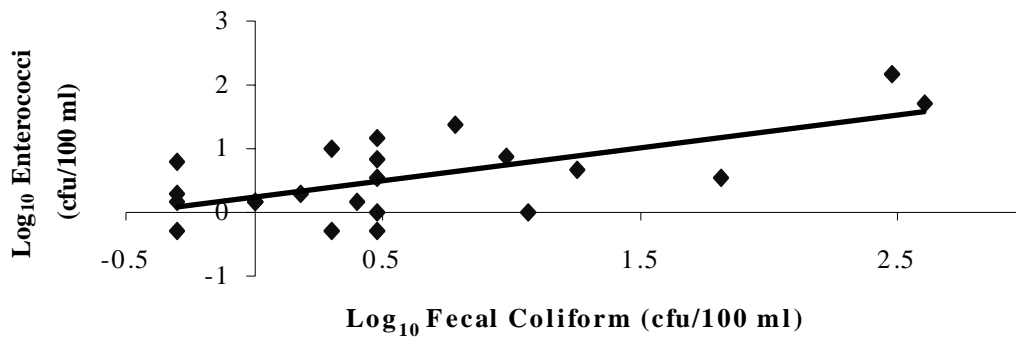
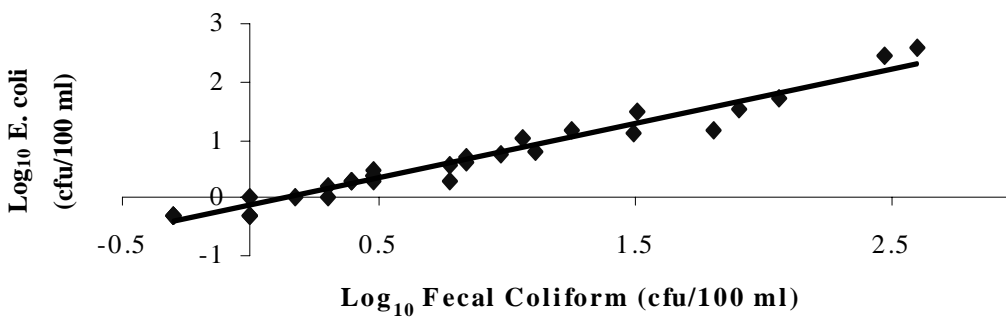
Figure 3 (continued): Regression analysis comparing (D) E. coli and enterococci, (E) fecal coliform and enterococci and (F) fecal coliform and E. coli concentrations from 11 WWTFs. Indicator concentrations were log_{10} transformed.

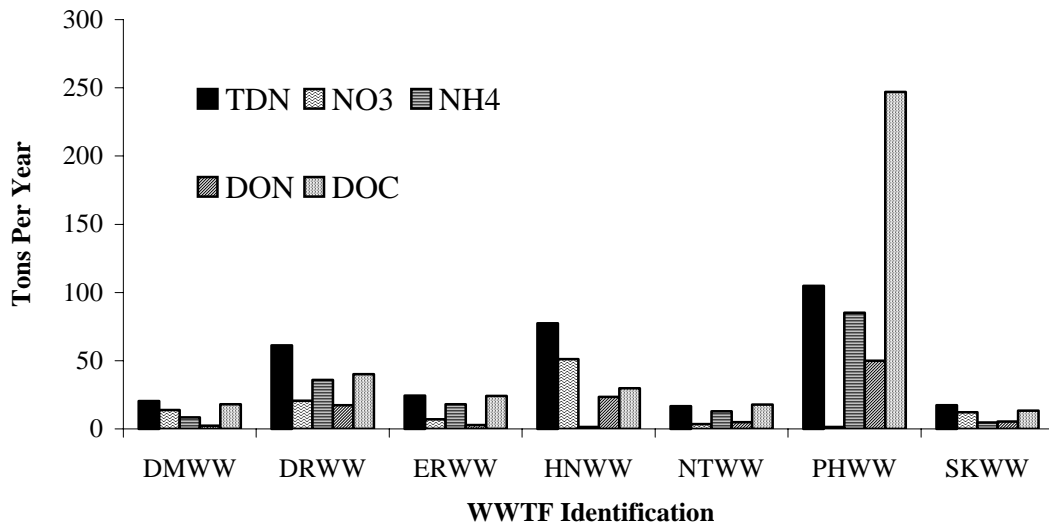
Figure 4: Nutrient loading at seven WWTFs. Loading is expressed as tons per year.

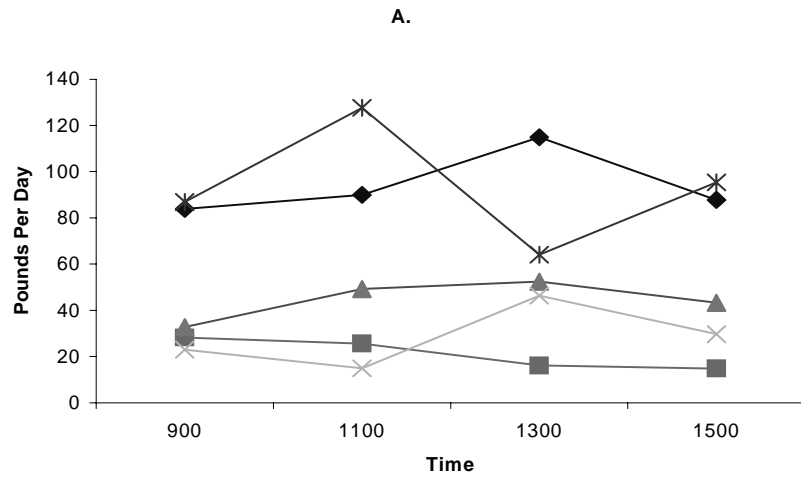
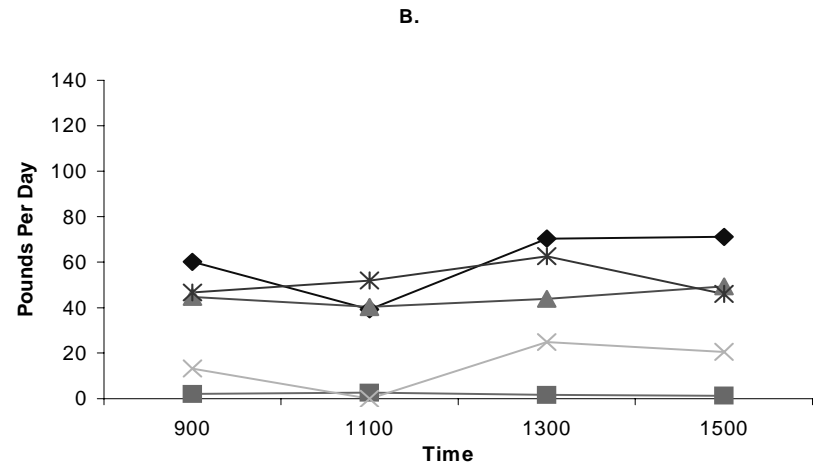
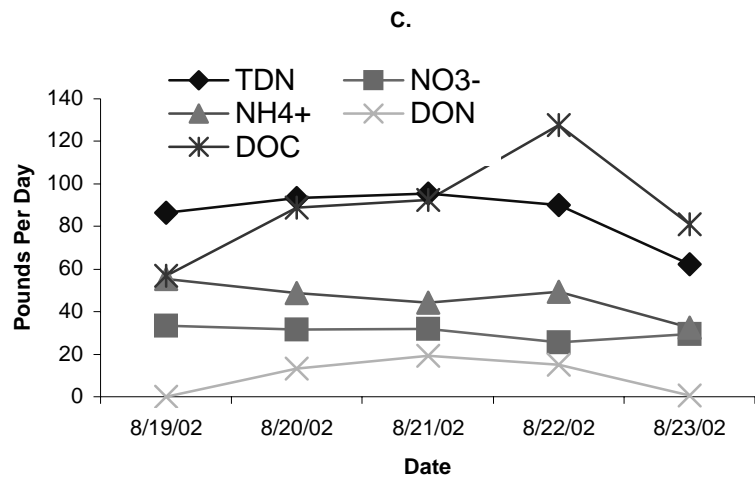
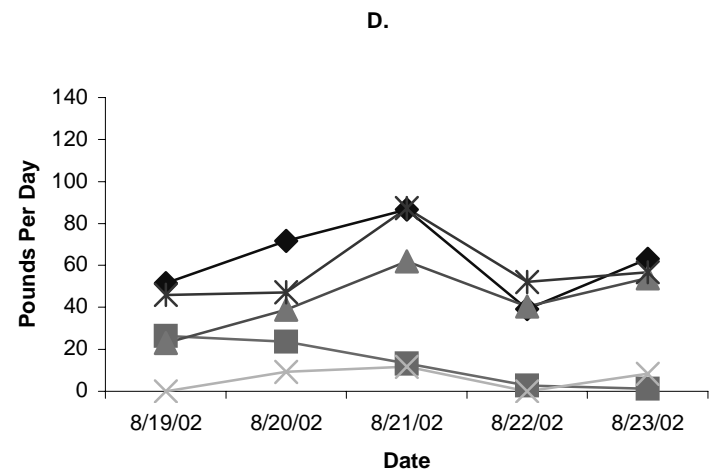
Figure 5: Daily and weekly variability in nutrient loading measurements at two subject WWTFs. (A) One day loading at NTWW, (B) one day loading at DMWW, (C) five day loading at NTWW and (D) five day loading at DMWW

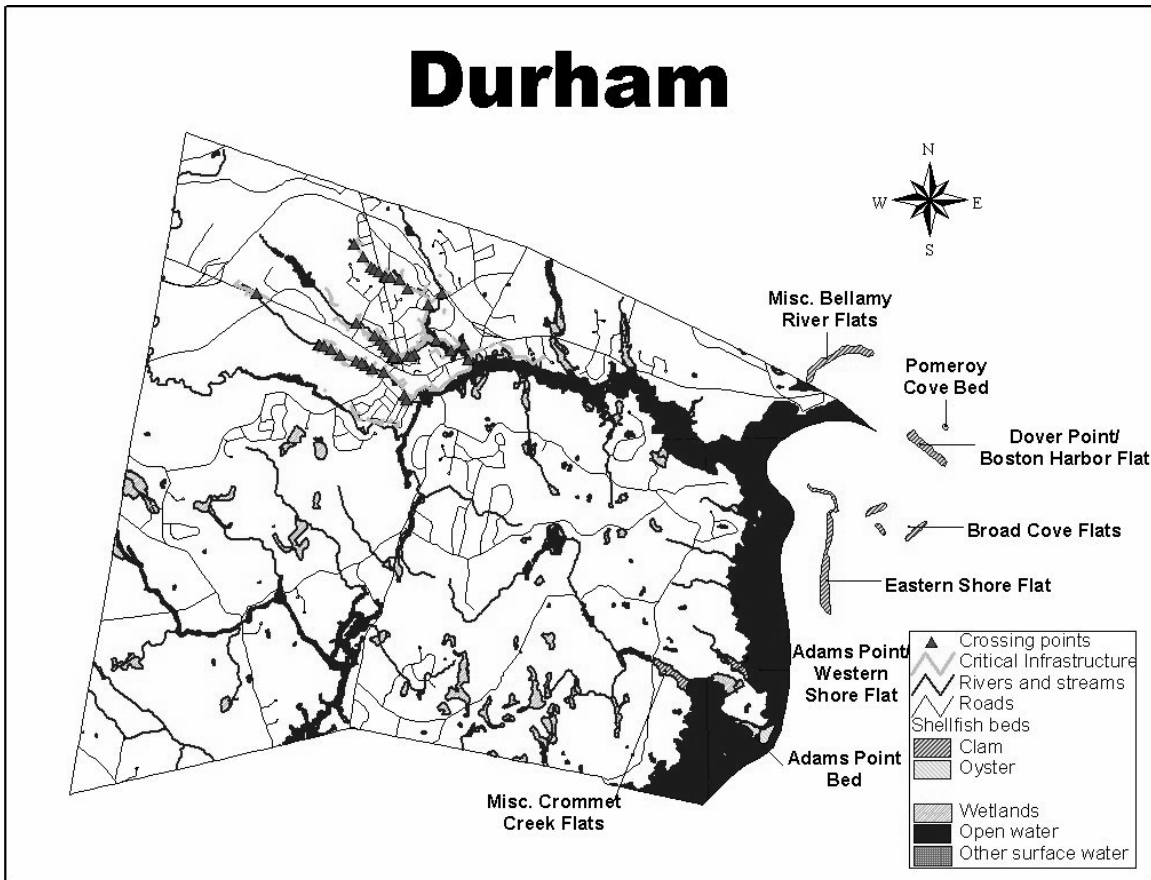
Figure 6: Sewer infrastructure map for Durham, NH showing critical infrastructure areas, including locations in which sewer lines cross surface water bodies.

Much of the infrastructure associated with the town of Durham and the University of New Hampshire appears to be below pavement or in areas that were not accessible during this study. The site that was investigated was at the mouth of Beards Creek near Rt. 4. A previous study had shown evidence of exfiltration of bacteria and freshwater into tidal waters at this site on one date, but was not observed on several other dates (Jones and Langan, 1994) and no signs (visual or olfactory) of exfiltration were observed during the site visit.

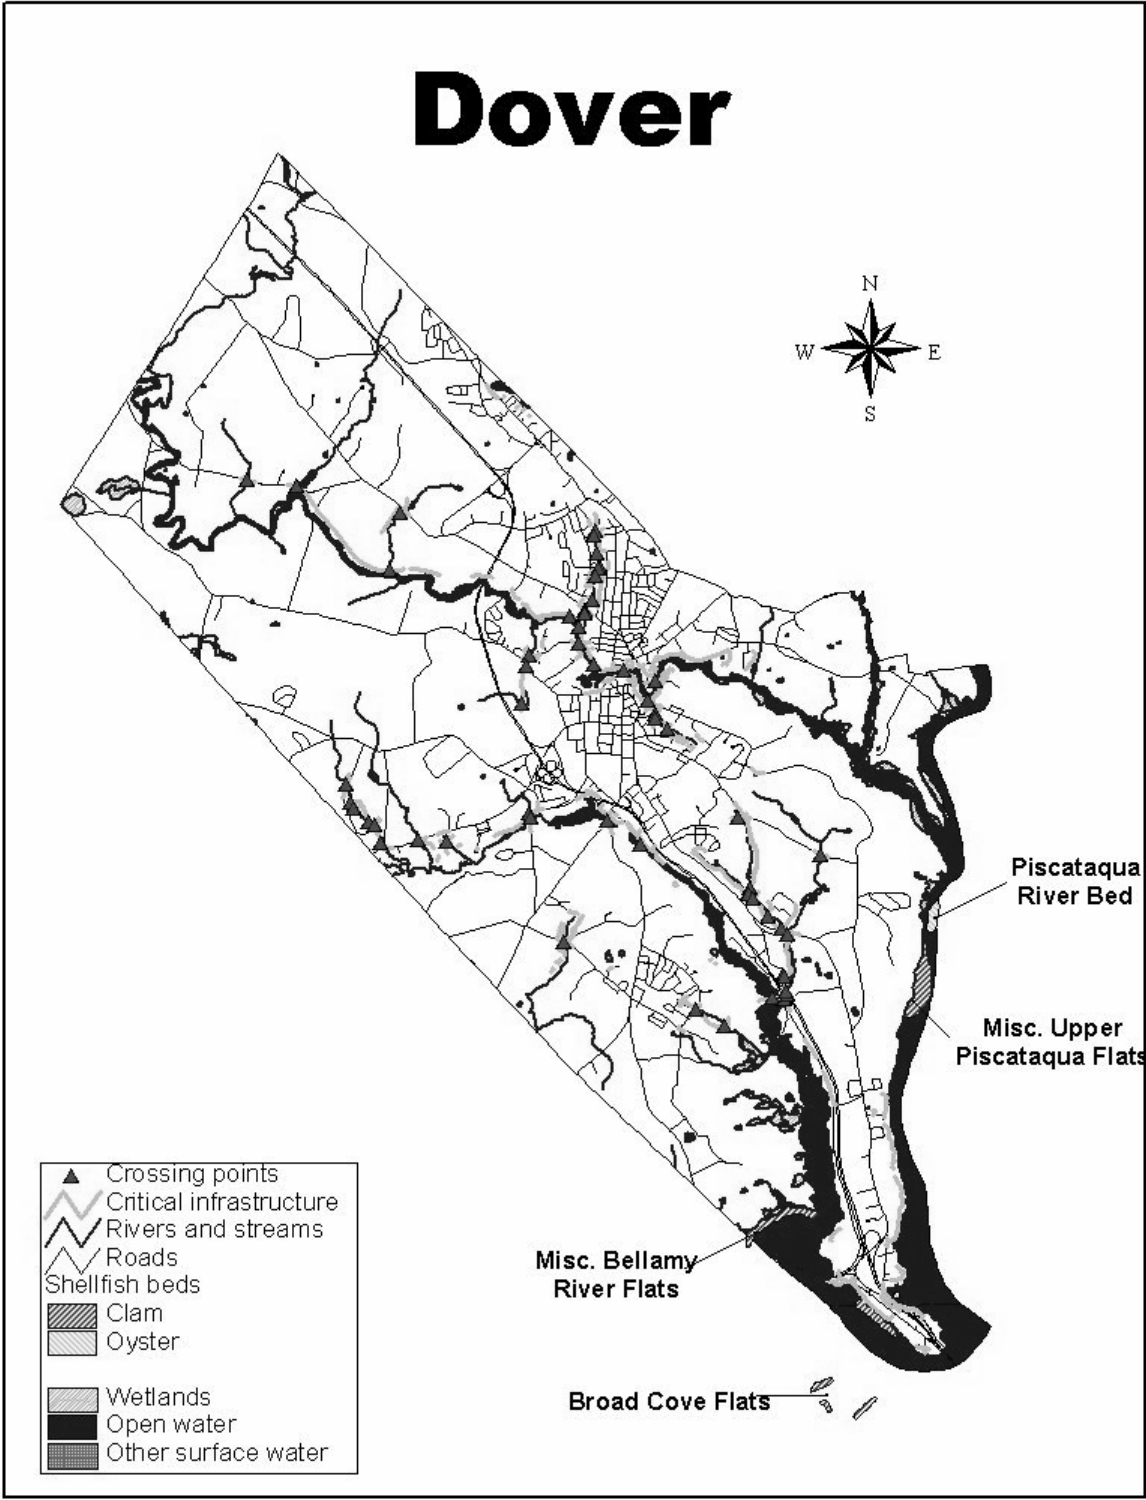
Figure 7: Sewer infrastructure map for Dover, NH showing critical infrastructure areas, including locations in which sewer lines cross surface water bodies.

Extensive sewer infrastructure is located in a residential area of Dover Point in the City of Dover. No direct observations were possible from land. Sewer infrastructure was observed directly in Canney Brook at Spur Road just west of Rt. 16. Multiple river crossings are also located along Burr Brook near Hough Road in Dover. Burr Brook is culverted and not in close proximity to the sewer pipe and is not likely impacted by sewer infrastructure. There was evidence of sewer repairs in this area, however. Sewer pipe infrastructure was also observed crossing the Cocheco River (associated with River Street Pump Station). All other sewer crossing locations along 6th Street, Washington Street and Rt. 155 appeared to be relatively new with no signs of exfiltration.

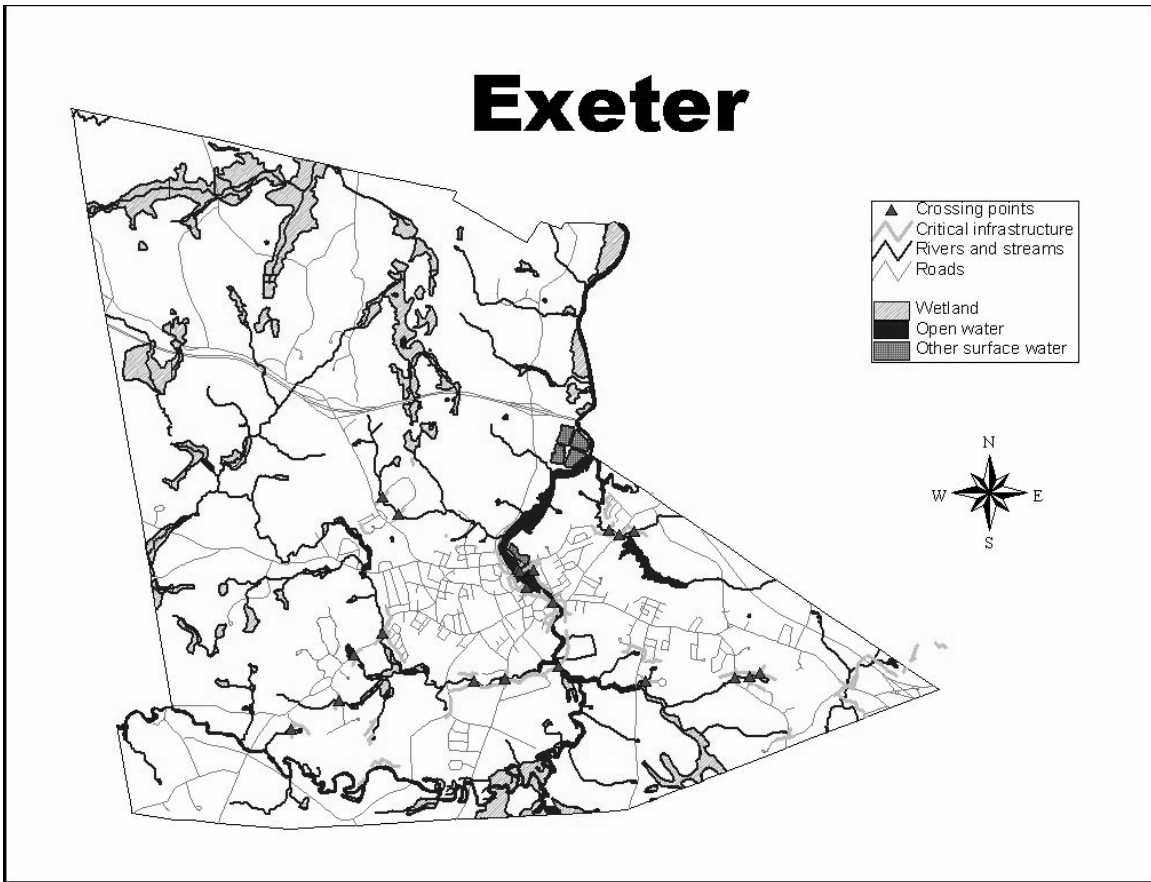
Figure 8: Sewer infrastructure map for Exeter, NH showing critical infrastructure areas, including locations in which sewer lines cross surface water bodies.

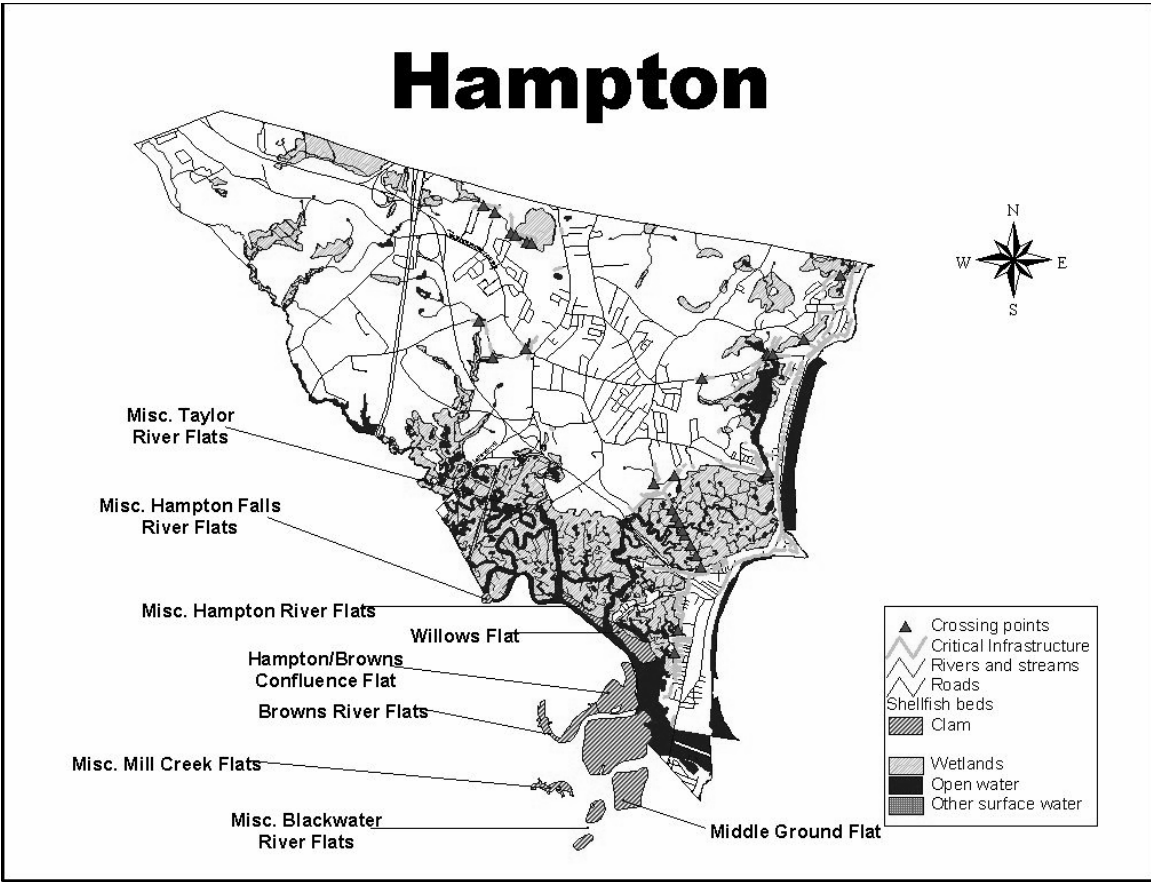
Hampton

Figure 9: Sewer infrastructure map for Hampton, NH showing critical infrastructure areas, including locations in which sewer lines cross surface water bodies.

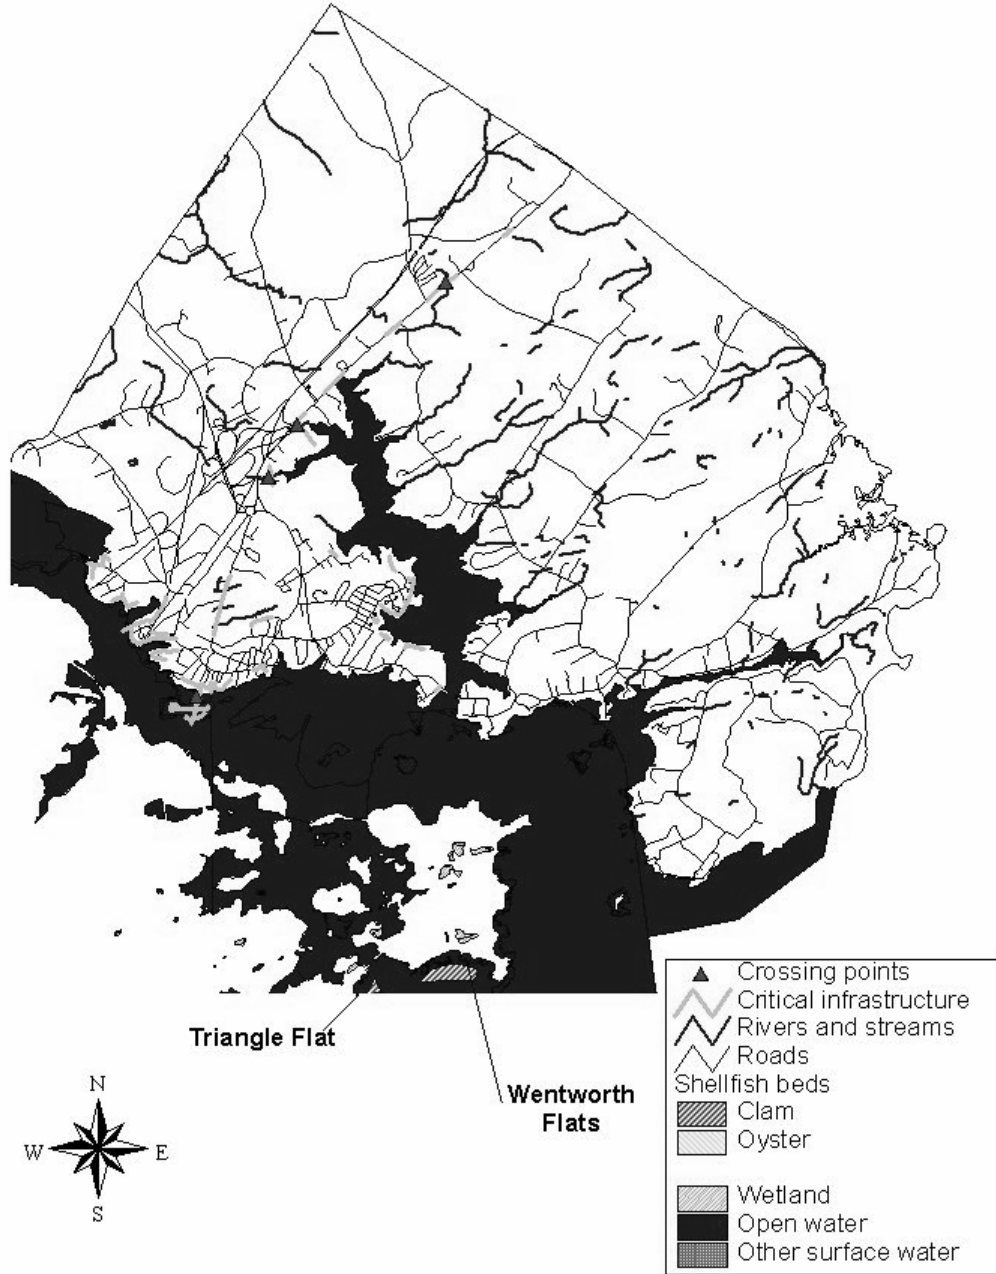
Kittery

Figure 10: Sewer infrastructure map for Kittery, ME showing critical infrastructure areas, including locations in which sewer lines cross surface water bodies.

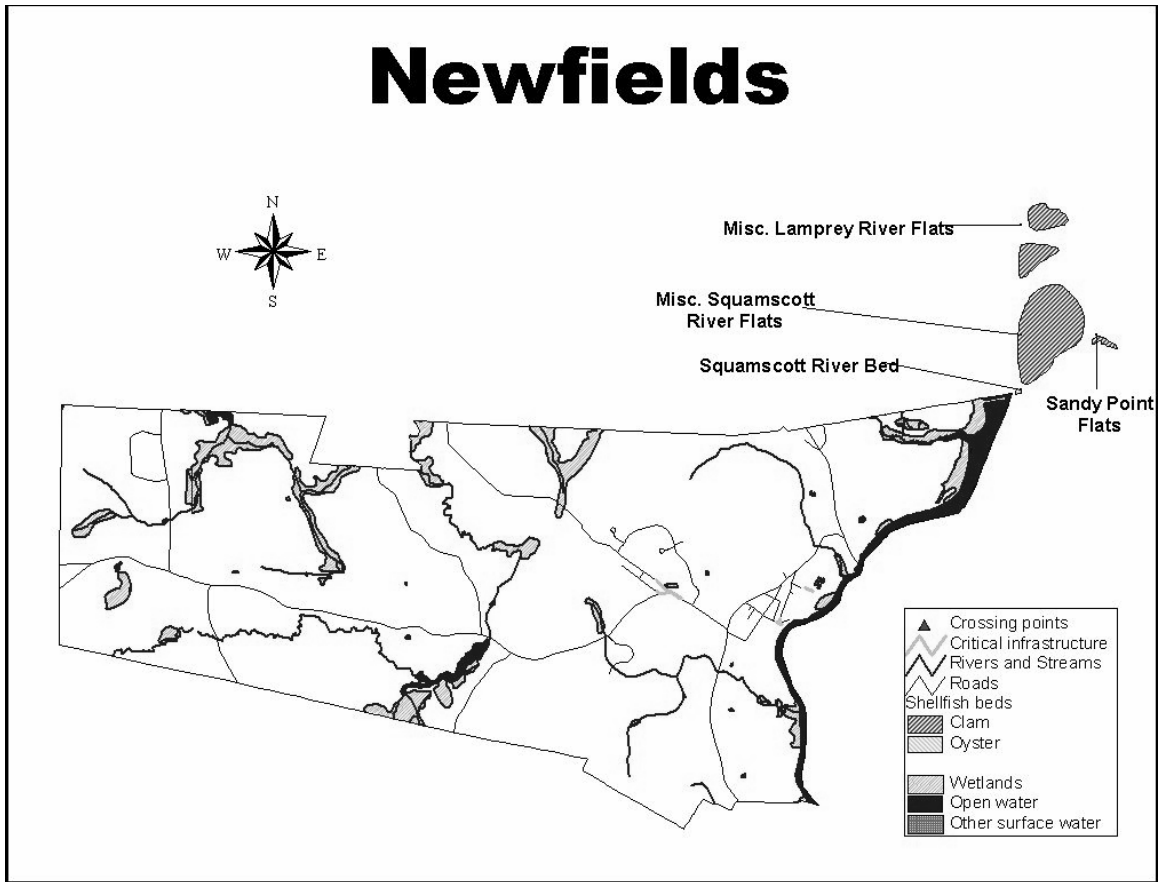
Newfields

Figure 11: Sewer infrastructure map for Newfields, NH showing critical infrastructure areas.

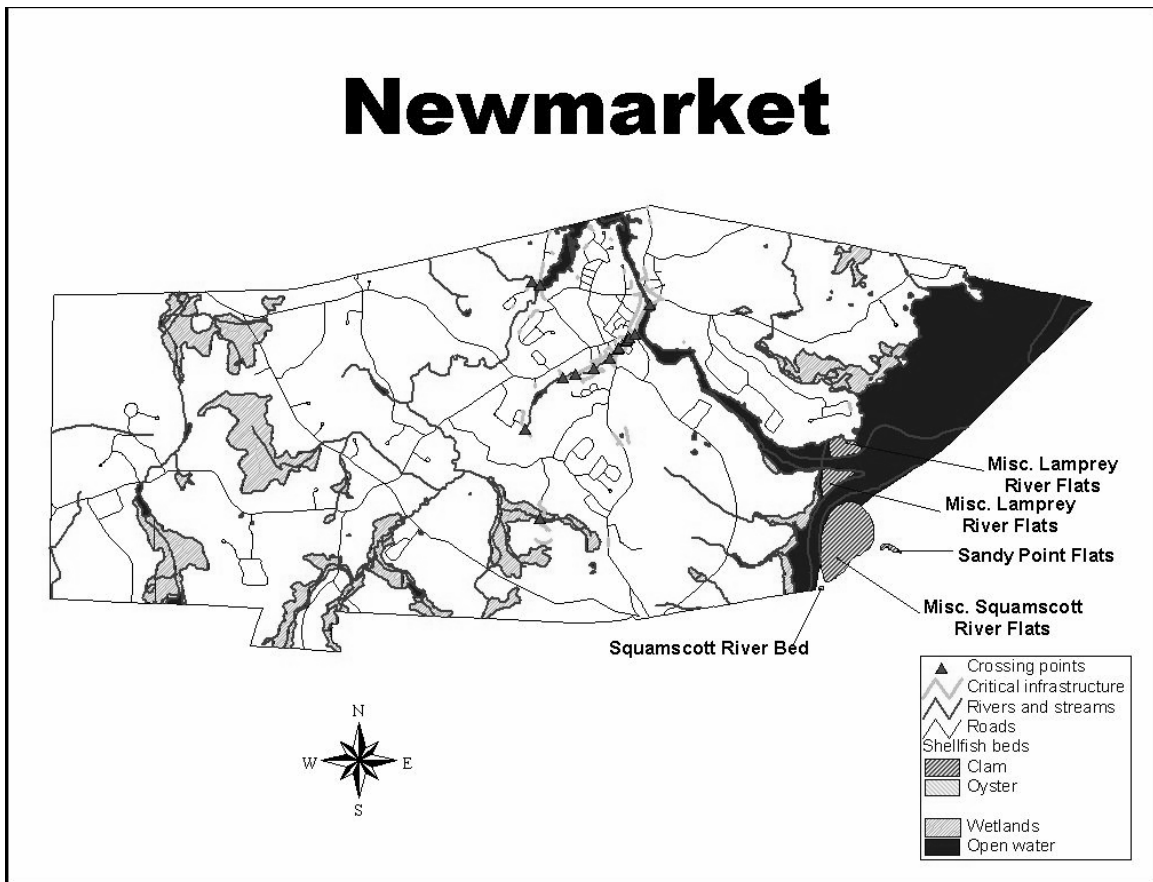
Newmarket

Figure 12: Sewer infrastructure map for Newmarket, NH showing critical infrastructure areas, including locations in which sewer lines cross surface water bodies.

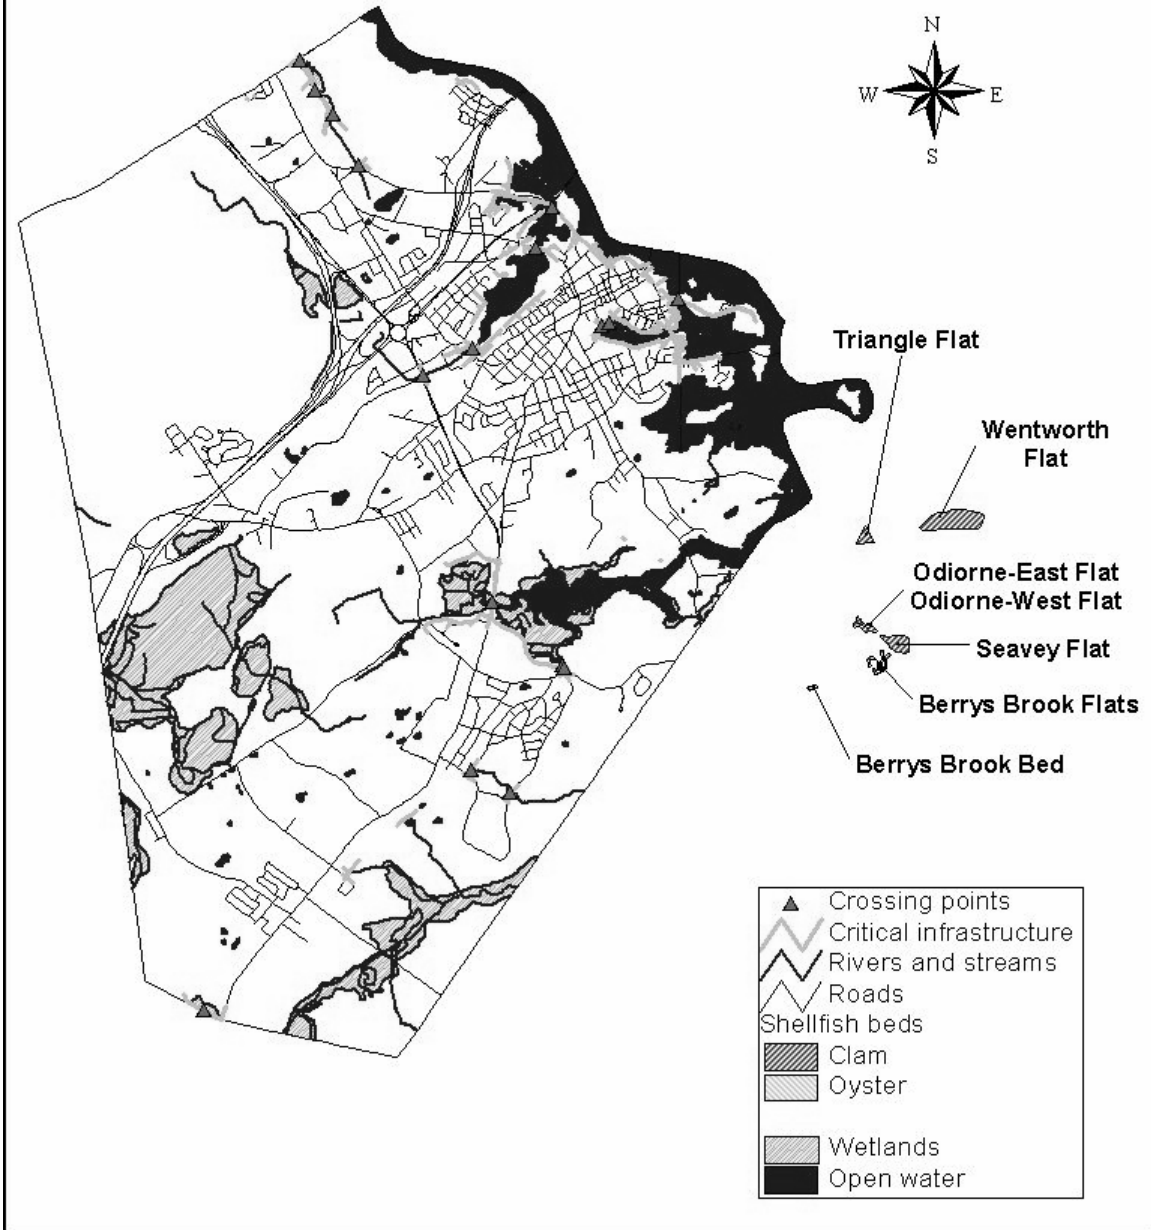
Figure 13: Sewer infrastructure map for Portsmouth, NH showing critical infrastructure areas, including locations in which sewer lines cross surface water bodies.

Sewer infrastructure around North Mill Pond in Portsmouth was identified at Bartlett Avenue and Maplewood/Vaughn Avenues. Visible sewer infrastructure was also observed at a bridge crossing out to Pierce Island and the Portsmouth WWTF. Investigations were also performed around South Mill Pond in Portsmouth. Although no visible crossings were identified, an on-going sewer replacement project was underway to remove the associated combined sewer overflow currently in place. An additional crossing was also noted at the Rt. 1/Sagamore Creek crossing in Portsmouth, but could not be accessed from the shore.

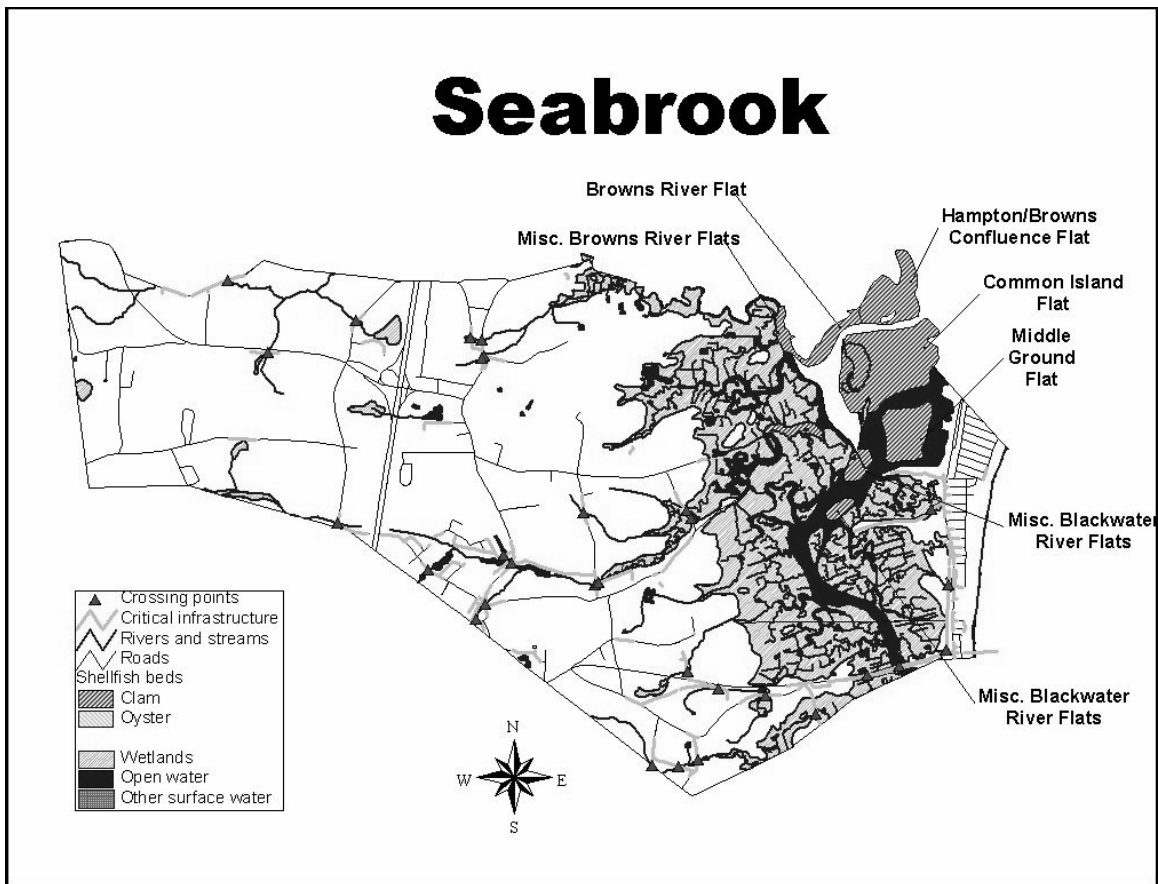
Seabrook

Figure 14: Sewer infrastructure map for Seabrook, NH showing critical infrastructure areas, including locations in which sewer lines cross surface water bodies.

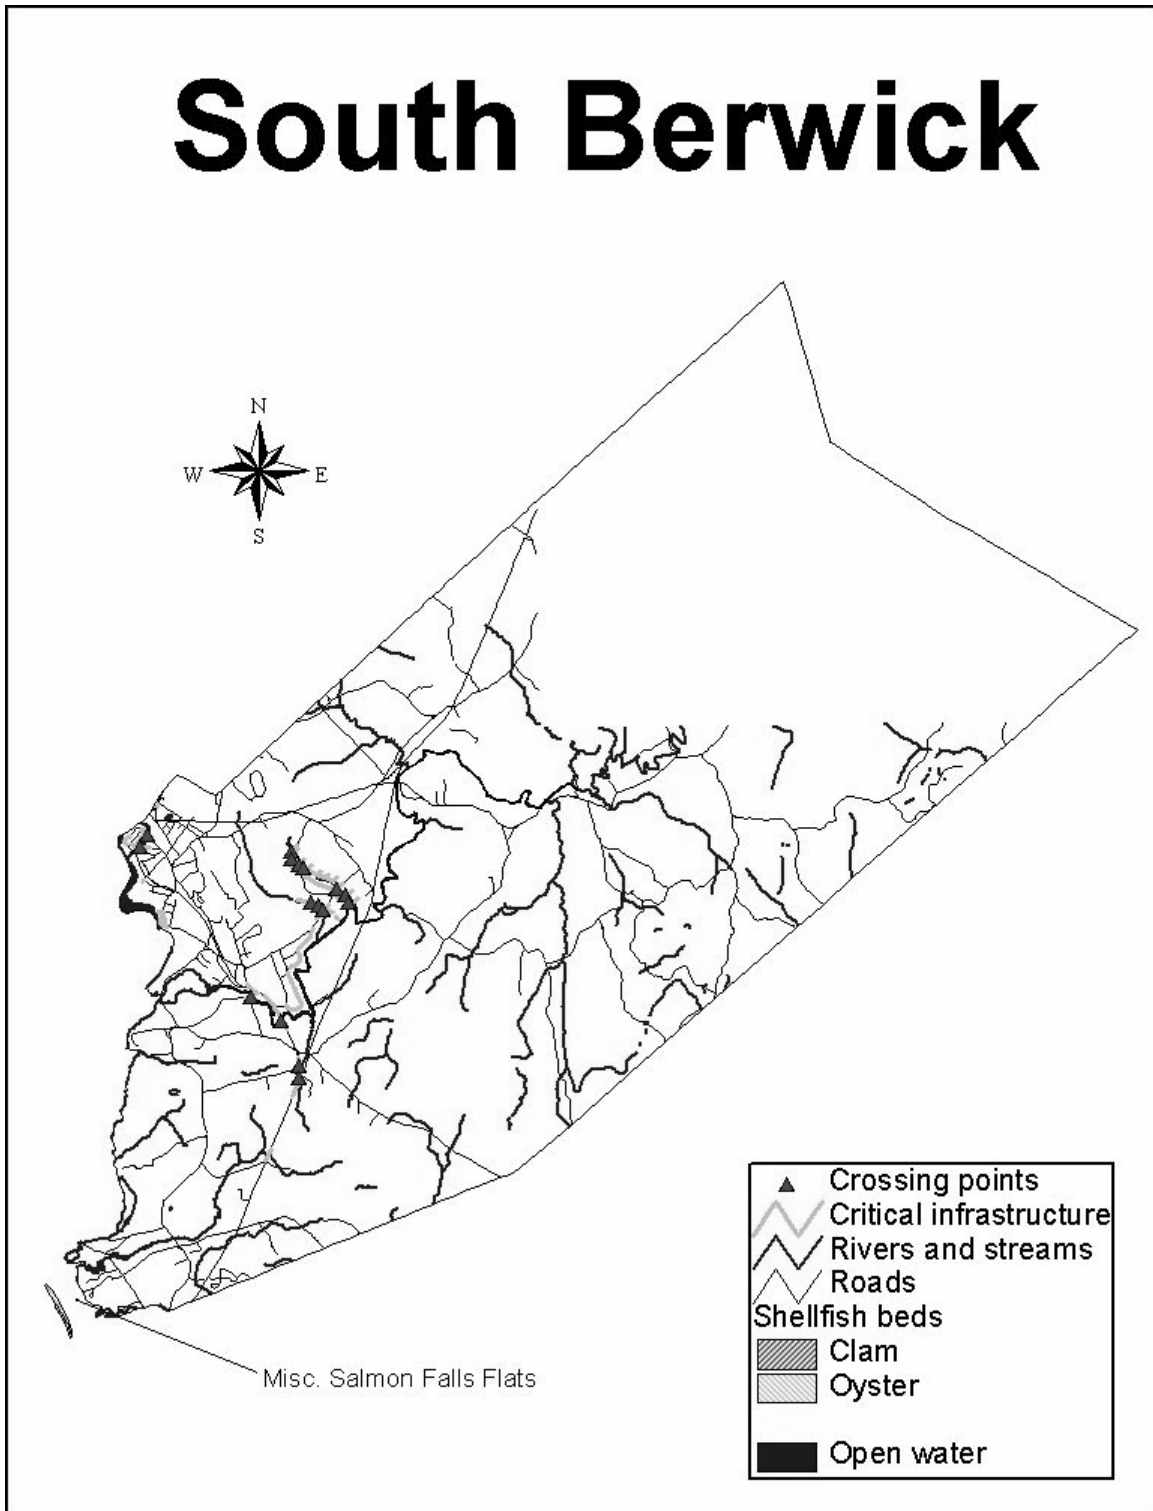
South Berwick

Figure 15: Sewer infrastructure map for South Berwick, ME showing critical infrastructure areas, including locations in which sewer lines cross surface water bodies.
